Neill-Cochran House Museum Slave Quarters Project
City of Austin Heritage Grant Application 2022

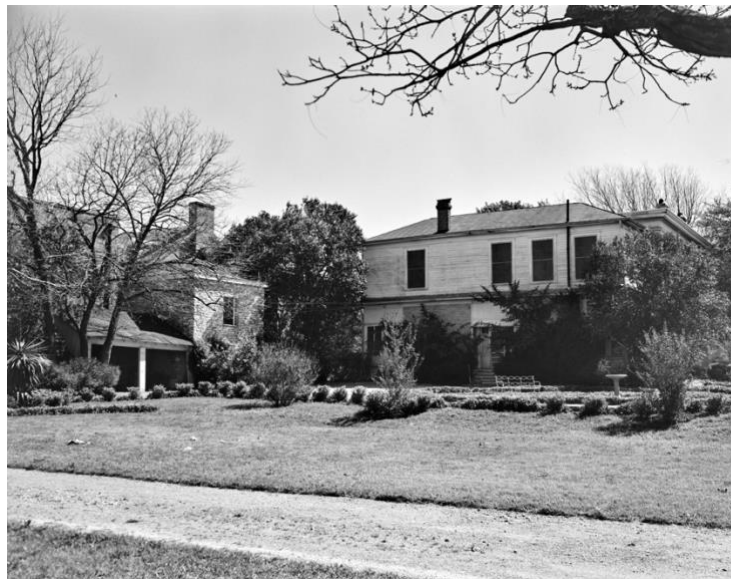
This photograph from c. 1960 soon after the NSCDA-TX acquired the property shows the back of the main house (you see the 1900 addition) along with the Slave Quarters to the left, and the carport that the Cochrans constructed just to the west of the Slave Quarters.

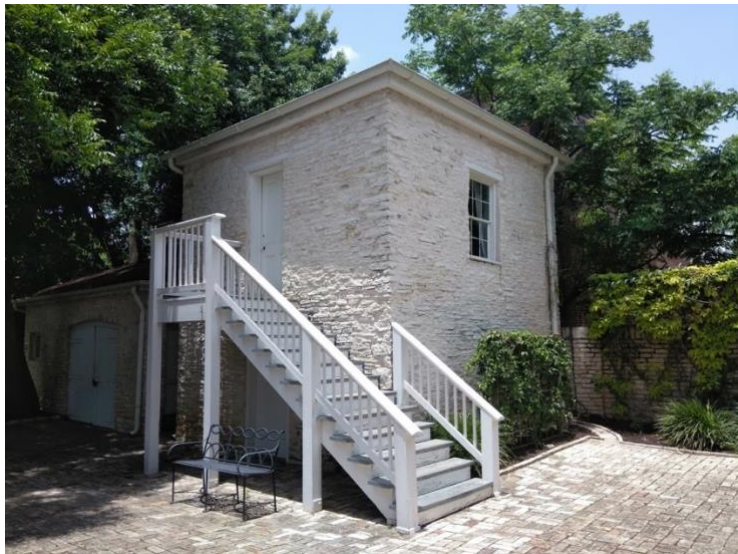
Contemporary view of the Slave Quarters from the southeast. The east façade window and 2 south façade doors are visible from this angle, along with the exterior staircase.

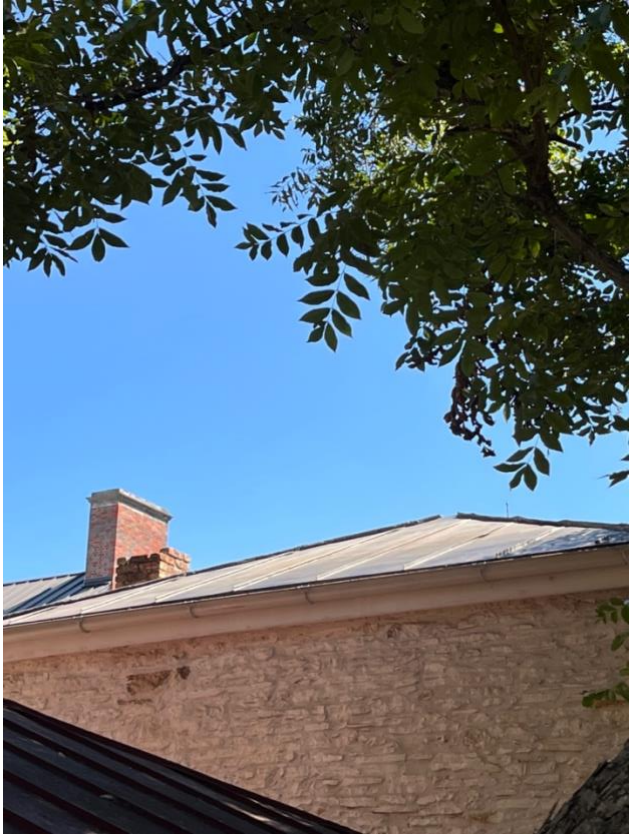
View of the roof and chimney from the west side. The chimney in the background is from the Texas Federation of Women's Clubs next door. The Slave Quarters chimney is in the foreground and has almost entirely deteriorated.

Work will be completed to restore, stabilize, and cap the chimney.

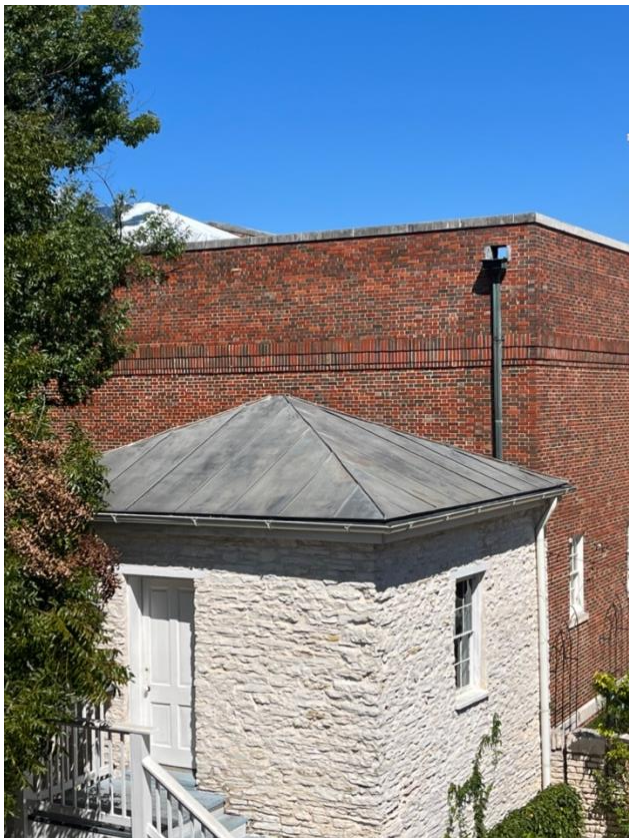
The metal roof has not been addressed in decades. We will conduct necessary repair and then will add a protective coating.

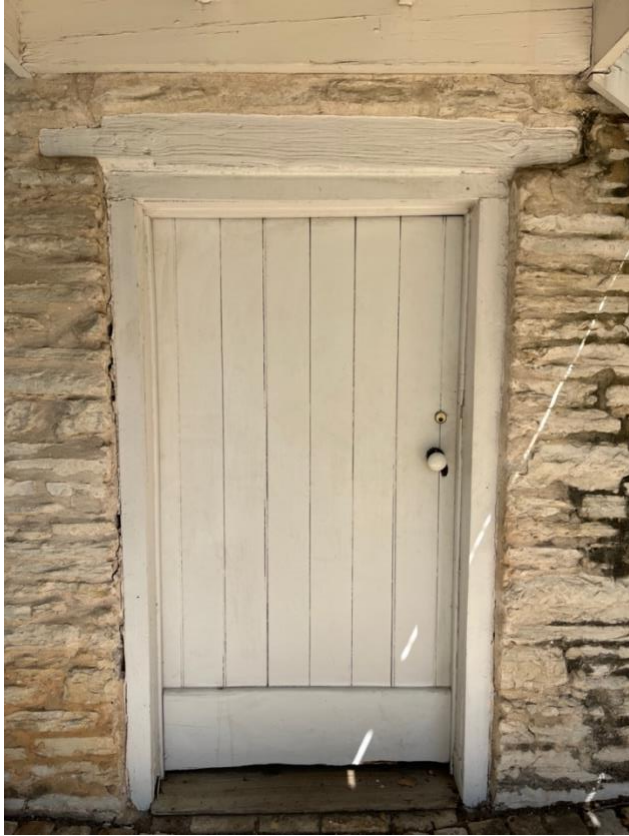
The first floor door has been cut down and altered over time as the elements have warped it. The door will be completely replaced, including the hardware, which has failed.

Wood trim and the structural lintel will be repainted to protect all wood surfaces.

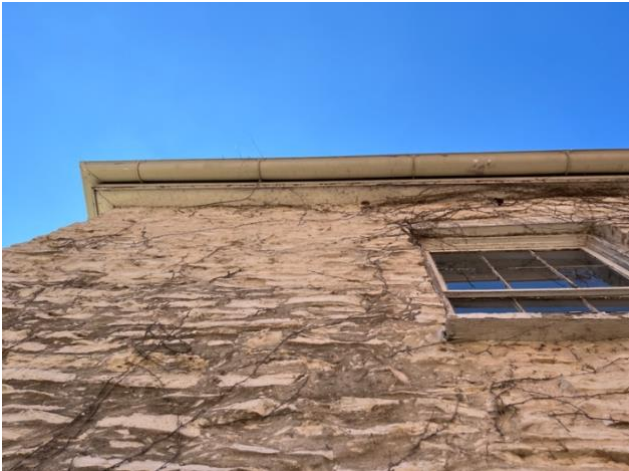
Wood fascia beneath the roof needs to be stripped and repainted to protect the original fabric.

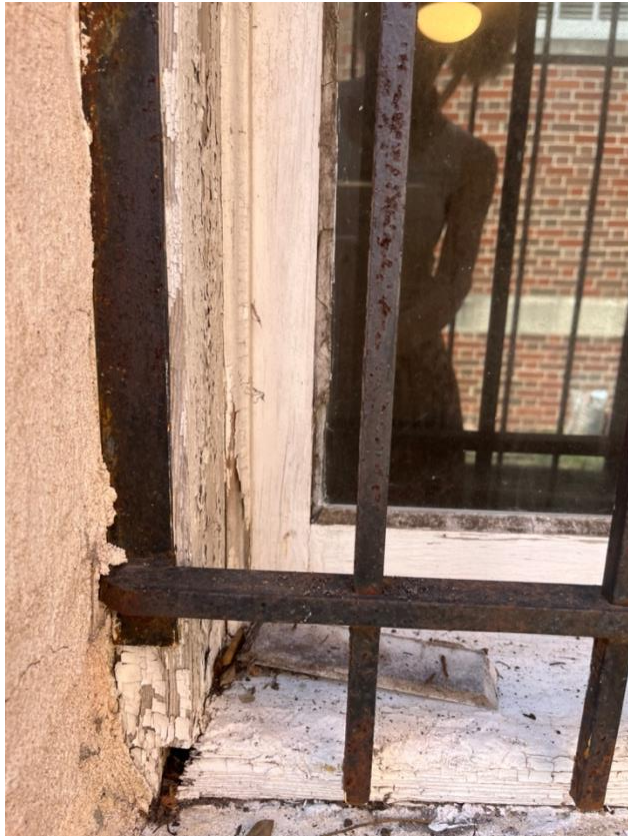
The first floor wood window has deteriorated over time and requires repair and repainting.

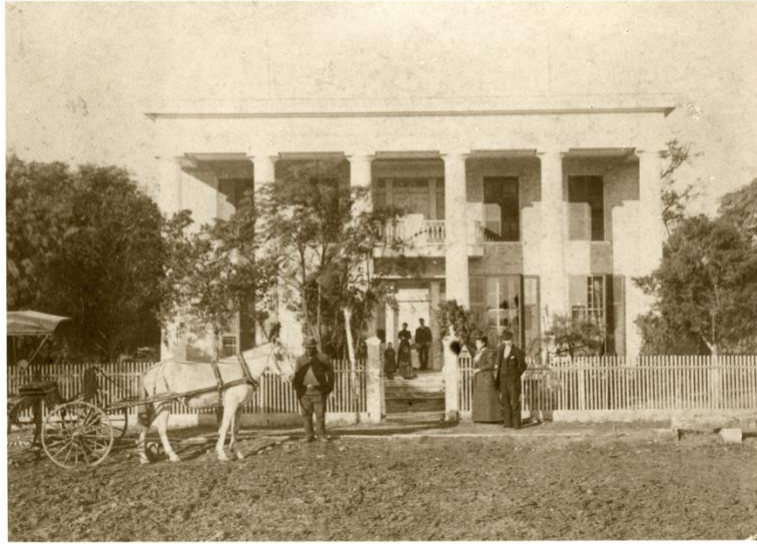
While this photograph c. 1893 (just after the Cochrans moved into the home) shows the front of the main house and not the Slave Quarters, the image is suggestive of the larger property and the way the site was run at this time.

The property was fenced with white palings, it was well-shaded with trees around the main house, and you see a man standing at the head of the single horse buggy who likely was responsible for care for the horse as well as for the

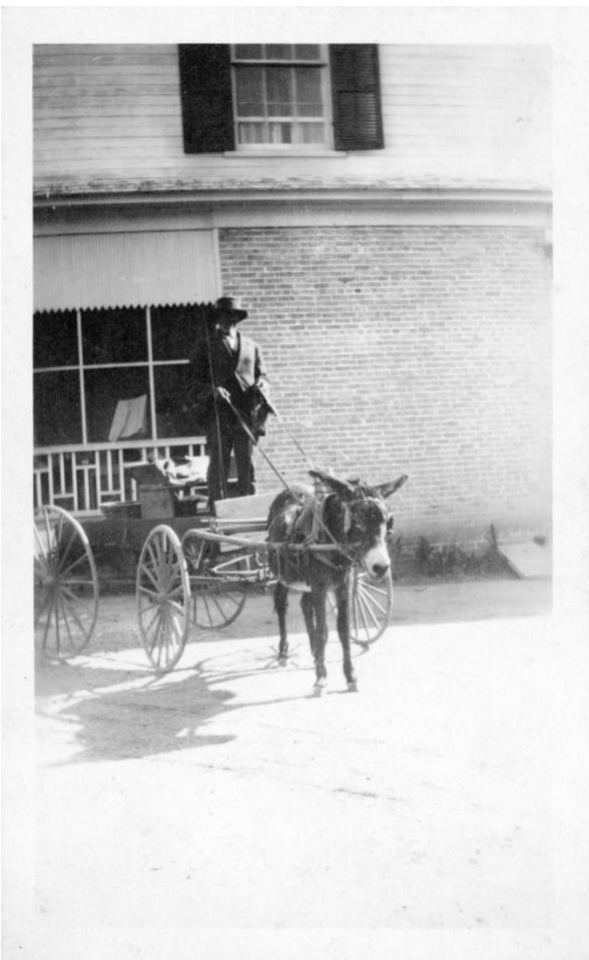
Rufus Howard is one of the individuals the NCHM will include in new interpretive materials. You see Mr. Howard, who worked on the grounds of the NCHM as well as at UT-Austin and who lived nearby in Wheatville, standing on his cart and holding the reins to control his donkey. UT records show that Mr. Howard hauled materials to and from campus during the 1920s and 1930s as the University expanded.

The photographer is facing east, and the 1900 addition to the main house is visible behind Mr. Howard and his cart. The Slave Quarters building stands unseen to the viewer's left outside of the camera's field of vision.
