## **PLANS AND SPECIFICATIONS OF PROPOSED WORK**

# PARAMOUNT EAST WALL - PROJECT AREA PHOTOS

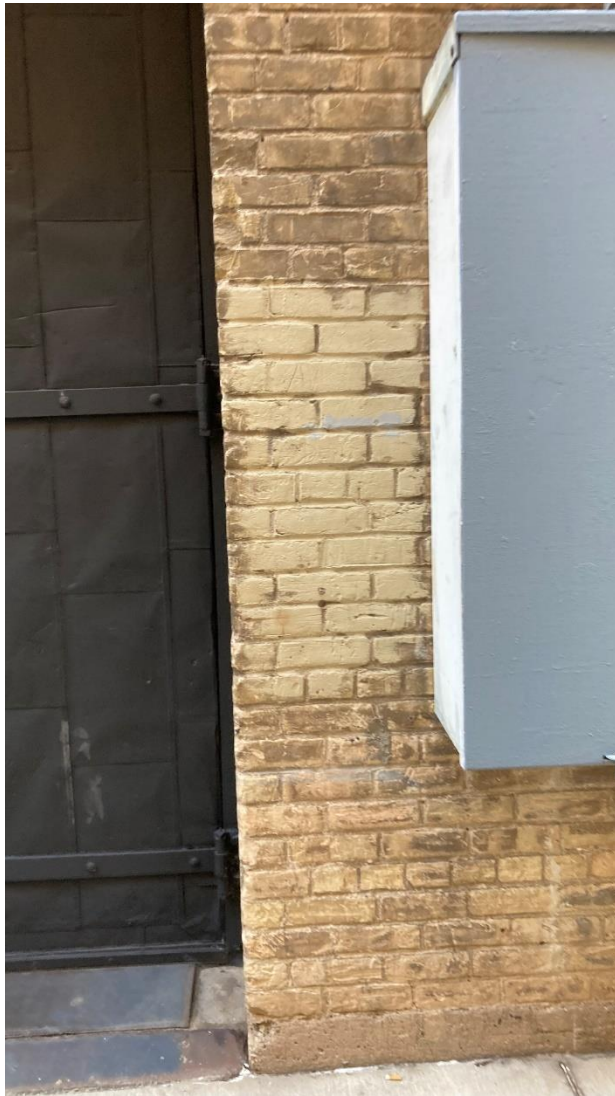
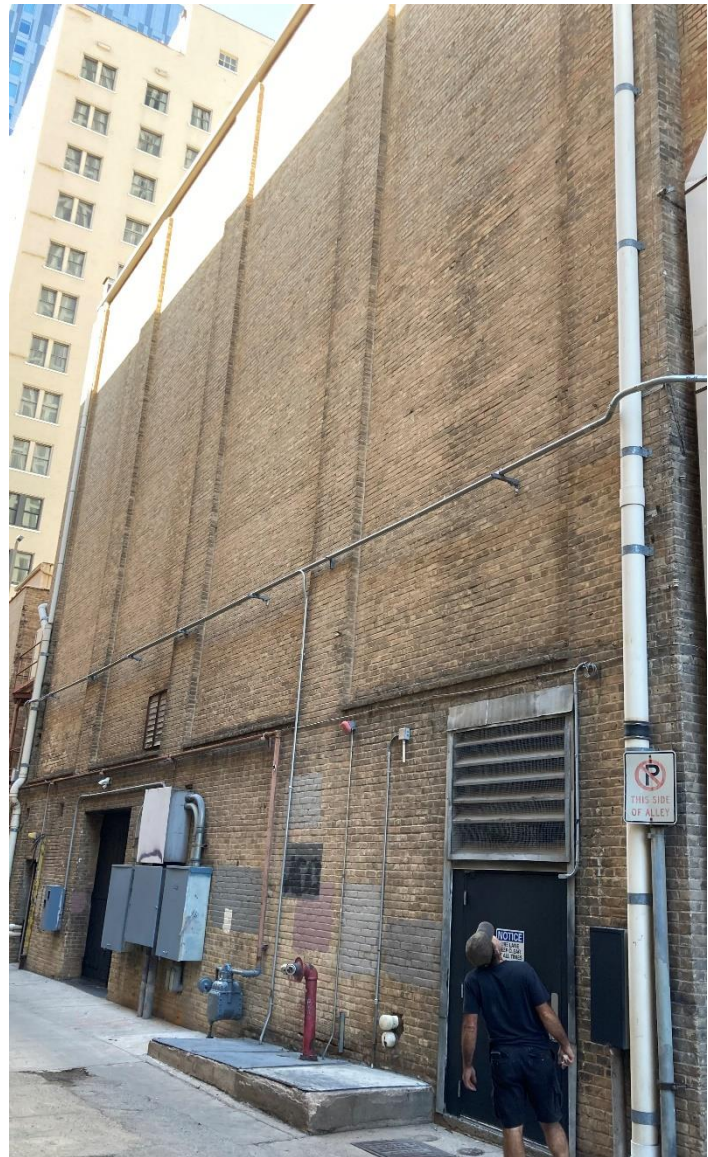
1. Paramount East Wall
2. Paramount East Wall north of stage door
3. Paramount East Wall lower central portion
4. Paramount East Wall center
5. Paramount East Wall west wall 16' above surface grade. Abandoned pipes to be removed and area to be filled.

The selected contractor will deliver and install, supervise, provide material and labor for the repointing of the visible and confirmed damaged mortar at the Paramount Theatre's east wall. The east wall will also be repaired in vulnerable areas such as lentils, sills and water tables. The wall will be patched and repaired in all needed areas. All unused nails, pipe, etc. will be removed from the wall. All penetrations will be patched and repaired.

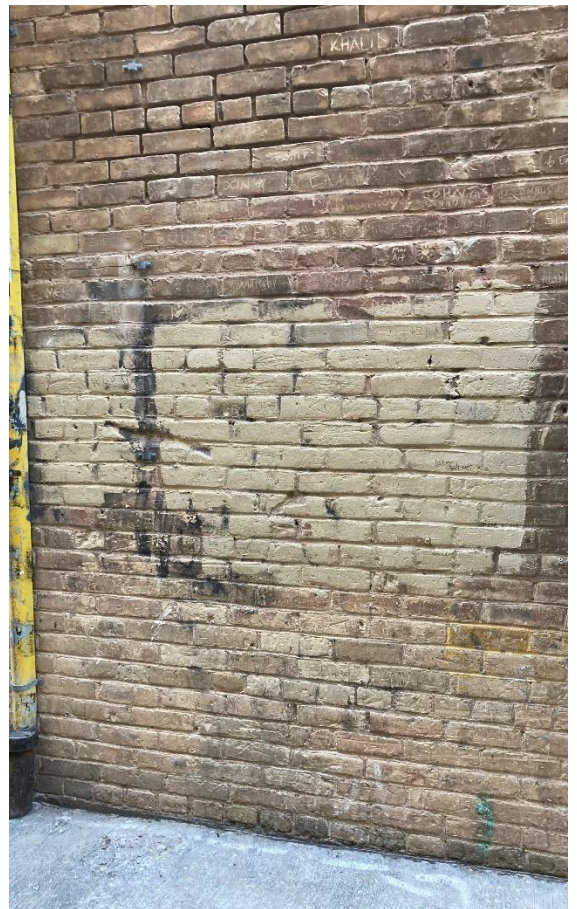
6. Paramount East Wall center lower
7. Paramount East Wall center lower
8. Paramount parapet southwest corner upper stage roof. Iron structure to be removed. Walls to be filled, flashed and coping installed

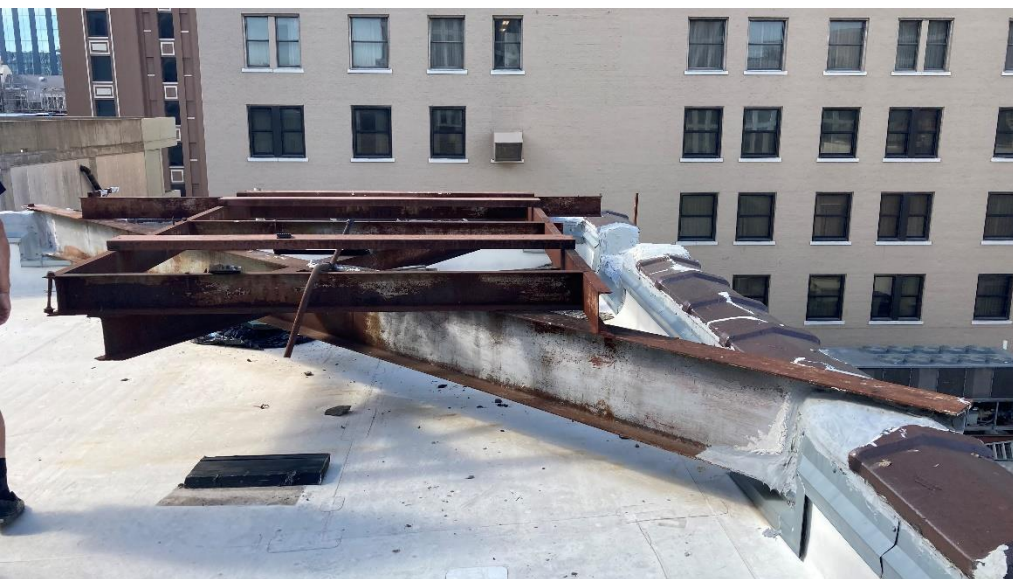
9. Paramount parapet southwest corner upper stage roof. Iron structure to be removed. Walls to be filled, flashed and coping installed
10. Paramount parapet southwest corner upper stage roof. Iron structure to be removed. Walls to be filled, flashed and coping installed

Rebuild exterior stage parapet. The area was removed where steel beams were installed to house a condenser unit no longer in use. The platform will be removed by crane, and the parapet will be repaired to stop water intrusion.

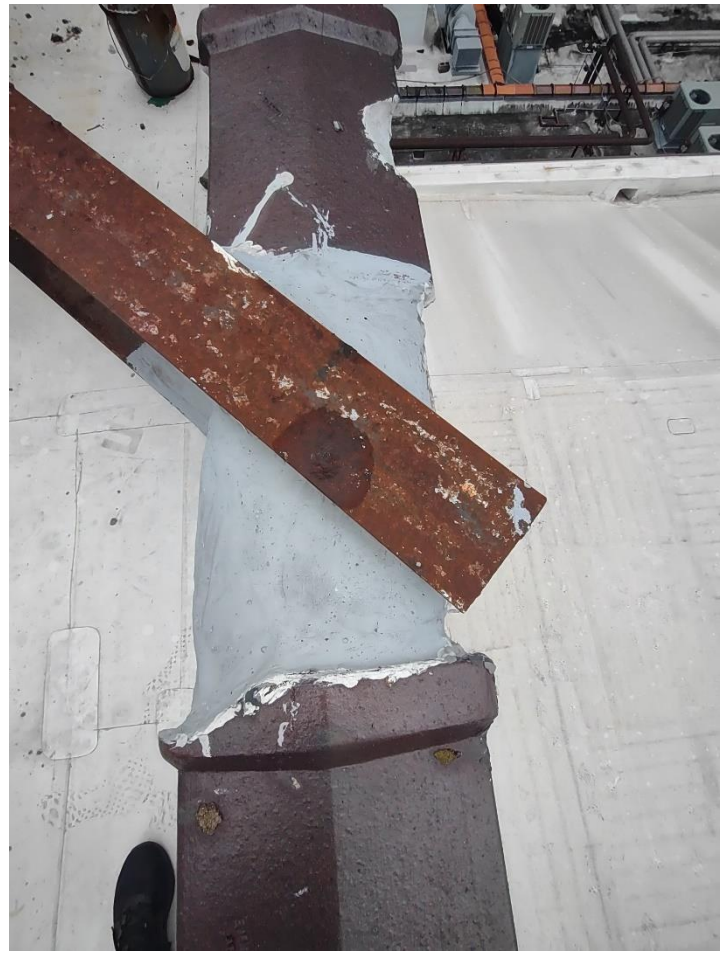
10.

11. Paramount upper stage roof parapet penetration
12. Paramount upper stage roof parapet penetration
13. Paramount upper stage roof parapet penetration
14. Paramount upper west stage wall south portion

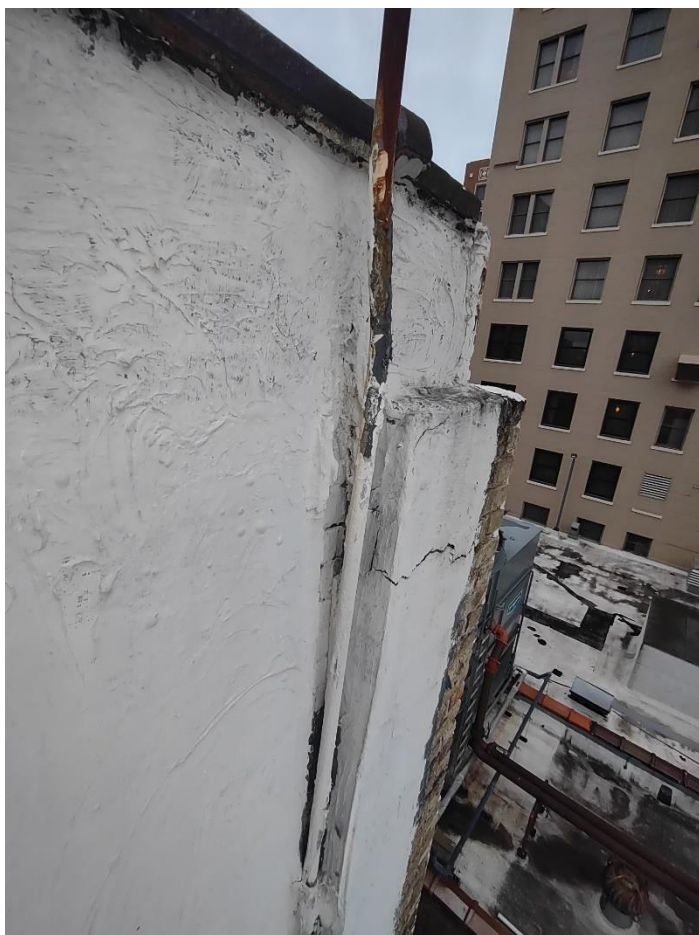
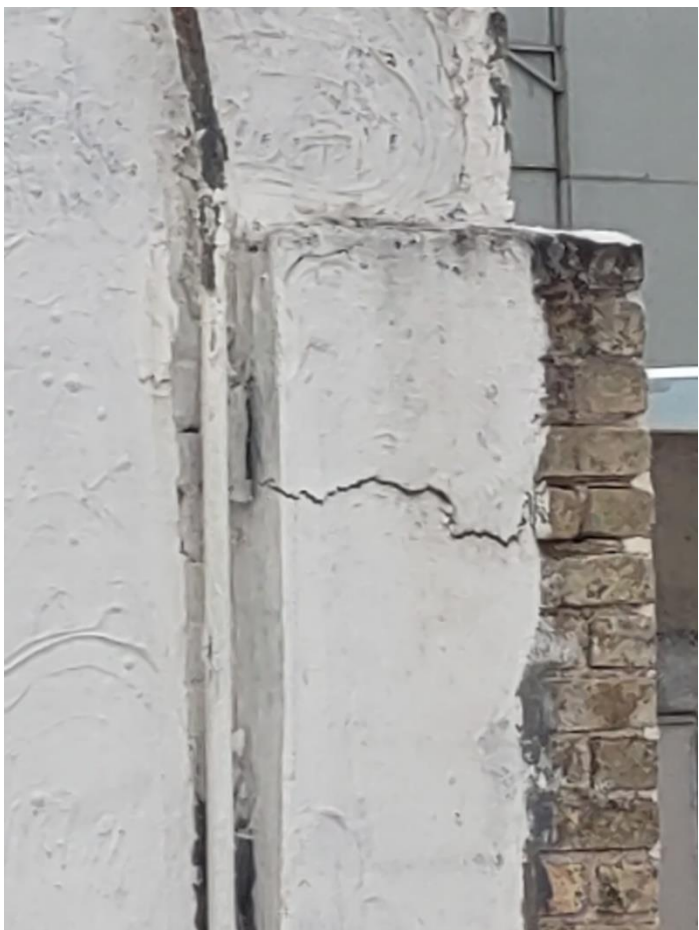
15. Paramount upper west stage wall south portion damage
16. Paramount upper west stage wall damage
17. Paramount upper west stage wall south upper parapet penetration

Repair and reseal west upper exterior stage wall. This area was coated in a roofing tar of sorts and has clear air pockets and penetrations. They must be stripped, repaired, patched, and resealed with an isothermal protective coat.

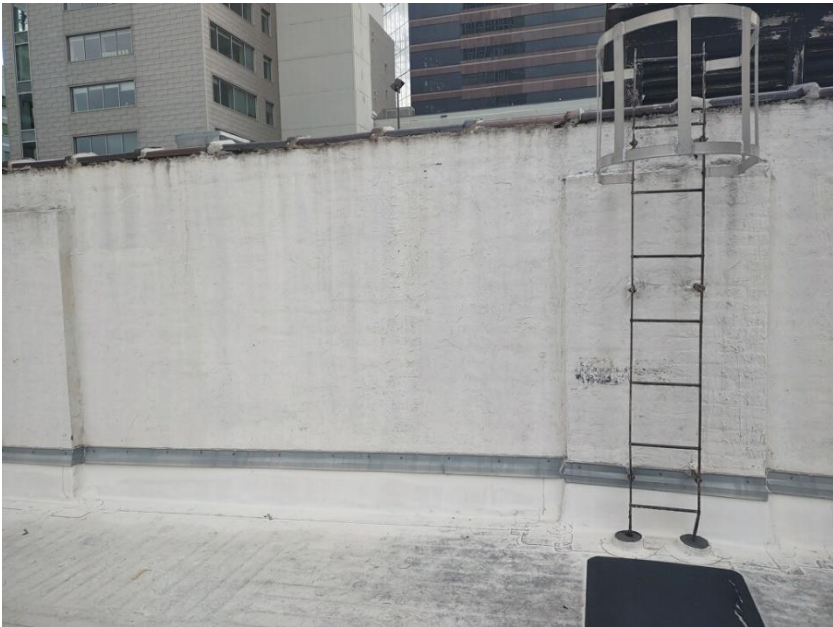
18. Paramount upper west stage wall north portion
19. Paramount upper west stage wall center portion
20. Paramount upper west stage wall south portion
21. Paramount upper west stage wall south portion damage

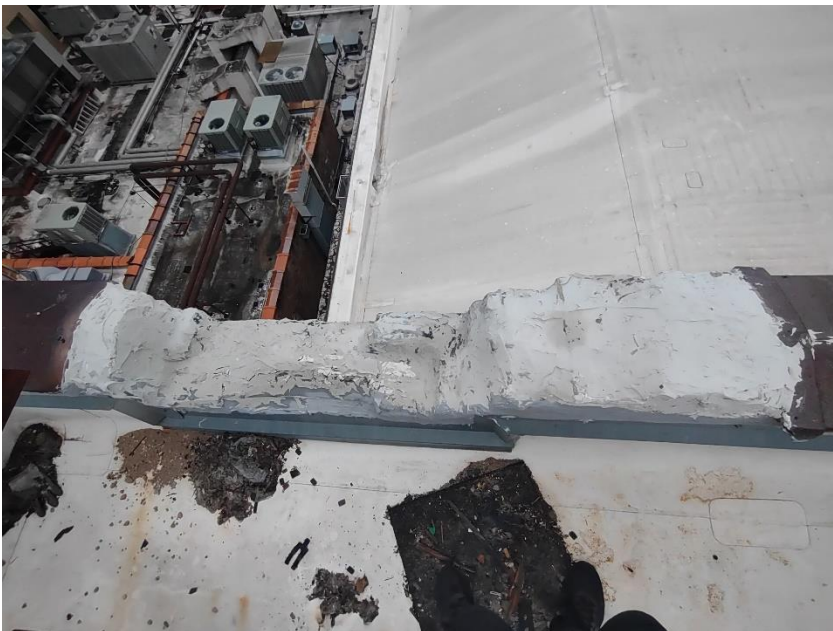
22. Paramount upper stage roof parapet penetration
23. Paramount upper stage roof parapet penetration
24. Paramount upper stage roof parapet penetration
25. Paramount upper west wall south portion damage
