809 Lydia
ca. 1935

Addition ca. 1948
Robertson/Stuart & Mair
Historic District

1203 E 9th ATX, LLC, Owner

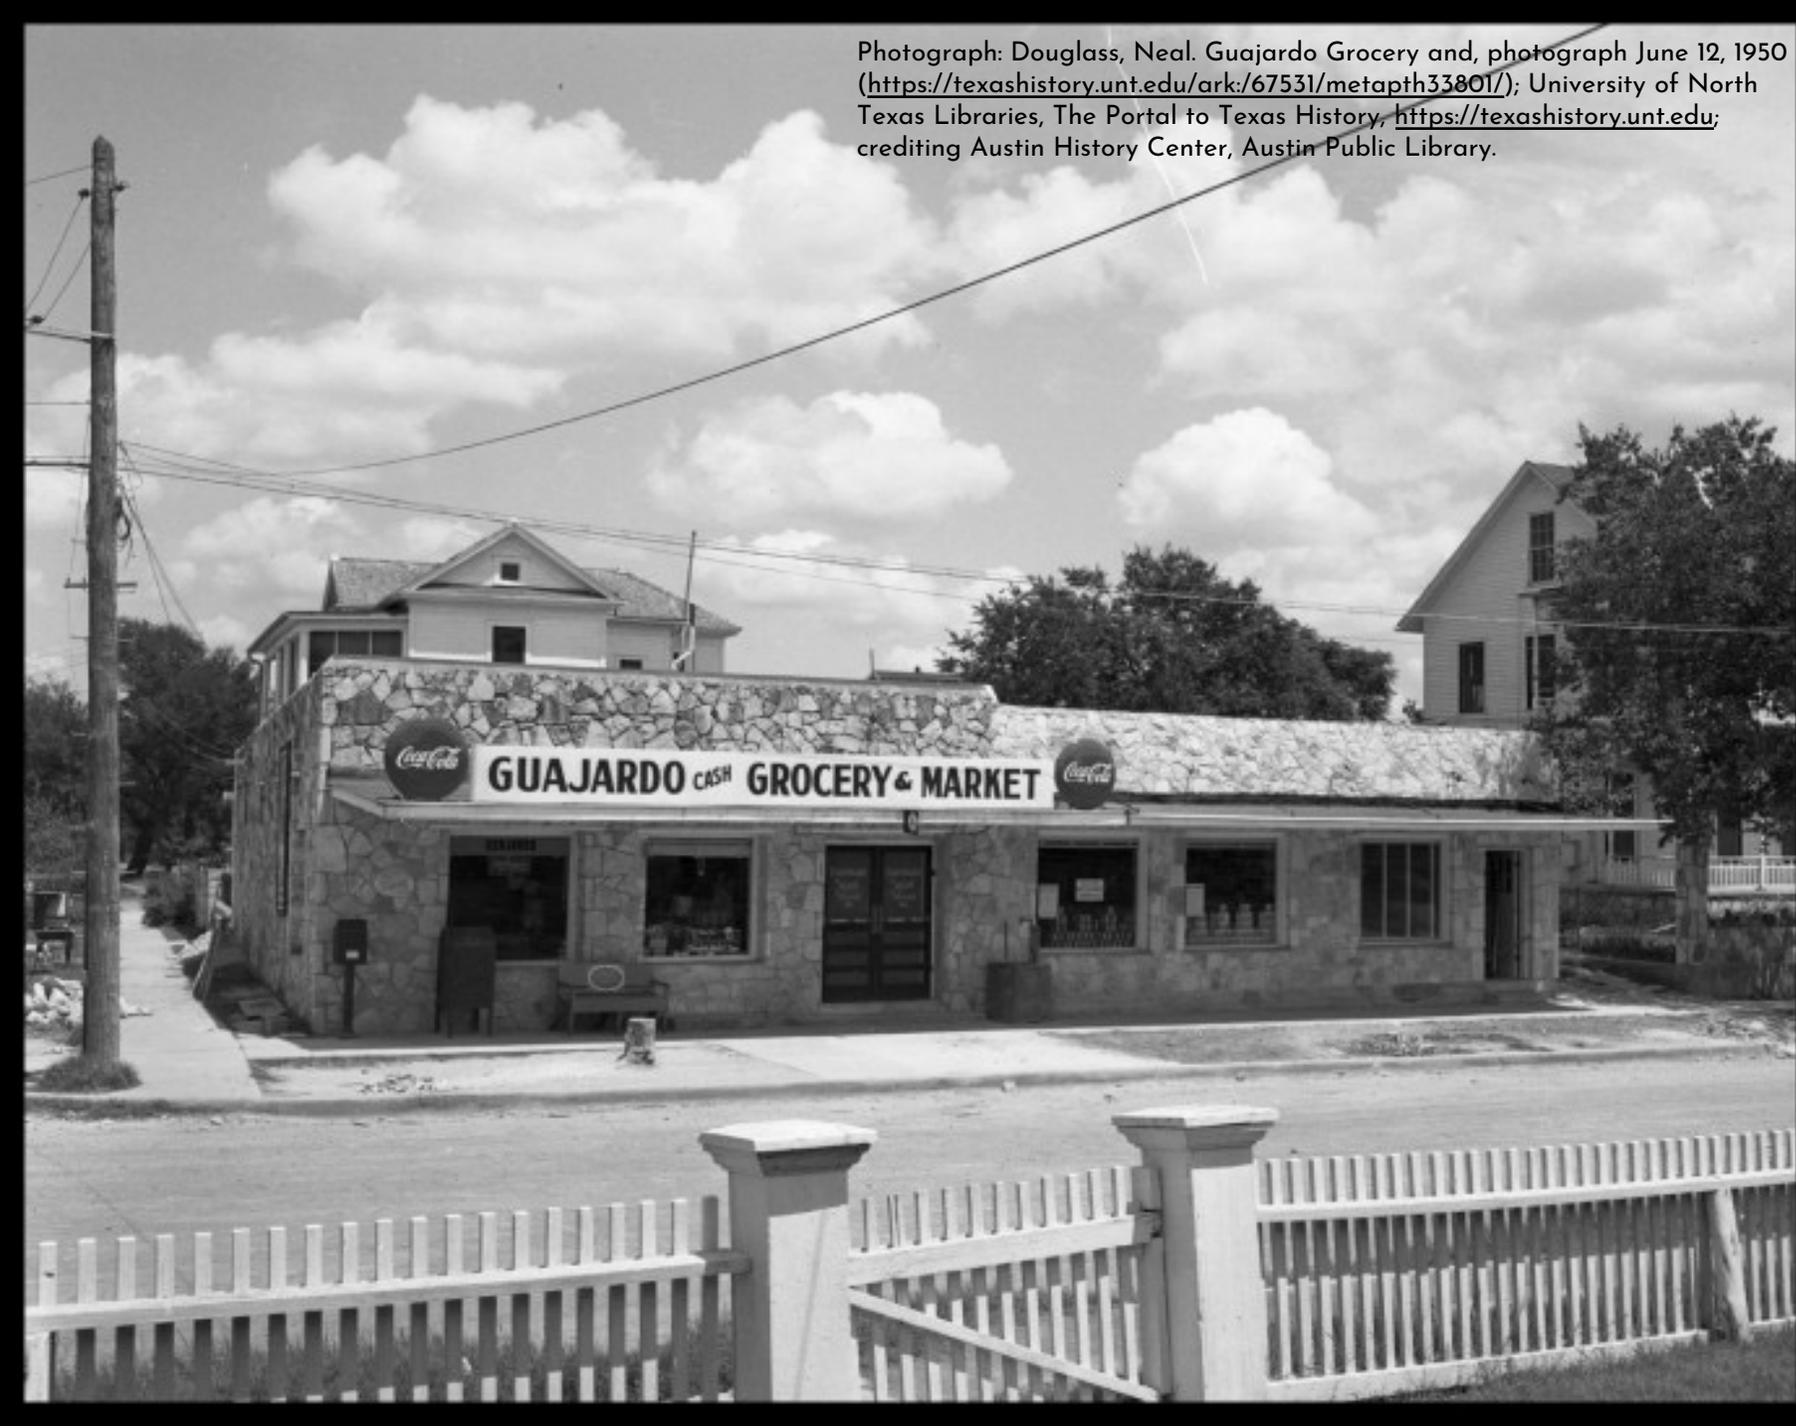
Photograph: Douglass, Neal. Guajardo Grocery and, photograph June 12, 1950 (<https://texashistory.unt.edu/ark:/67531/metaph33801/>); University of North Texas Libraries, The Portal to Texas History, <https://texashistory.unt.edu/>; crediting Austin History Center, Austin Public Library.

Reconstruct historic canopy based on historical evidence (see historic photo)

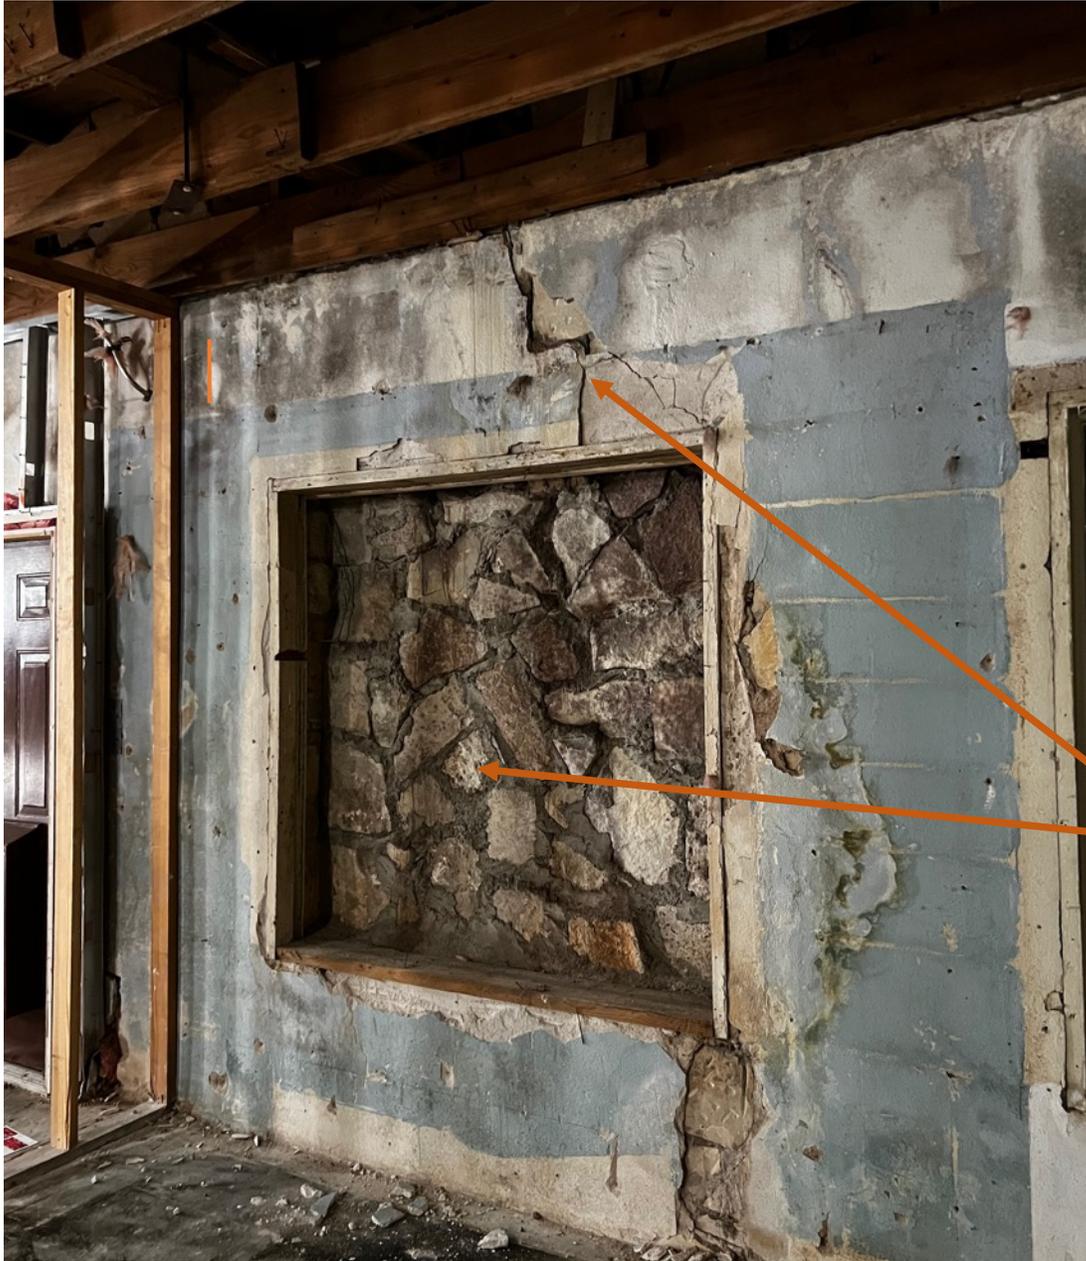
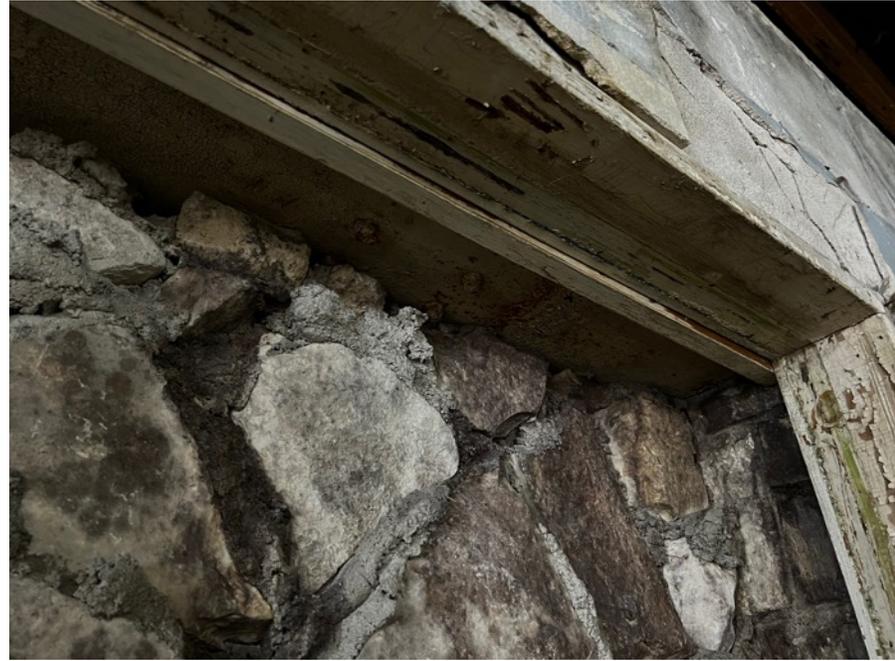
Interior view of window infill on south elevation

Rebuild masonry where makeshift beam above has stressed wall. Remove infill and install new storefront windows to match historic photograph

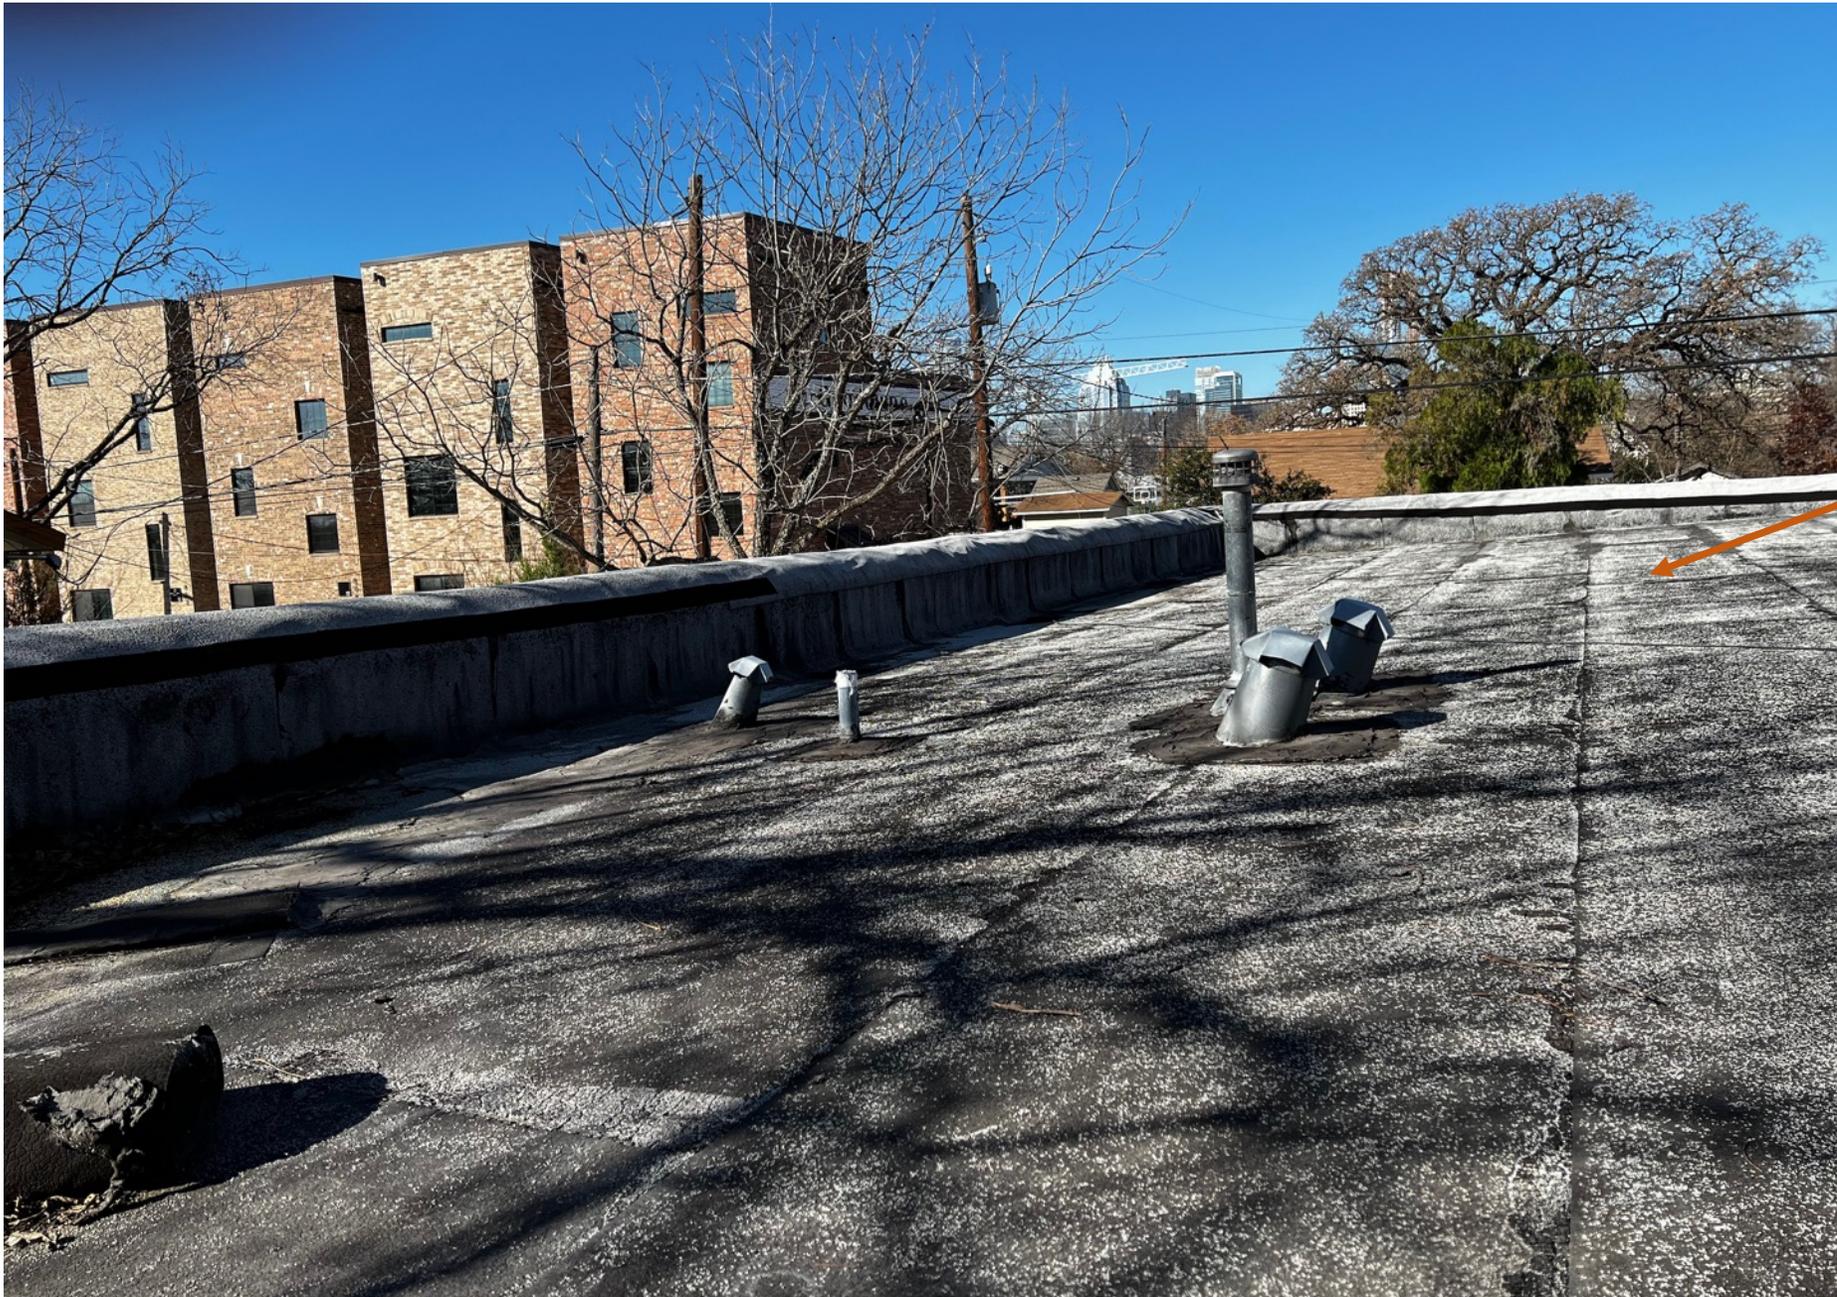
809 Lydia

Roof condition

Remove and replace existing built-up roof system with new single-ply membrane roof

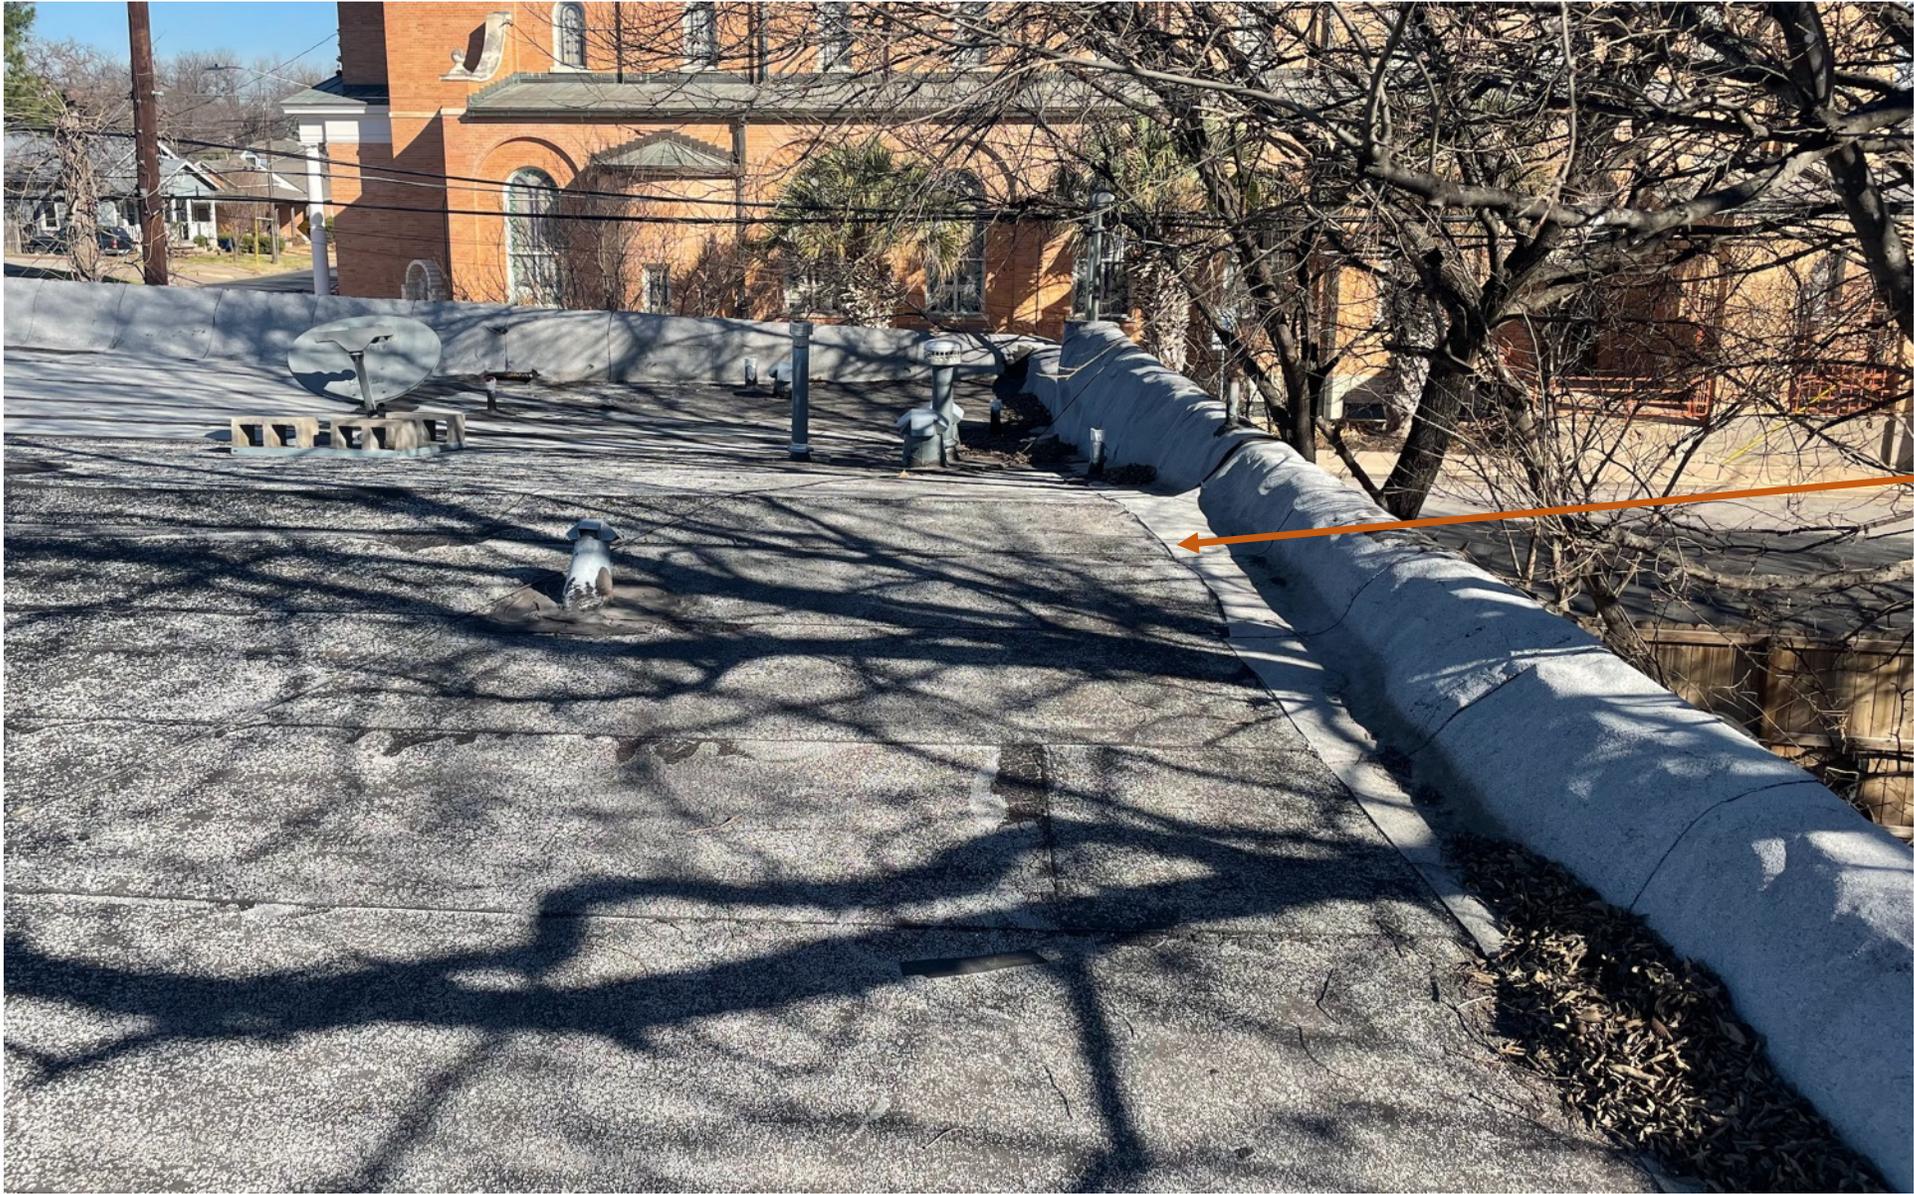
809 Lydia

Condition of roof and parapet

Replace and remove existing built-up roof system

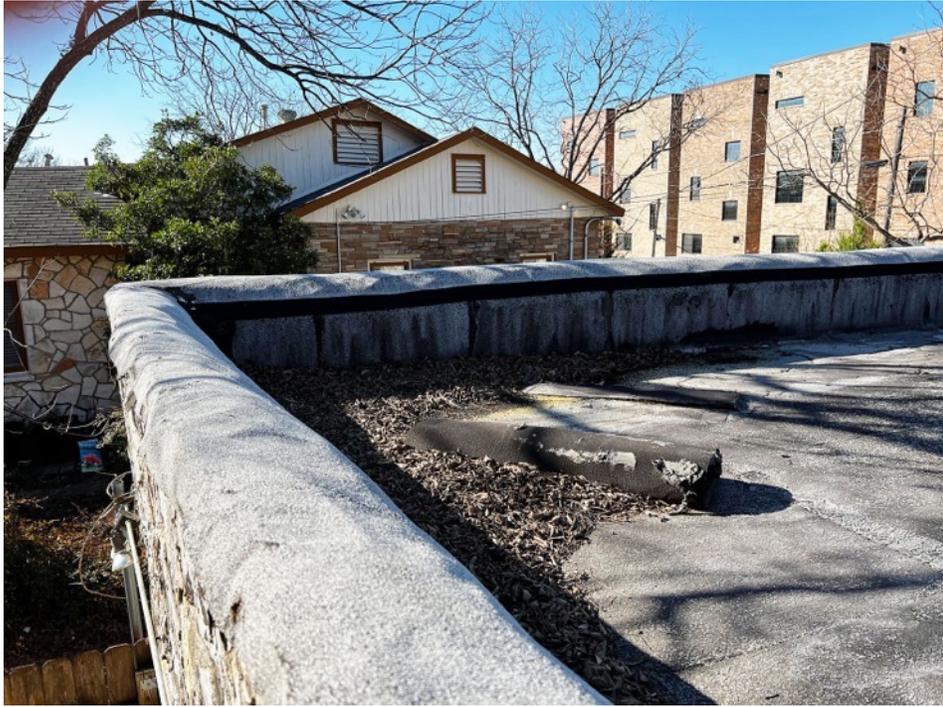
809 Lydia

Parapet detail
