# Vehicle Safety Mitigation Plan

Event Name	
Event Date	
Event Type	
Contact	
Location	6 <sup>th</sup> St, Red River to Brazos
Meridian Contact	Caleb Paxton
Objectives	<ul><li>Secure access points</li><li>Protect pedestrian activities</li></ul>
Additional Considerations

2/6/2023

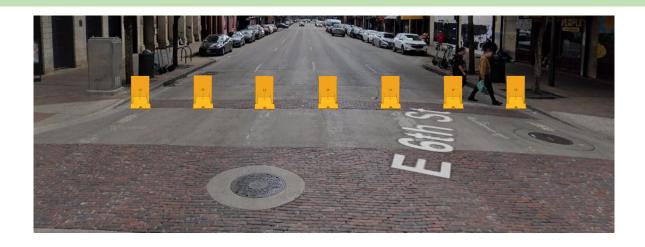
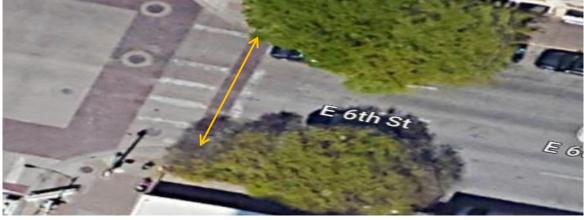
#### **Location : A** 6<sup>th</sup> east of Brazos St

7 – Barriers0 – 4' Cables0 – Cable Covers

**Orientation:** Each deployment location is visualized as an aerial view represented in a compass north orientation followed by a ground-level view represented from the perspective of on-coming traffic (unless otherwise noted). Barriers and beam gates will be deployed with the ramp facing in the direction of the potential threat.

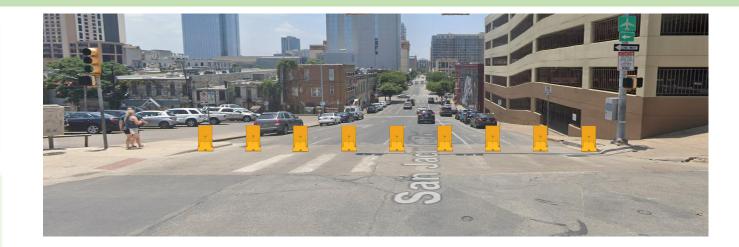
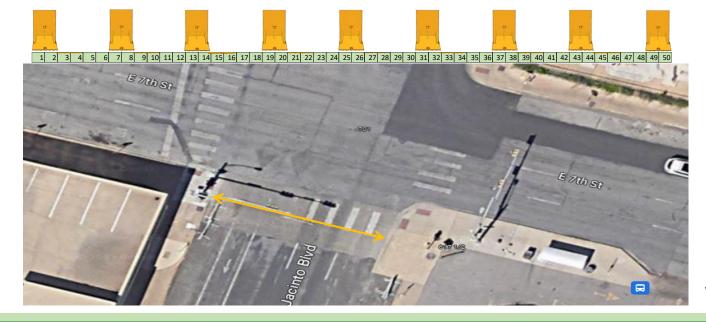
### **Location : B** San Jacinto Blvd south of 7<sup>th</sup> St

9 – Barriers 0 – 4' Cables 0 – Cable Covers

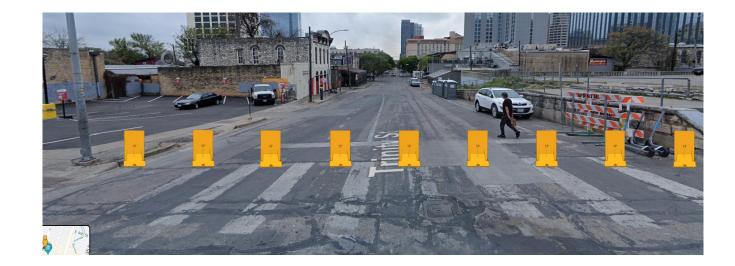
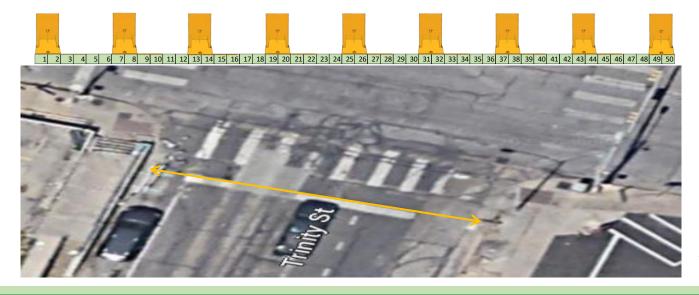
# Location : C Trinity St south of 7th

9 – Barriers 0 – 4' Cables 0 – Cable Covers

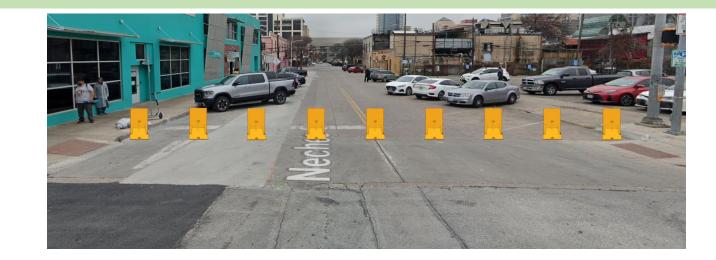
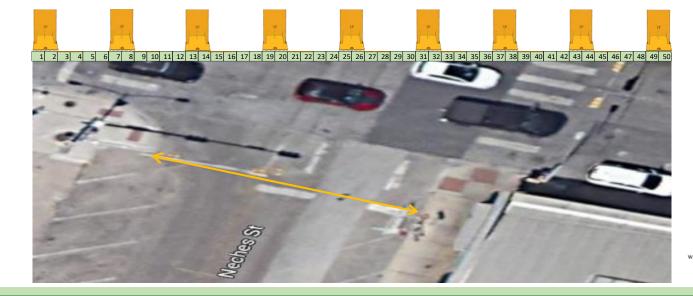
### Location : D Neches St south of 7th

9 – Barriers 0 – 4' Cables 0 – Cable Covers

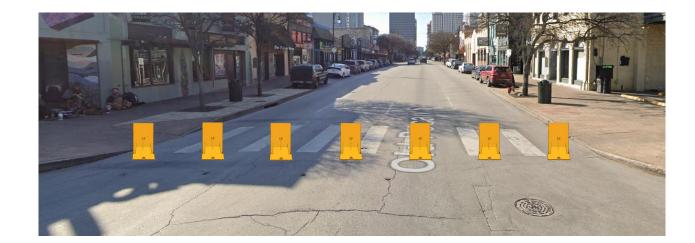
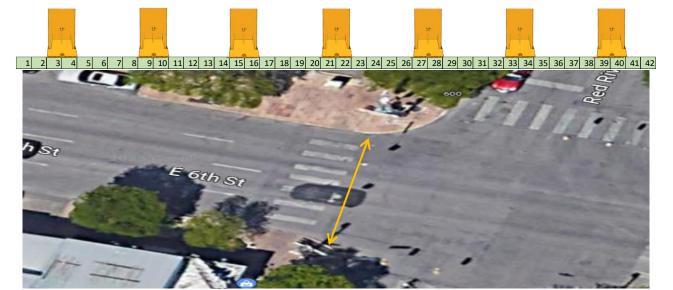
### **Location : E** E 6<sup>th</sup> St west of Red River St

7 – Barriers0 – 4' Cables0 – Cable Covers

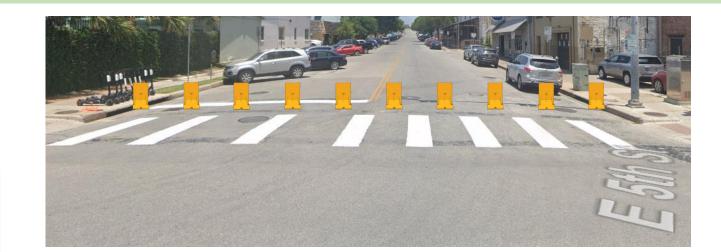
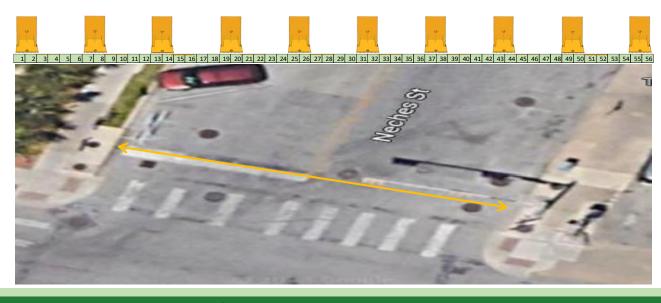
### **Location : F** Neches St north of E 5<sup>th</sup> St

10 - Barriers0 - 4' Cables 0 - Cable Covers

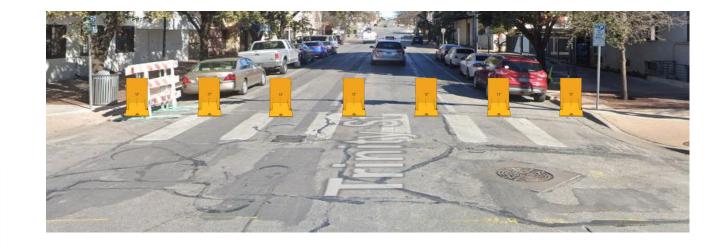
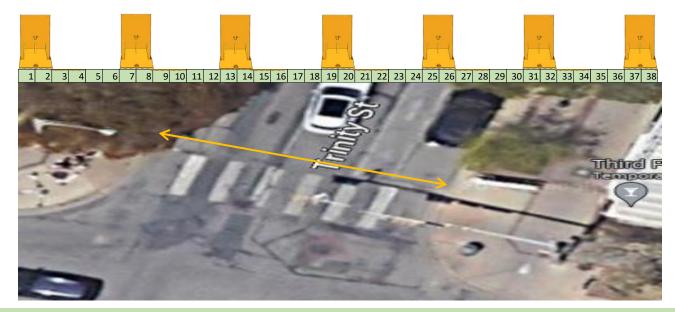
### **Location : G** Trinity St north of E 5<sup>th</sup> St

7 – Barriers0 – 4' Cables0 – Cable Covers

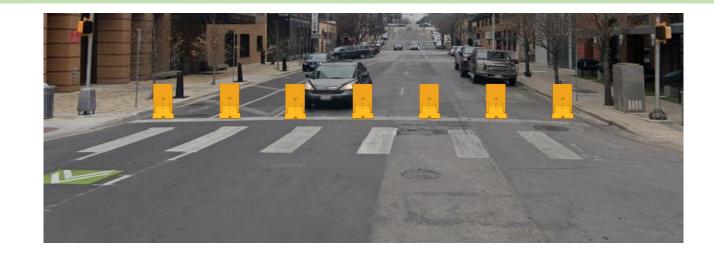
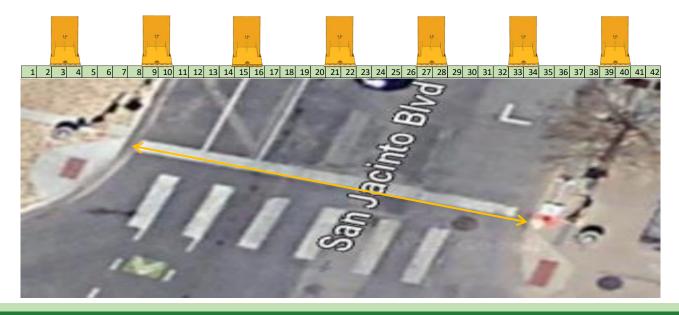
### **Location :** H San Jacinto Blvd north of E 5<sup>th</sup> St

7 – Barriers0 – 4' Cables0 – Cable Covers
