**Moore-Williams House**  
**ca. 1890**

Travis Heights-Fairview Park  
Historic District  
Coleman McAuley and Elisabeth Pefanis, Owners

Moore-Williams House  
1312 Newning

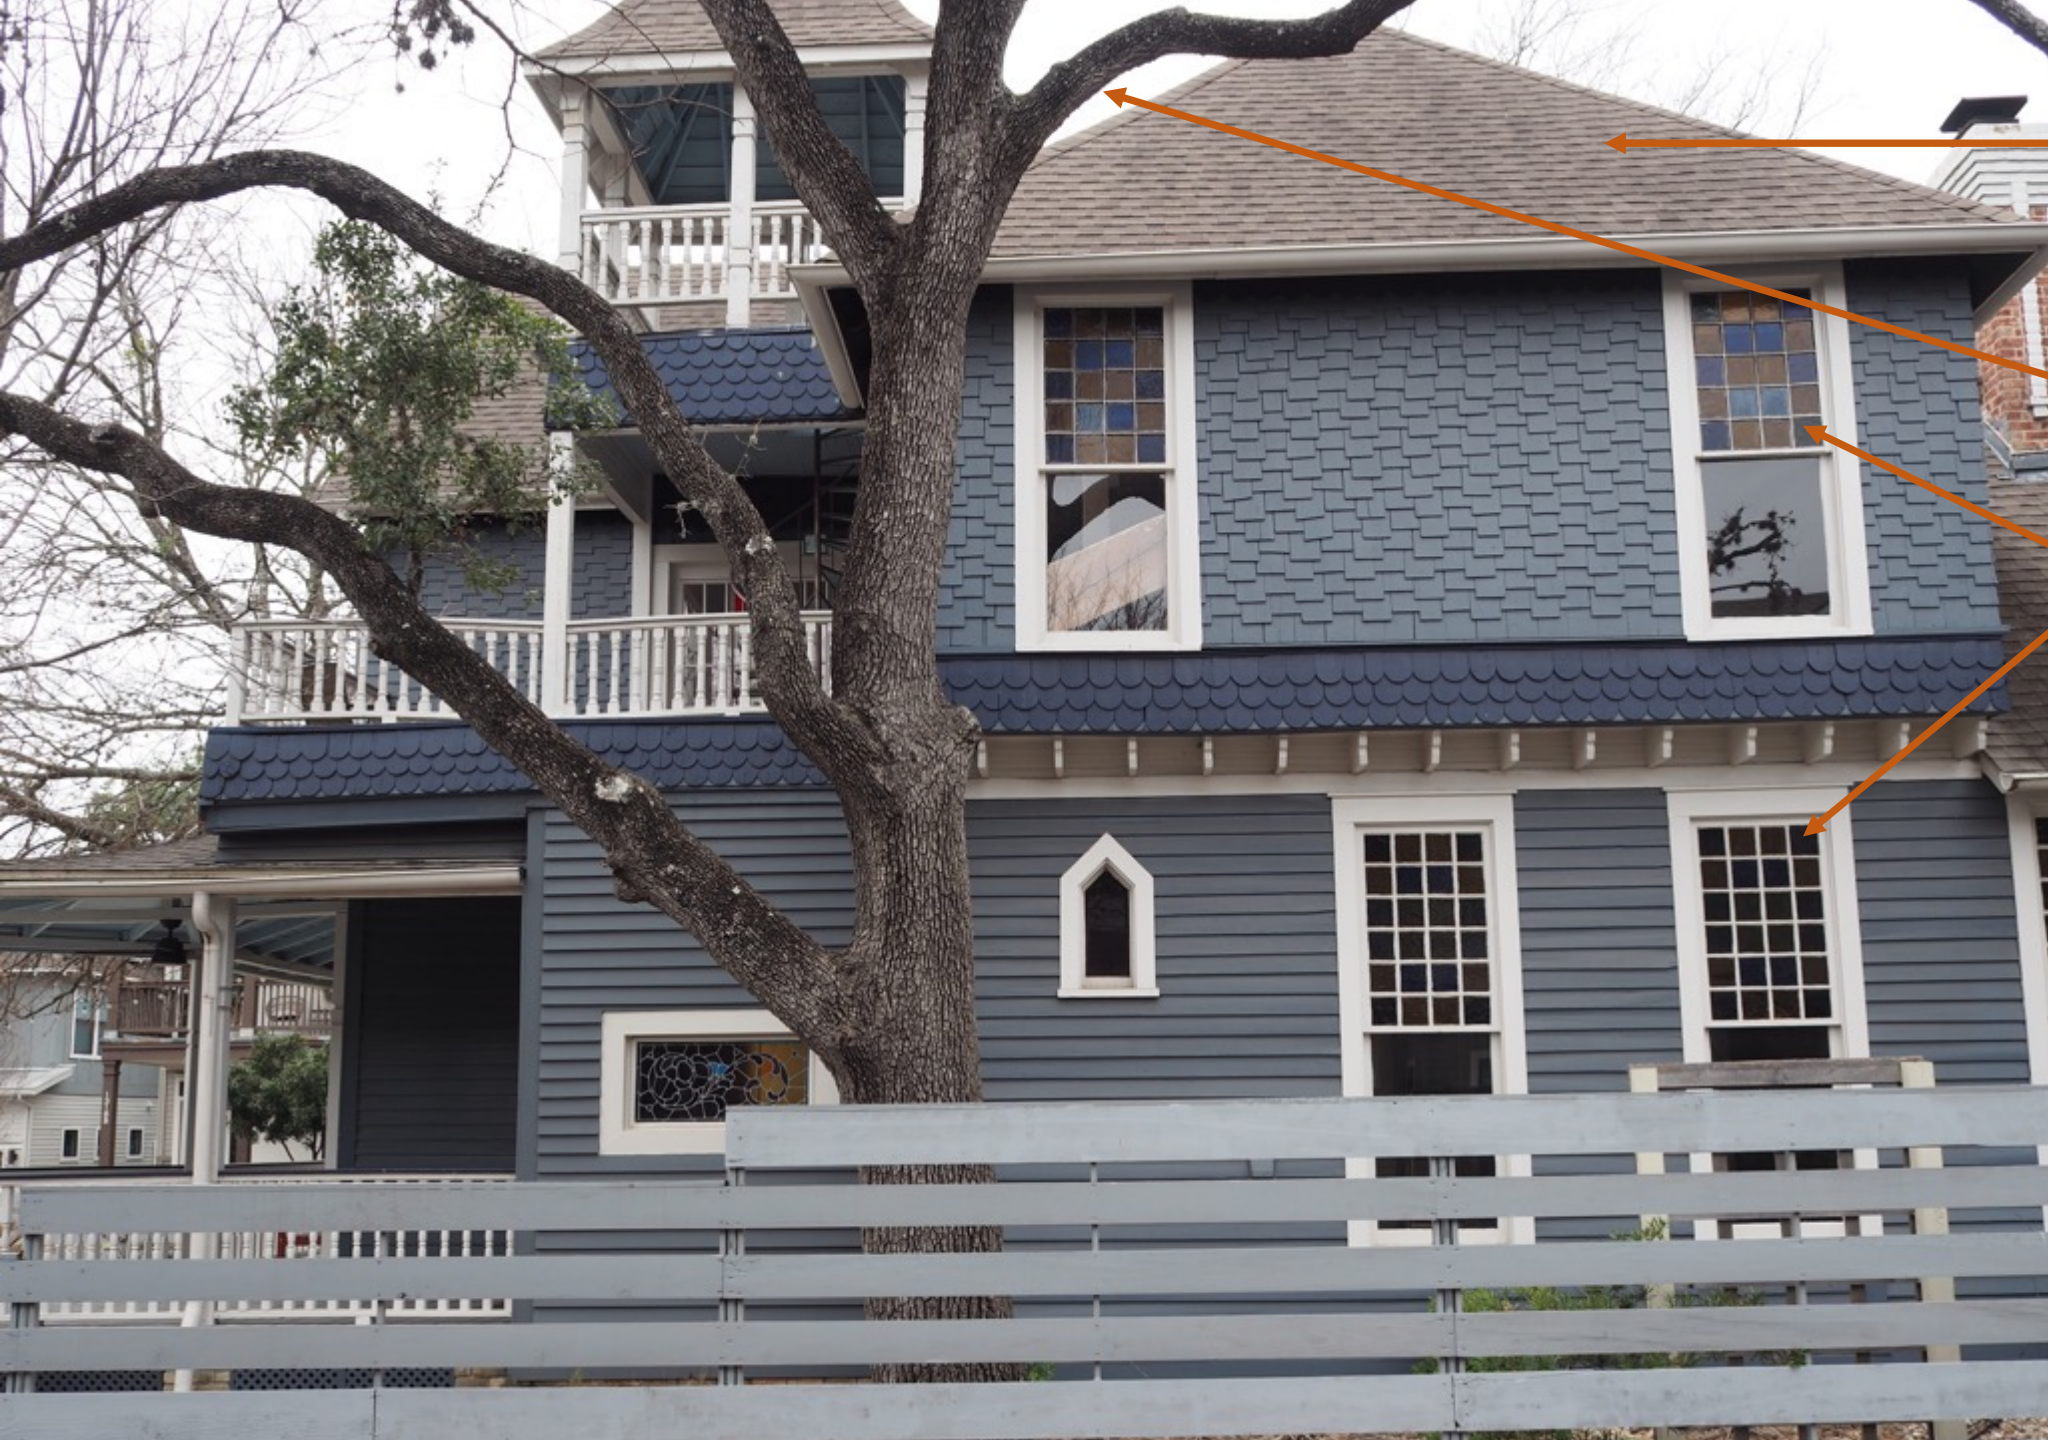
**North Elevation**  
Moore-Williams House  
1312 Newning

Location of proposed dormer connection to belvedere

Replace roof with new composition shingles

Restore original windows, typical

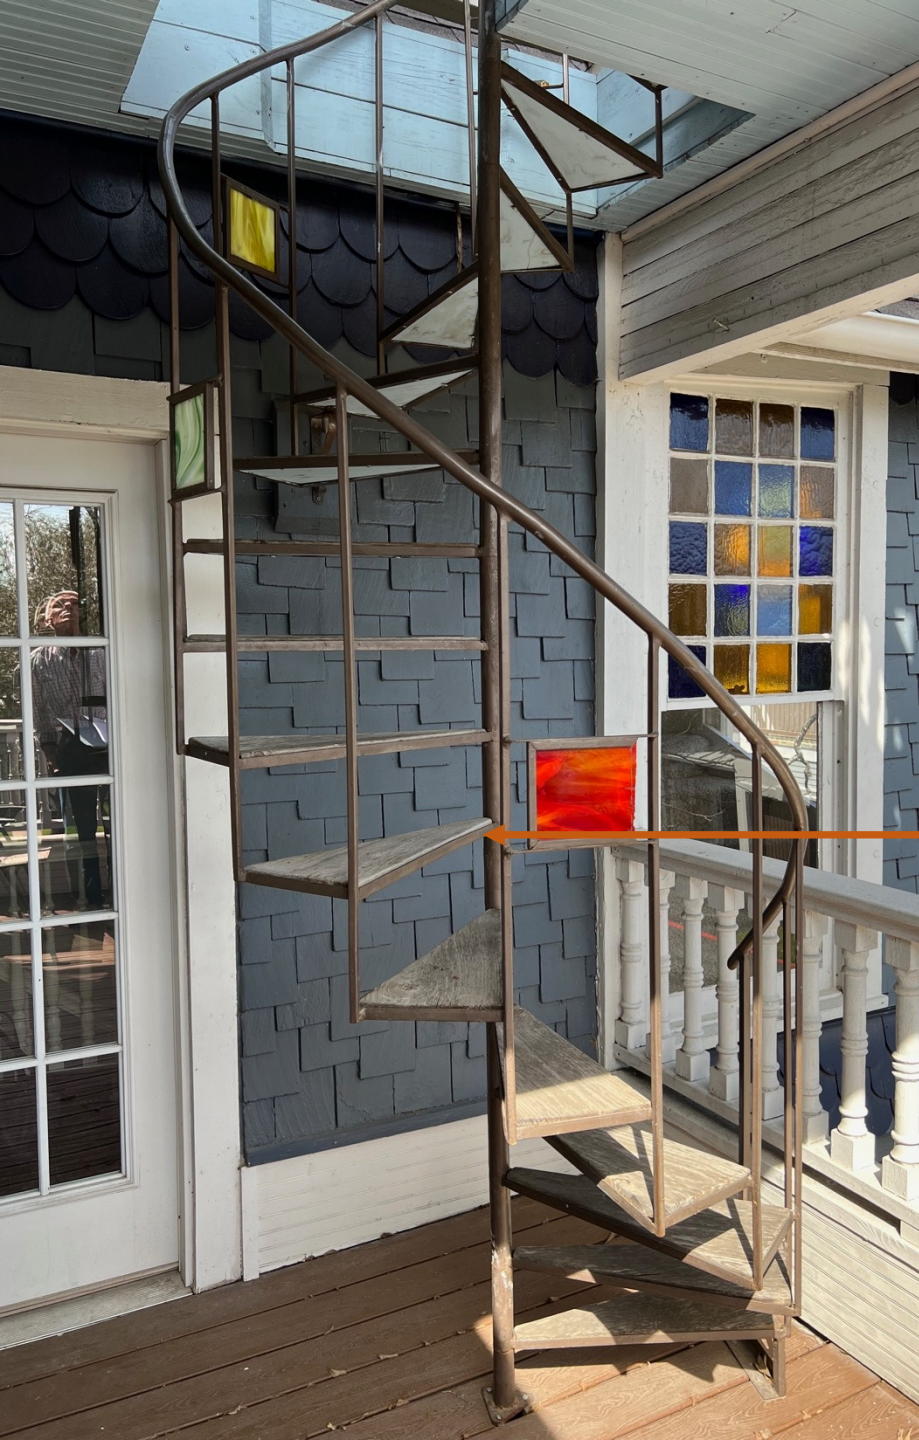
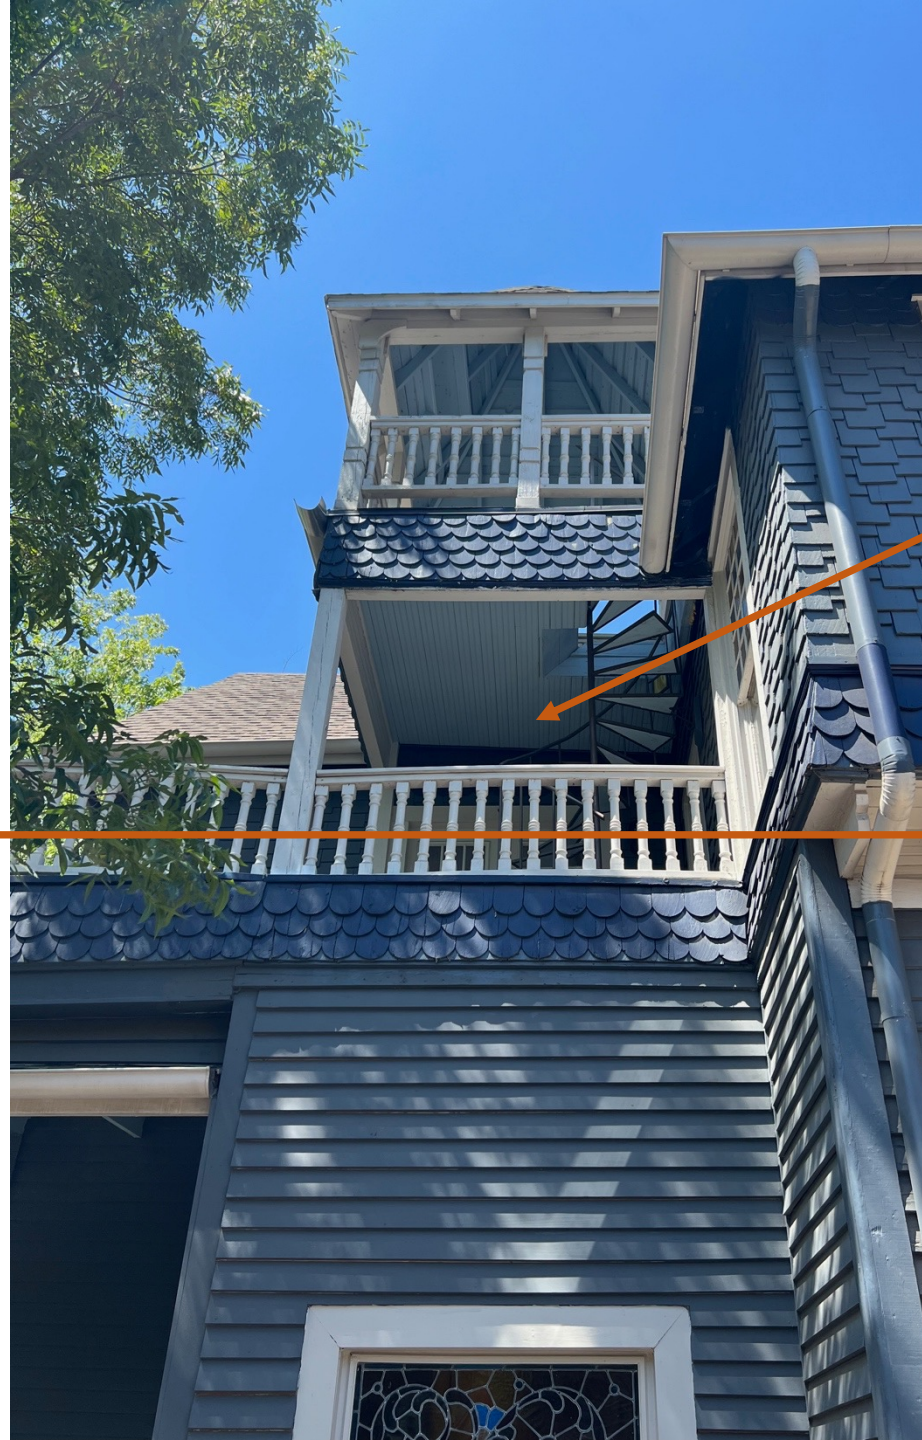
BELVEDERE RESTORATION

Note slope of second floor porch ceiling sloped towards face of house, indicating structural failure due to water damage

Non original spiral stair is unstable and damaged beyond repair

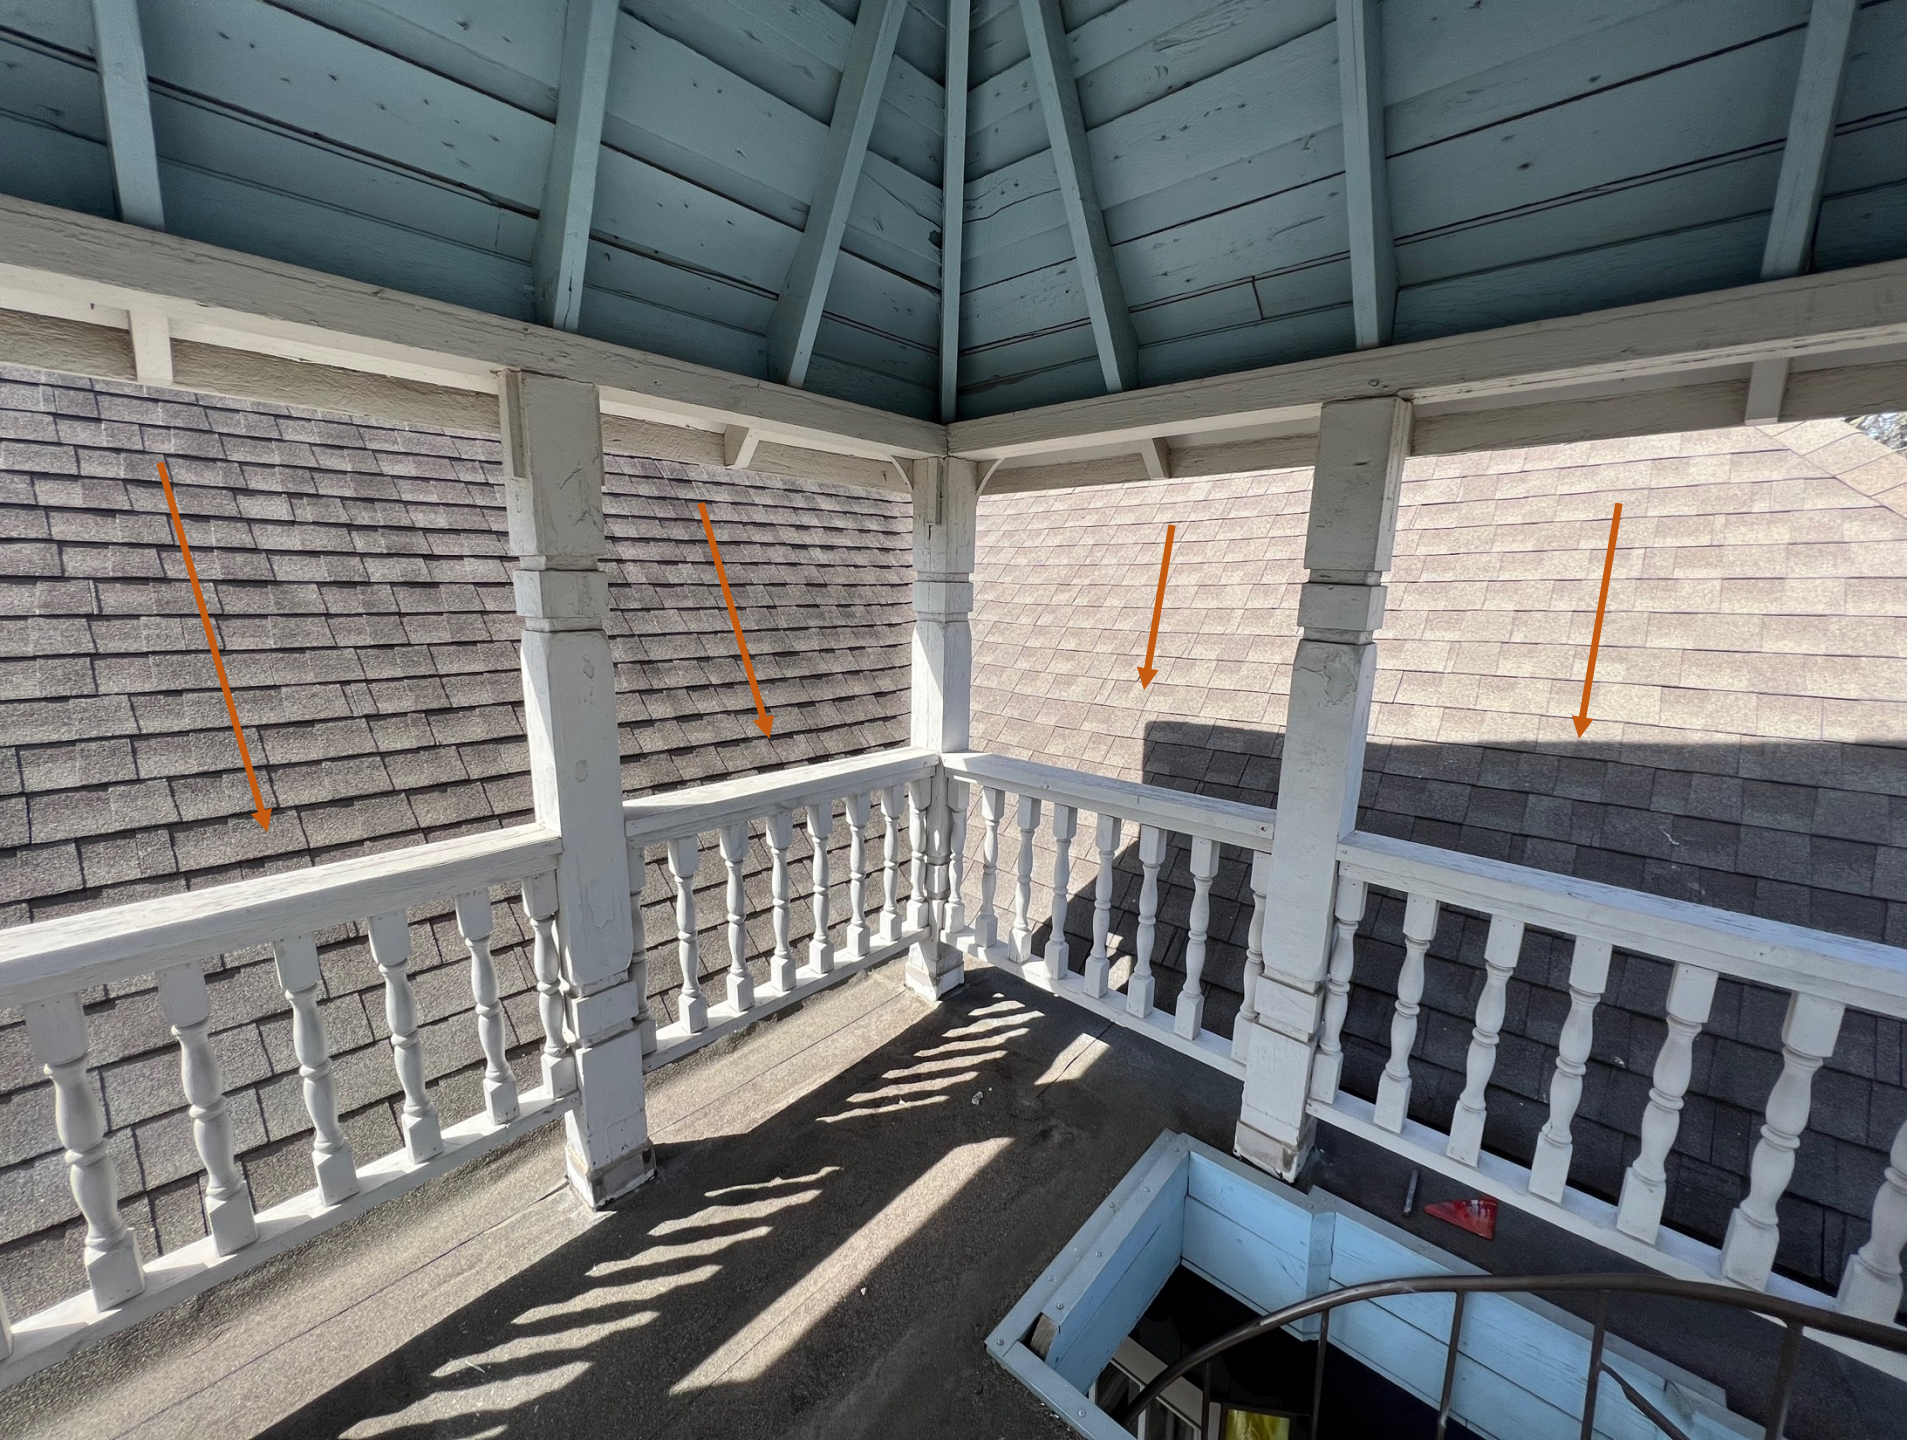
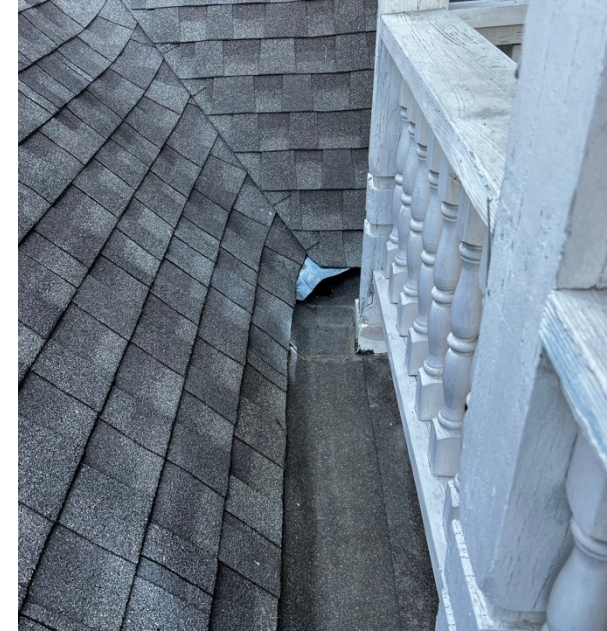
#### BELVEDERE RESTORATION

#### EXISTING CONDITION:

Belvedere receives water from 2 large areas of roof. Long term water infiltration has caused rot both above and below roof system.

Curb at spiral stair has been patched several times

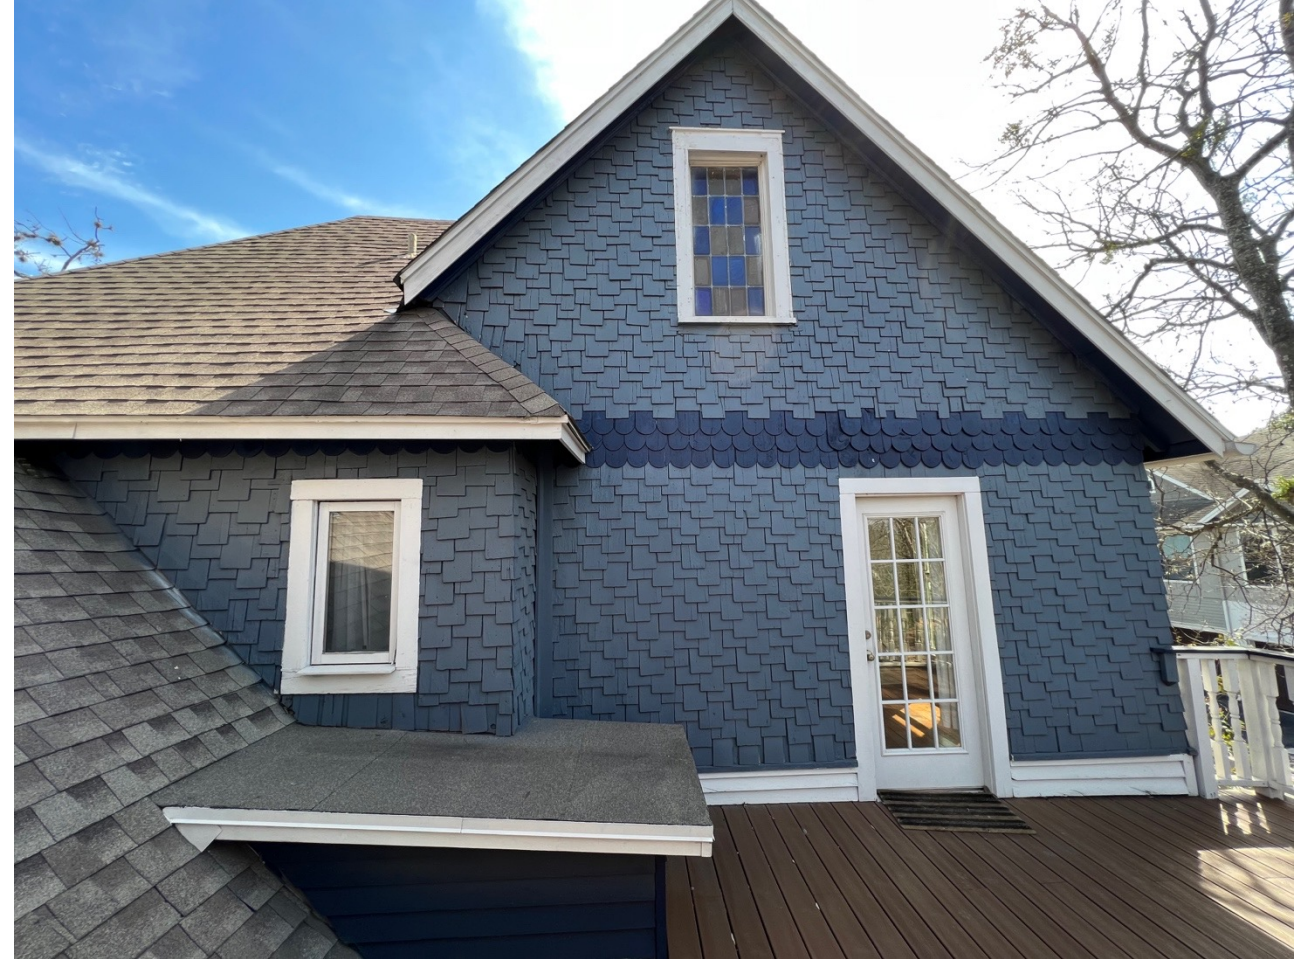
View towards house  
Siding to remain exposed inside new playroom
