CITY OF AUSTIN URBAN KARST FEATURE WATER QUALITY EVALUATION AND MITIGATION

Olivia Bramlet, P.E.

March 28, 2023

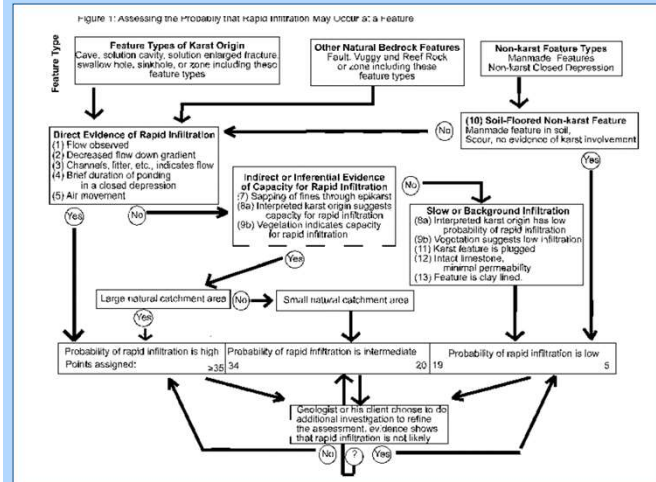
Flowchart for Determining Relative Infiltration Rate

- Assess Geologic Sensitivity
- Based on:
 - Feature size
 - Estimate of relative infiltration rate
 - Connectivity to impervious cover
- All 8 features were determined to be highly sensitive
- Assign a **geologic sensitivity score** to use in prioritization matrix

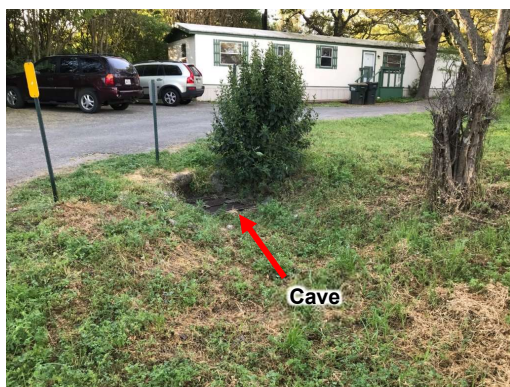
- Located within Honeycomb Trailer Park
- Walnut Creek Watershed
- Recharges Northern Edwards Aquifer
- DA = 27 ac; IC = 38%; single family res, offices, undeveloped land
- Runoff from 15 ac receives treatment

Honeycomb Trailer Park Cave	3/26/2019	Cave	30	Surface opening filled with 26-in. diam. corrugated metal pipe. At approx. 4 ft below ground, the cave opening is approx. 2-ft by 2-ft.	No infill observed in the cave. The depressed area around the cave opening is vegetated with grass.	High - Trailer park manager indicated that drainage to cave does not back up even during heavy rain events.	35	Appears structurally stable.	Unknown	Moderate, surrounded by grass	5	70	High	0.78	Cave opening is covered with a metal gate.
Blackfoot Trail Sinkhole	3/26/2019	Sinkhole	20	Two 18-in. diam. corrugated metal standpipes. Standpipe appear to extend 10-15 feet below ground surface.	Surface covered with leaves, sticks, and soil. Trees and shrubs appear healthy.	High based on drainage features	35	Appears structurally stable.	Unknown	High, storm drain routed to feature.	10	65	High	0.72	Standing water at bottom of standpipes. Storm main on top of standpipes clogged with leaves and sticks. Some displacement of material surrounding standpipes.

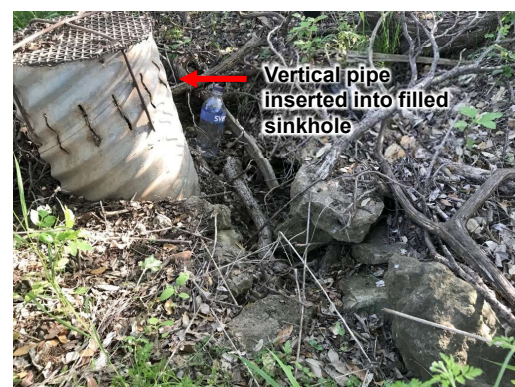
Blackfoot Trail Sink

- Intersection of Blackfoot Tr./McNeil Dr.
- Walnut/Brushy Creek Watersheds
- Recharges Northern Edwards Aquifer
- DA = 9 ac; IC = 19%; single family res, commercial, undeveloped land
- No runoff receives treatment

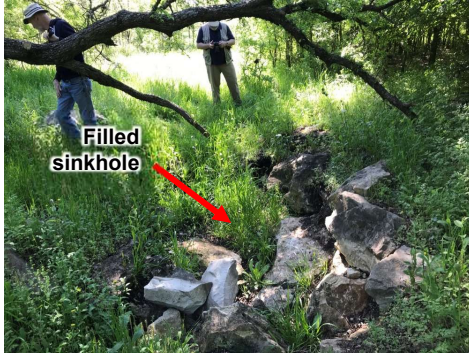
Divide Swamp Sink

- Located north of W Slaughter Ln and east of Mopac
- Slaughter Creek Watershed
- Recharges Barton Springs Edwards Aquifer
- DA = 58 ac; IC = 27%; single family res, undeveloped land
- Runoff from 48 ac receives treatment

Divide Swamp Sinkhole	3/26/2019	Sinkhole	20	Approximately 25-ft by 10-ft surface depression, 3 to 4 ft deep. No visible opening.	Filled with broken boulder-sized rocks and soil.	High (1,500 to 1,900 gpm) based on City measurements and video taken by City staff in October 2018.	35	Appears structurally stable.	Unknown	Low, surrounded by exclusion berm.	0	55	High	0.61	Broken rocks evidence of historical infilling, surrounded by earthen berm.
Brodie Cave	3/26/2019	Cave	30	Sinkhole opening measures approximately 25-ft by 20-ft at grate, approximately 10 feet below threshold. Dimensions of cave opening greater than 3 ft.	Partial infilling with leaves, woody debris and logs, and smaller rocks.	High based on large opening, very large drainage area, no standing water.	50	Unknown structural stability. No apparent instabilities.	Unknown	High, located in stream bed	10	90	High	1.00	Cave is located in stream bed and protected with horizontal grate and gate. Chain link fence surrounding cave was damaged, evidently by past high stream flows debris. Extensive deposits of cobbles and boulders in stream bed indicative of high energy intermittent flow.

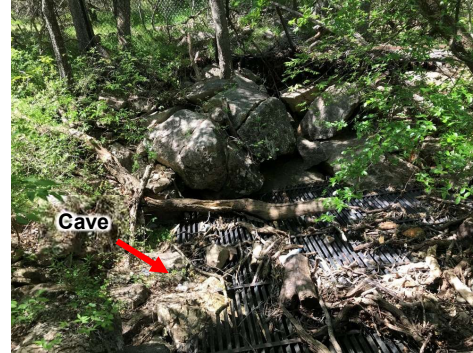
Brodie Cave

- Located on an undeveloped tract near Brodie/Slaughter Ln
- Slaughter/Williamson Creek Watershed
- Recharges Barton Springs Edwards Aquifer
- DA = 556 ac; IC = 20%; single family res, apts, commercial, utility development
- Runoff from 165 ac receives treatment

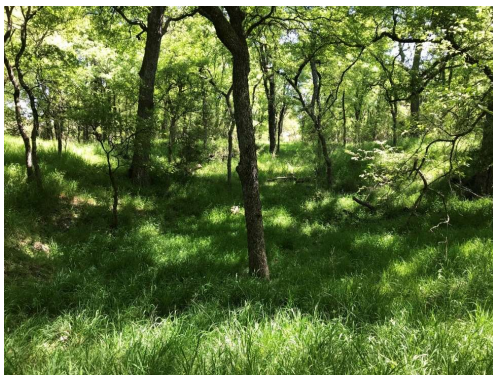
Kentucky Sink

- Located on an undeveloped tract near Brodie Ln
- Slaughter Creek Watershed
- Recharges Barton Springs Edwards Aquifer
- DA = 21 ac; IC = 11%; single family res, undeveloped land
- No runoff receives treatment

Kentucky Sinkhole	3/26/2019	Sinkhole	20	2 small approximately 1-ft diameter animal burrow holes at bottom of sinkhole. Sinkhole is approximately 10 to 15 ft deep and approximately 50-ft by 50-ft wide at bottom.	Filled with soil and leaves. Trees and grasses appear healthy.	High based on feature dimensions, large drainage area, and healthy vegetation (evidence of subsequent standing water).	40	Appears structurally stable.	Unknown	Moderate, channelized drainage from west, relatively large vegetative buffer.	5	65	High	0.72	Very well developed, prominent surface expression bounded by roads with surface drainage towards sink.
Shady Hollow Sinkhole	5/31/2019	Sinkhole	20	Sinkhole is approximately 10 ft deep and approximately 50-ft by 50-ft wide at bottom.	Filled with soil and leaves. Trees and grasses appear healthy.	High based on presence of storm drain pipes, large drainage area, and healthy vegetation (evidence of subsequent standing water).	40	Appears structurally stable.	Unknown	High, storm drain pipes routed to feature.	10	70	High	0.78	Sinkhole located behind private fence. Sinkhole partially visible from Coyote Court. Storm drain pipes are connected to sinkhole.

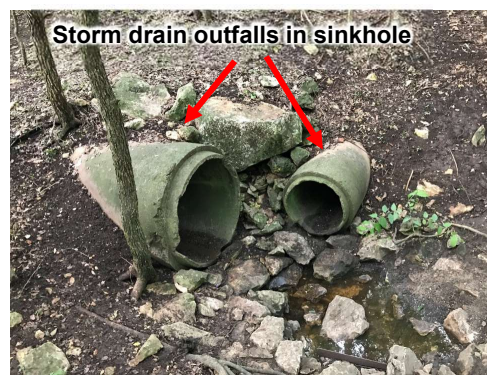
Shady Hollow Sink

- Located on private property in neighborhood
- Slaughter Creek Watershed
- Recharges Barton Springs Edwards Aquifer
- DA = 17 ac; IC = 11%; single family res
- No runoff receives treatment

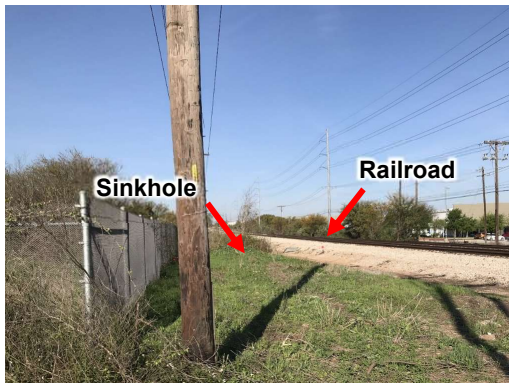
Railroad Sink

- Located adjacent to CapMetro ROW
- Brushy Creek Watershed
- Recharges Northern Edwards Aquifer
- DA = 12 ac; IC = 0%; railroad ROW
- No runoff receives treatment

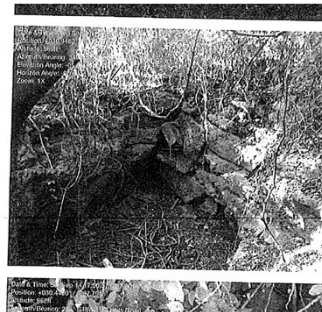
Photo 2
Feature S-1 - Smaller Sinkhole that is approximately 15 feet in diameter within Watershed Sinkhole (possible cave but not accessible)
Position Lat/Long NAD83:
N30° 26' 54.5" W97° 47' 40.4"

- Located on private property, access not granted by owners
- Lake Creek Watershed
- Recharges Northern Edwards Aquifer
- DA = 29 ac; IC = 50%; church, gas station, roadway, undeveloped land
- Runoff from 16 ac receives treatment
