ITEM FOR ENVIRONMENTAL COMMISSION AGENDA

Blueridge Multifamily at Wildhorse Ranch

SP-2022-0426C.SH

Variance request is as follows. Request to vary from

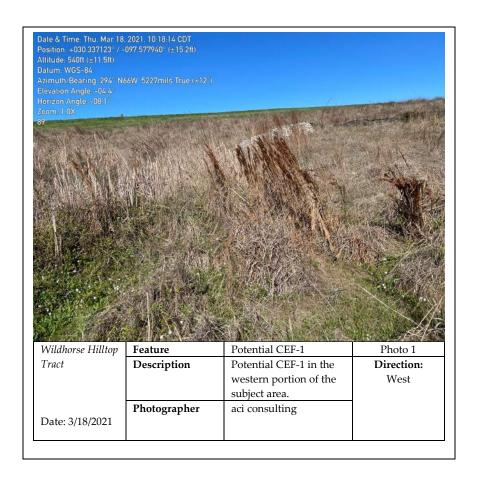
CEF-1 is an emergent riverine wetland located in the western portion of the subject area around a pond. CEF-1 was saturated at the time of the field visit. CEF-1 had wetland hydrology, hydric soils, and is dominated by hydrophytic vegetation such as common spike rush, bushy bluestem, and broadleaf cattails. The boundary between CEF-1 and the adjacent non-wetland was identified based on changes in hydrology, dominant plant composition, and soils. No FEMA Flood Hazard Zones extend onto the subject area at CEF-1. The total area of CEF-1 is approximately 30,582 square feet (0.702 acre) within the subject area (Photo 1).

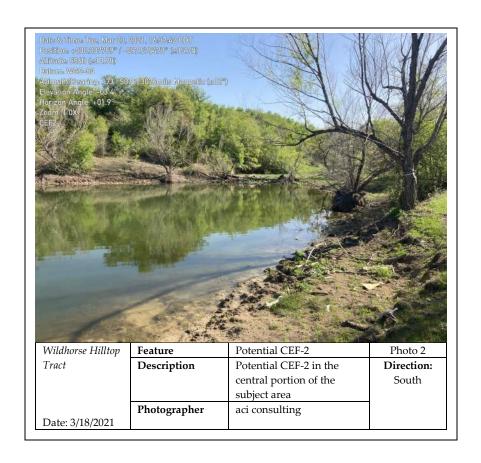
CEF-2 is a wetland fringe located in the central portion of the subject area. CEF-2 was saturated at the time of the field visit. CEF-2 had wetland hydrology, hydric soils, and is dominated by hydrophytic vegetation such as common spike rush and broadleaf cattails. The boundary between CEF-2 and the adjacent non-wetland was identified based on changes in hydrology, dominant plant composition, and soils. No FEMA Flood Hazard Zones extend onto the subject area at CEF-2. The total area of CEF-2 is approximately 3,793 square feet (0.087 acre) within the subject area (Photo 2).

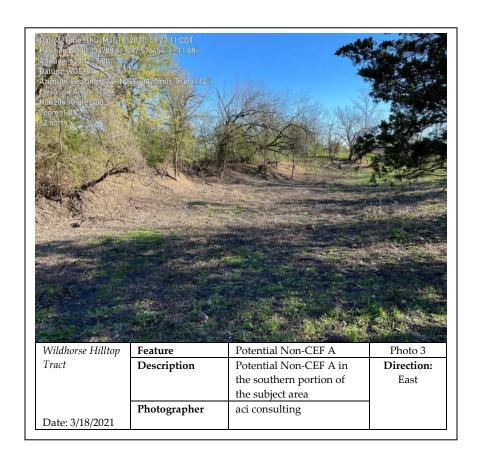
Non-CEF A is a stock pond located in the southeastern portion of the subject area. Non-CEF A was not inundated or saturated at the time of the field visit. No FEMA Flood Hazard Zones extend onto the subject area at Non-CEF A. Non-CEF A lacks emergent vegetation and hydric soils and is therefore a non-wetland. The total area of Non-CEF A is approximately 3,489 square feet, or approximately 0.08 acre within the subject area (Photo 3).

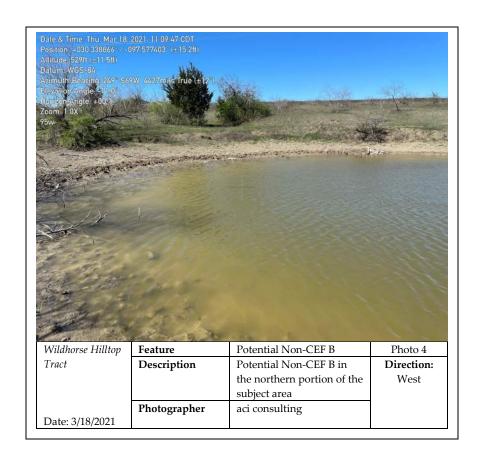
Non-CEF B is a stock pond located in the northern portion of the subject area. Non-CEF B was inundated at the time of the field visit. No FEMA Flood Hazard Zones extend onto the subject area at Non-CEF B. Non-CEF B lacks emergent vegetation and hydric soils and is therefore a non-wetland. The total area of Non-CEF B is approximately 8,603 square feet, or approximately 0.19 acre within the subject area (Photo 4).

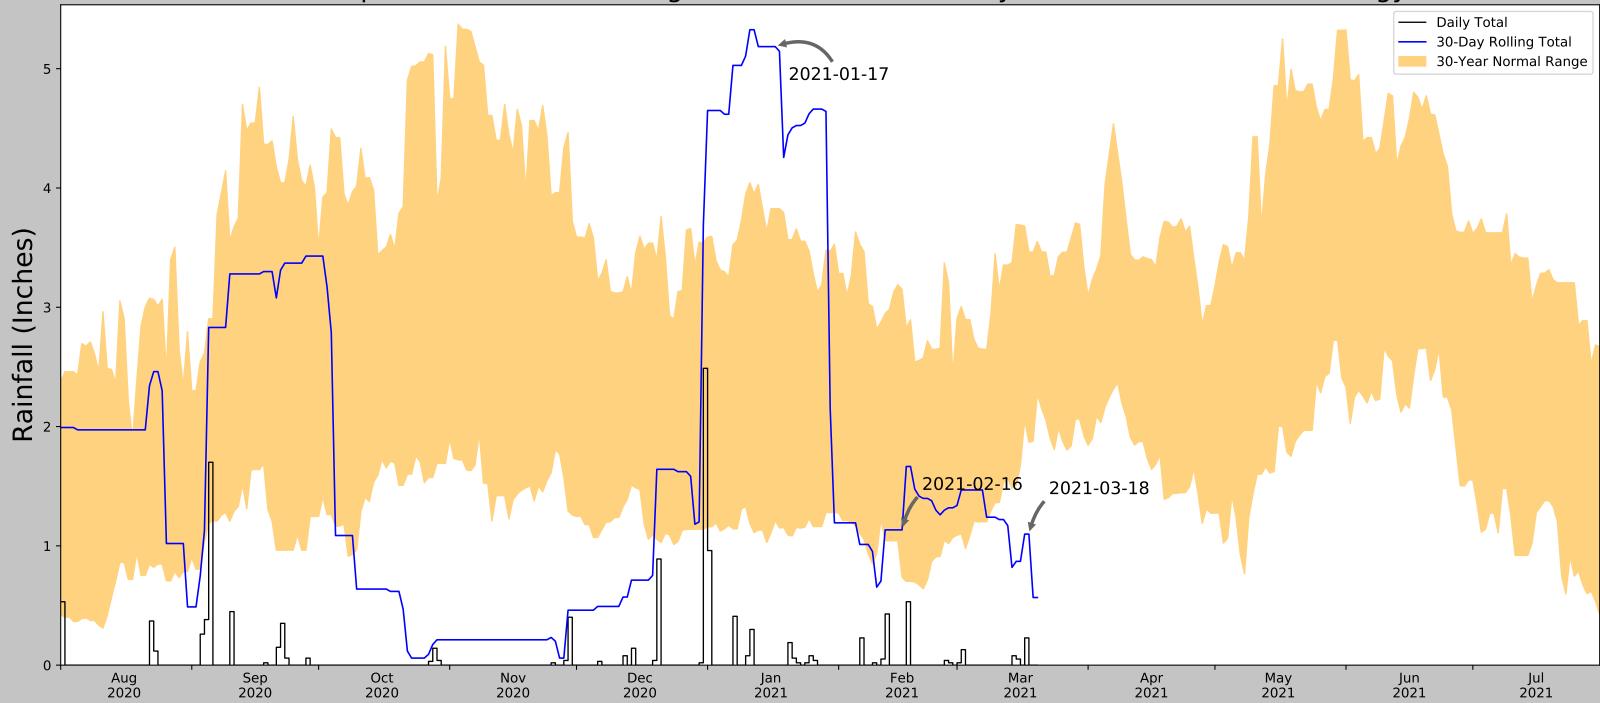
Antecedent Precipitation vs Normal Range based on NOAA's Daily Global Historical Climatology Network

Coordinates	30.336217, -97.577626
Observation Date	2021-03-18
Elevation (ft)	549.28
Drought Index (PDSI)	Severe drought (2021-02)
WebWIMP H ₂ O Balance	Wet Season

30 Days Ending	30 th %ile (in)	70 th %ile (in)	Observed (in)	Wetness Condition	Condition Value	Month Weight	Product
2021-03-18	1.868504	3.462992	1.098425	Dry	1	3	3
2021-02-16	0.73622	3.149606	1.133858	Normal	2	2	4
2021-01-17	1.209055	3.826378	5.18504	Wet	3	1	3
Result							Normal Conditions - 10

The APT was utilized for the date of **aci consulting's** original site visit on March 18, 2021, to assess the local current conditions. The subject area scored a 10, which indicated normal conditions.
