# ANN and ROY BUTLER HIKE AND BIKE TRAIL SITE ANALYSIS and RECOMMENDATION

## Executive Summary

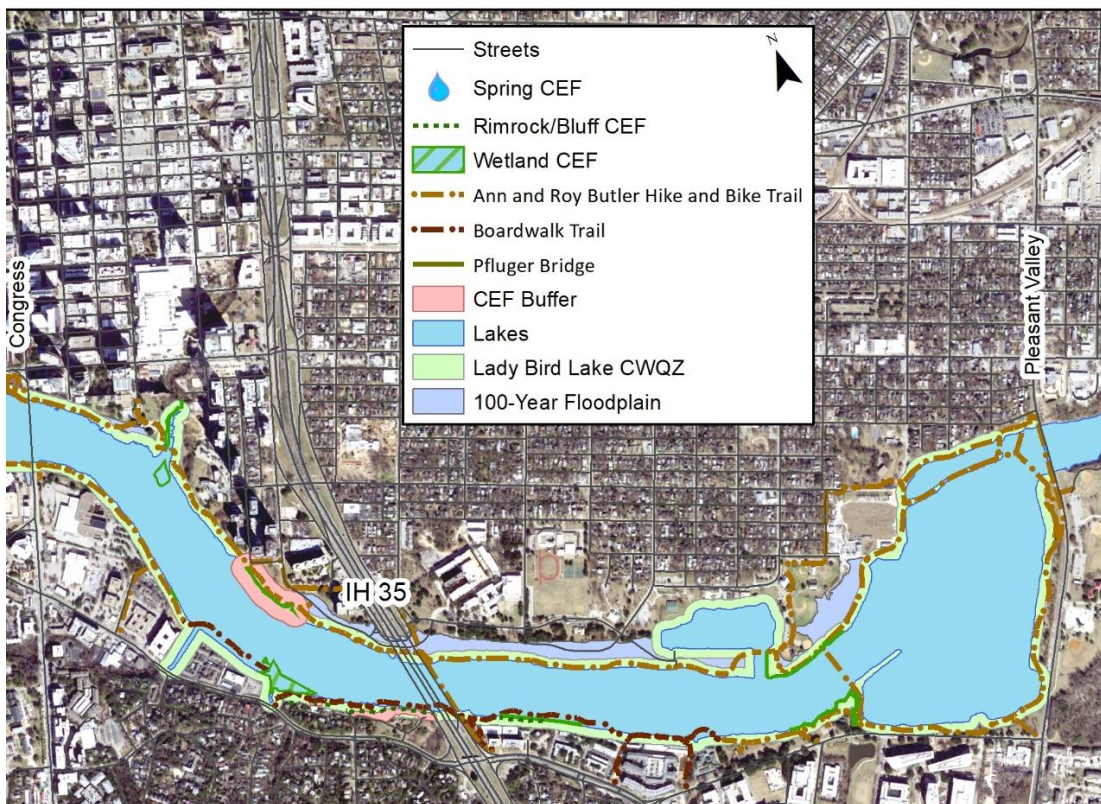
In several areas along the 10-mile loop, the Trail has slopes in excess of 15%. Particularly in the parkland around Zilker Park and in the Downtown region, slopes adjacent to the trail may exceed 35%, impeding relocation or modification of the Trail. The northwest and eastern portions of the Trail are in areas that are relatively flat.

Eastern portion of Butler Trail (Congress Ave to Pleasant Valley)

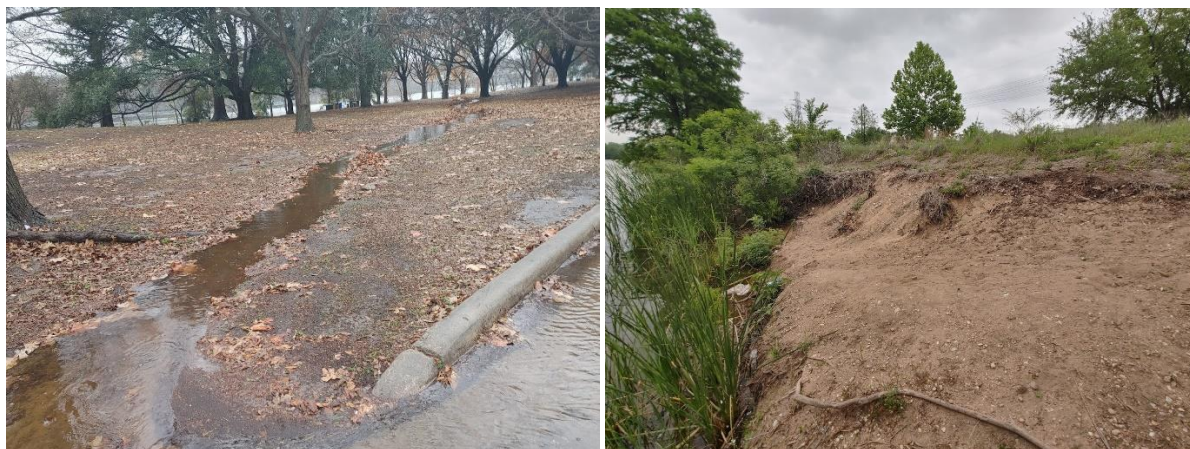
Heavy seasonal rain events bring high velocity stormwater flows through the parkland and onto the Butler Trail when water is diverted from adjacent impervious surfaces and directed into Lady Bird Lake as part of Austin's drainage conveyance system. Hard armored surface drainage structures, including concrete channels, drainage pipes, and culverts, are installed around the Trail and adjacent parkland to manage the impact of stormwater. However, the decomposed granite trail surface along with erosive storm flows have created erosion issues for the Trail that can worsen without improvements to the Trail, surrounding parkland, and stormwater infrastructure. Additionally, the erosive conveyance of storm flows through riparian and wetland areas degrades the condition of those habitats.

Photo taken at Festival Beach (LEFT) and Longhorn Shores (RIGHT)
