ITEM FOR ENVIRONMENTAL COMMISSION AGENDA

HCA Behavior Health Hospital

SP-2022-0516C

Request to vary from LDC 25-8-342 to allow fill to 14 feet.

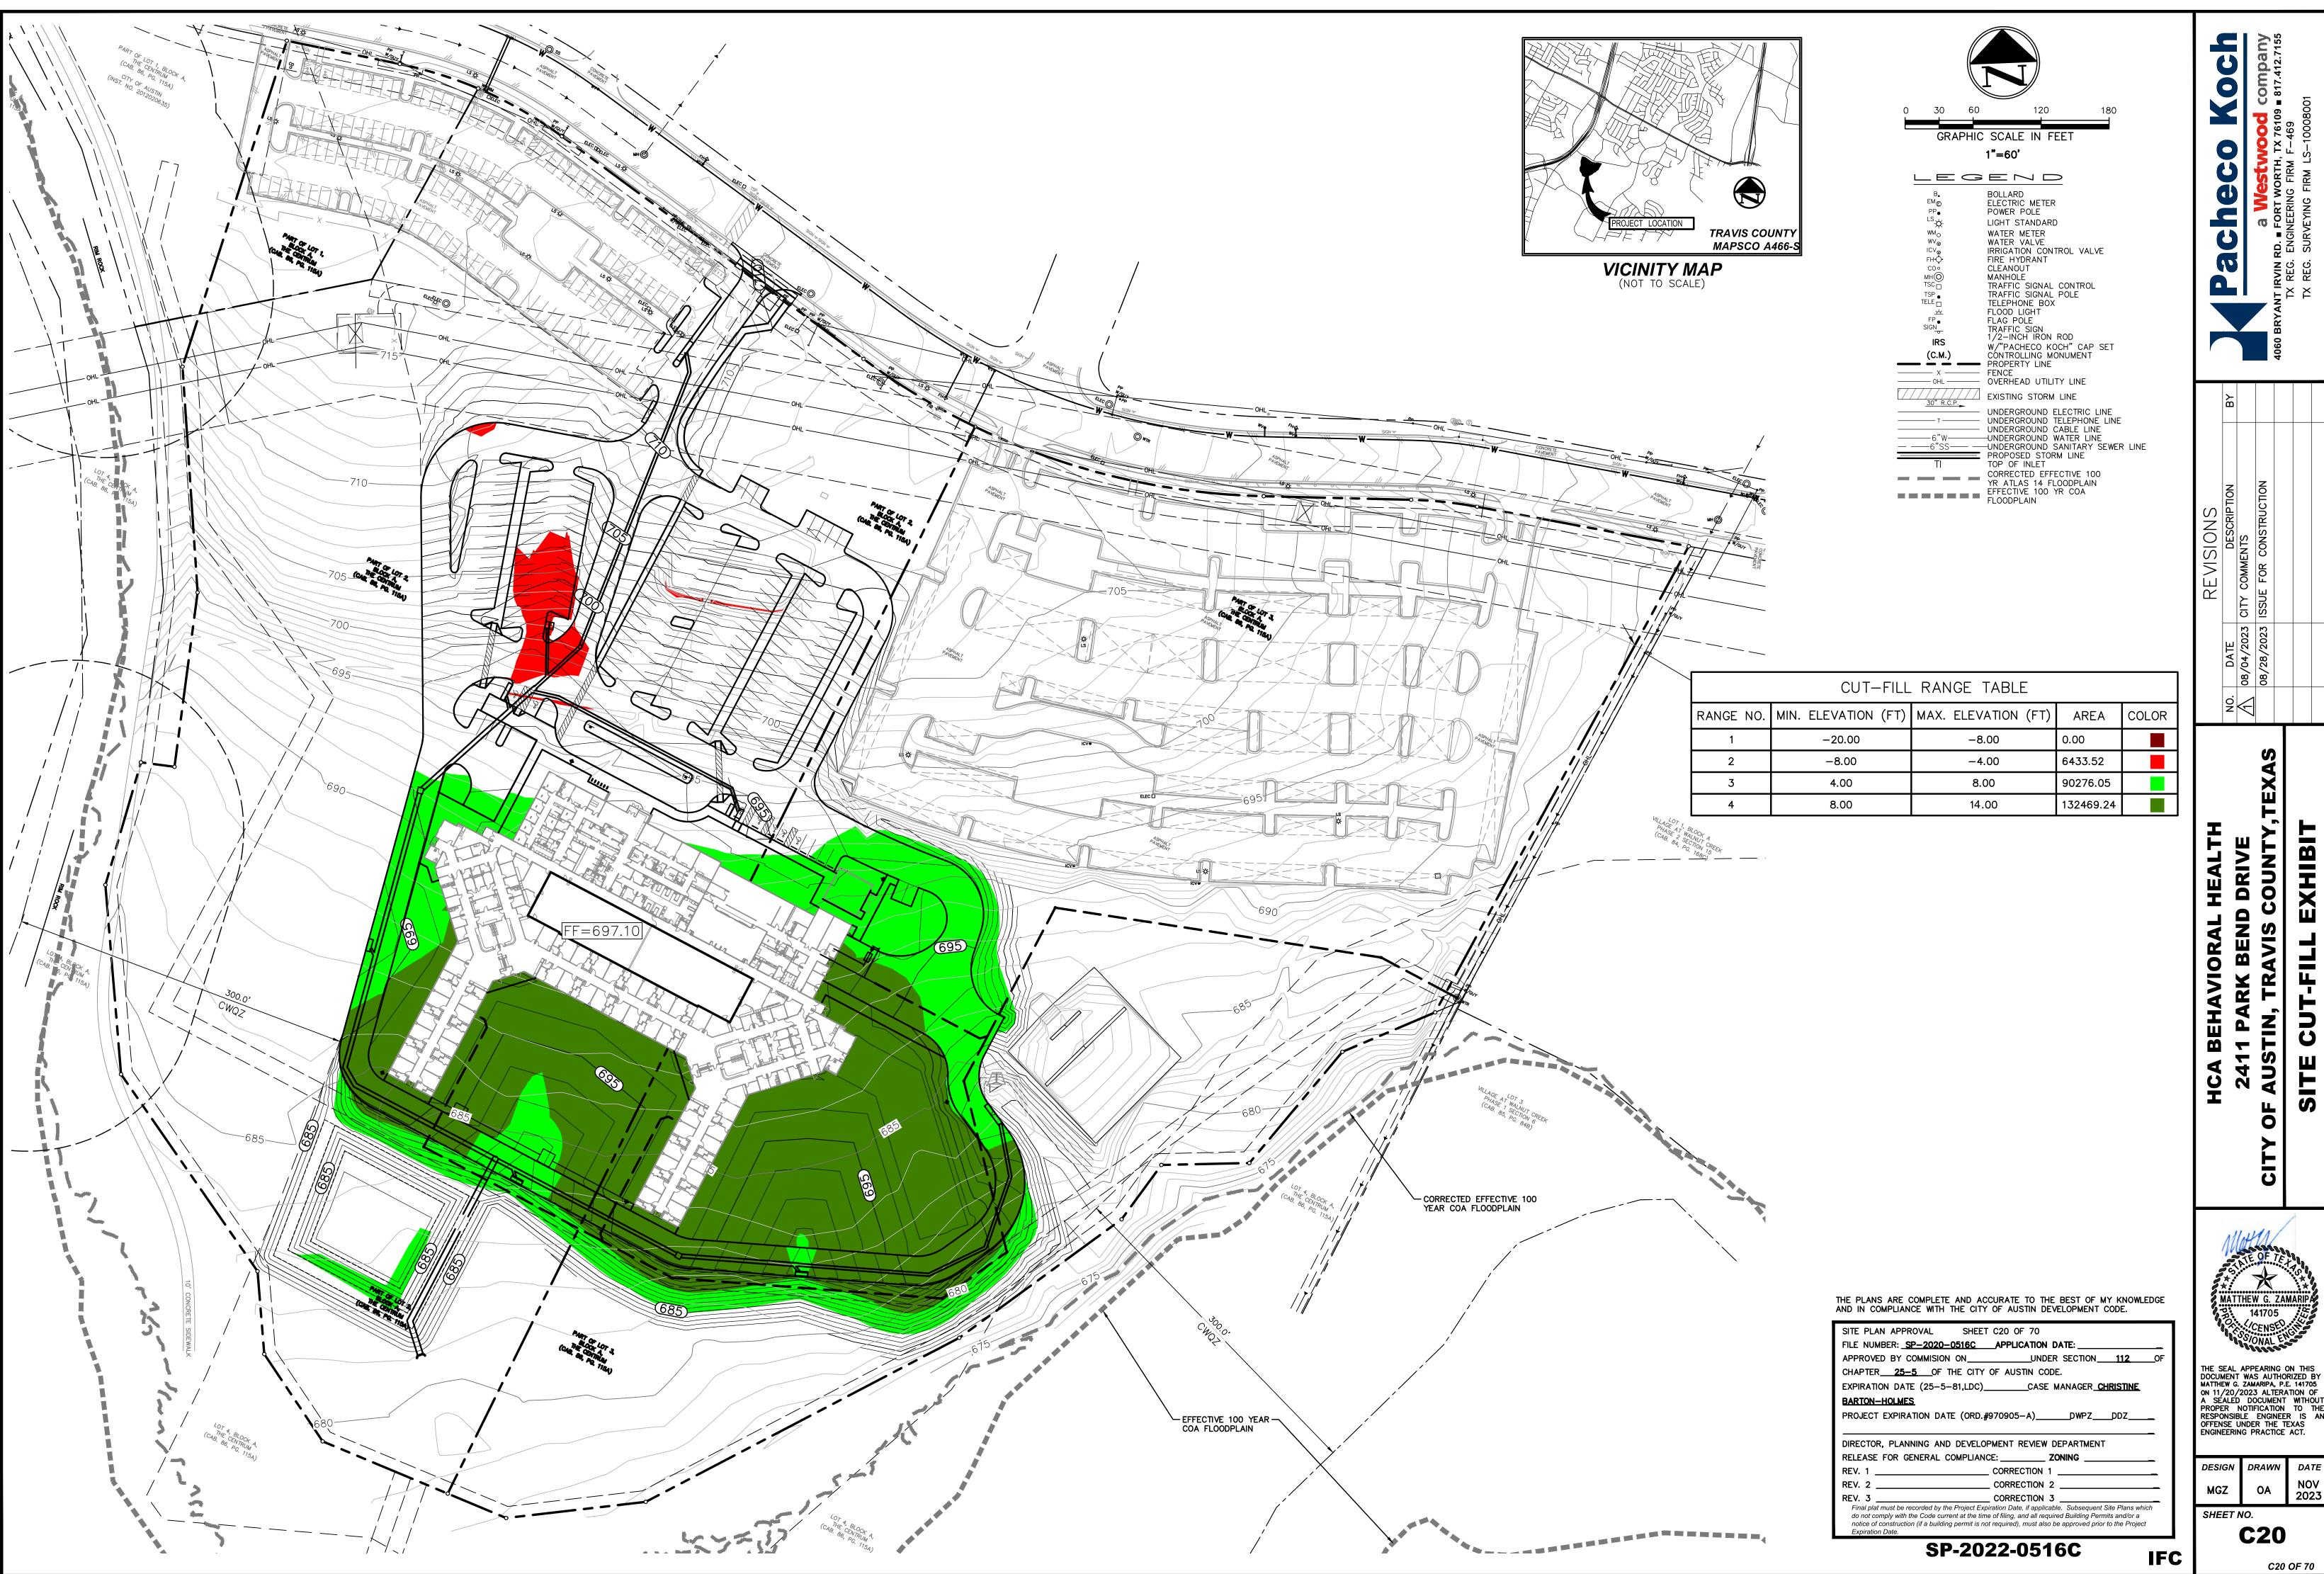
C20

- For cut/fill variances, a plan sheet showing areas and depth of cut/fill with topographic elevations. [Attached]
- Site plan showing existing conditions if development exists currently on the property
 [Attached, See Existing Conditions]

The proposed site development includes fill greater than 4' (max fill is 13.1')

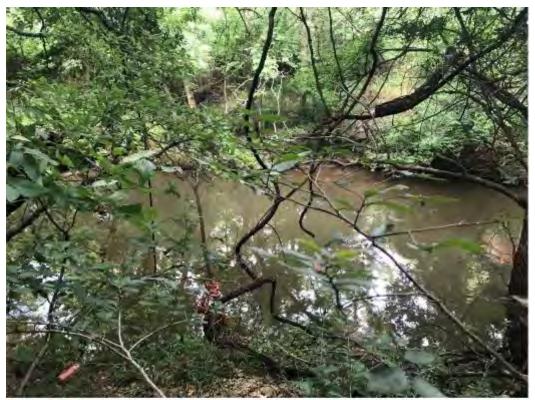
Photo 3 View of Walnut Creek, off-site to the west of the subject property but within the 150-foot survey buffer.

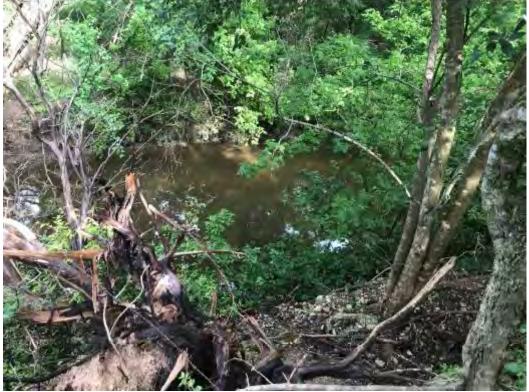
Photo 4 View of Walnut Creek, off-site to the west of the subject property but within the 150-foot survey buffer.

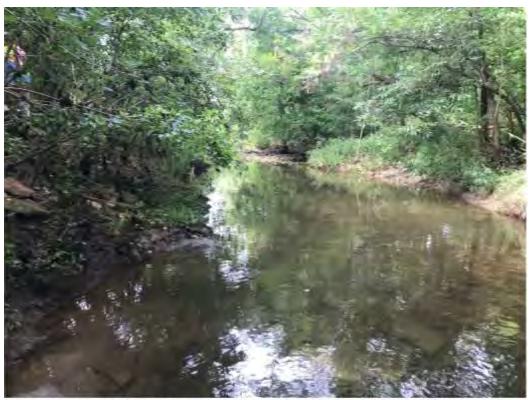
Photo 5 View of Walnut Creek, off-site to the west of the subject property but within the 150-foot survey buffer.

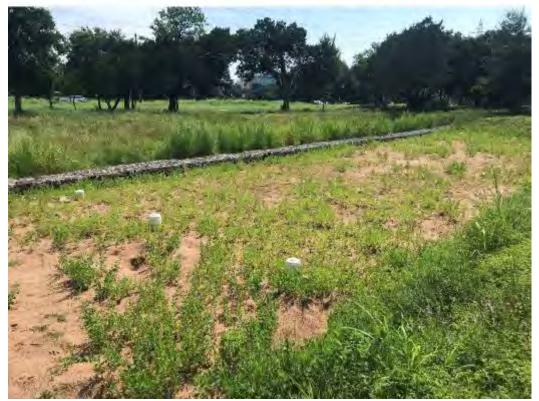
Photo 16 View of the recently constructed stormwater pond in the north-central portion of the property.

One small area in the north-central portion of the site appears to be a recently constructed stormwater pond. This area contains some hydrophytic vegetation, including rush (*juncus sp.* – FACW/OBL), bentawn flatsedge (*Cyperus reflexus* – FAC), Roosevelt weed (*Baccharis neglecta* – FAC), and annual marshelder (*Iva annua* – FAC), as well as upland vegetation, including prairie tea (*Croton monanthogynus*), silverleaf nightshade (*Solanum elaeagnifolium*), johnson grass (*Sorghum halepense*), and Mexican hat (*Ratibida columnifera*). Photographs of this stormwater pond can be found in Appendix C.

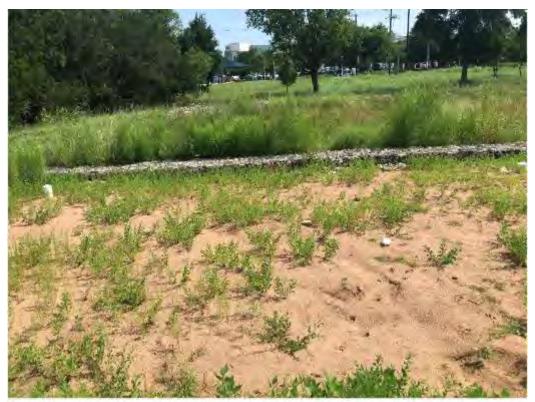
Photo 17 View of the recently constructed stormwater pond in the north-central portion of the property.

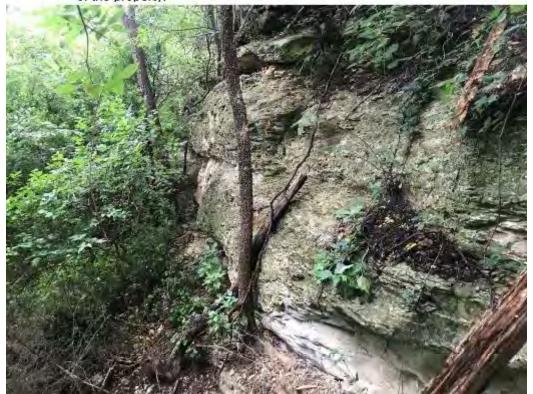
Photo 18 View of rimrock CEF (R-1).

Rimrock features R-1, R-2 and R-3 were observed west of the project boundary, off-site but within 150-feet of the site. These CEFs are adjacent to the off-site portions of COA named stream segment Walnut Creek. Photographs of R-1, R-2 and R-3 can be found in Appendix C.

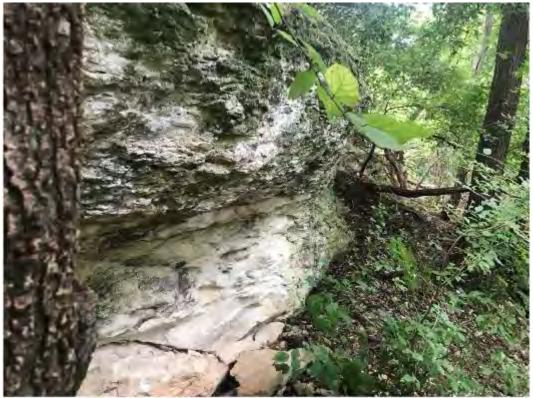
Photo 19 View of rimrock CEF (R-1).

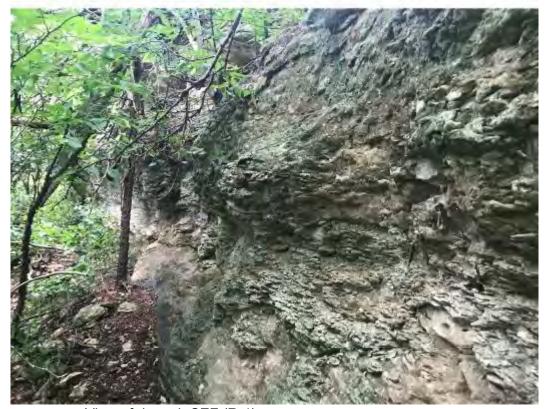
Photo 20 View of rimrock CEF (R-1).

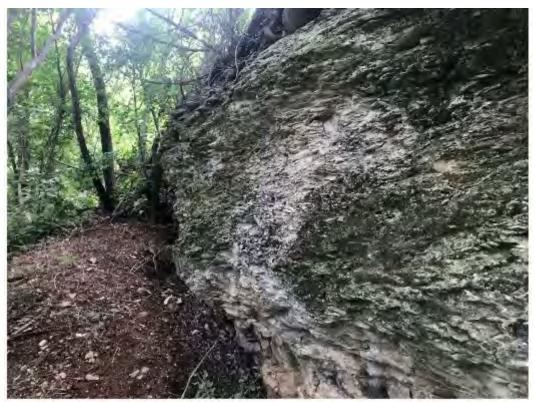
Photo 21 View of rimrock CEF (R-2).

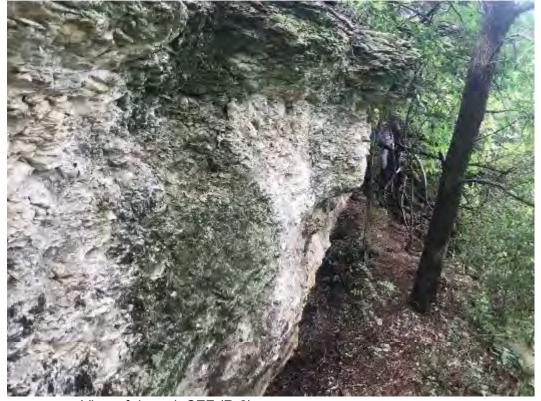
Photo 22 View of rimrock CEF (R-2).

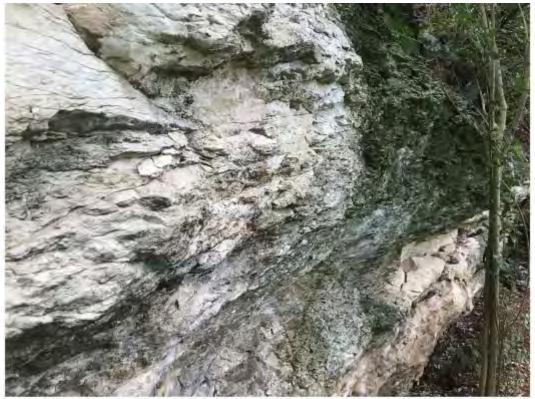
Photo 23 View of rimrock CEF (R-2).

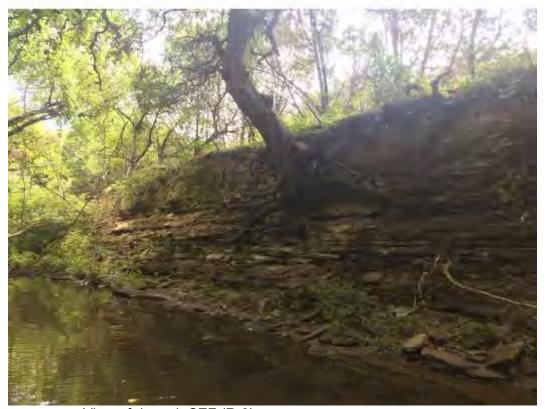
Photo 24 View of rimrock CEF (R-3).

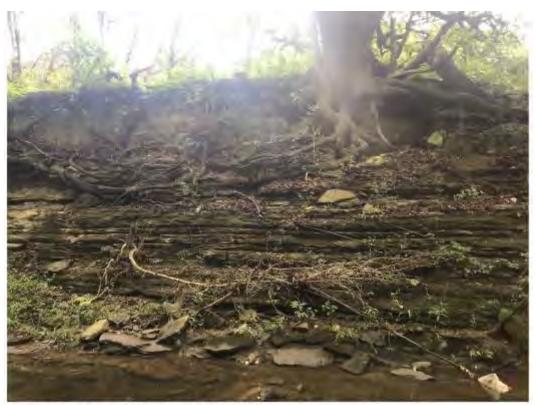
Photo 25 View of rimrock CEF (R-3).

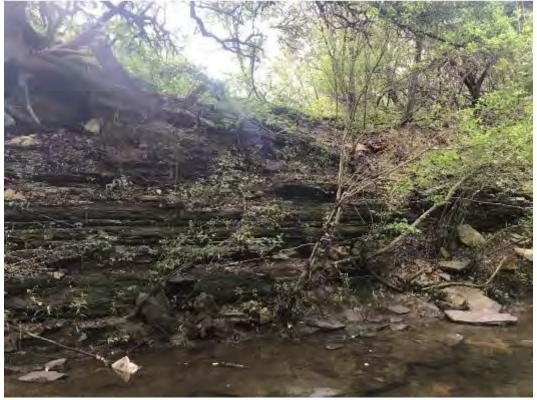
Photo 26 View of rimrock CEF (R-3).
