ANN and ROY BUTLER HIKE AND BIKE TRAIL SITE ANALYSIS and RECOMMENDATION

Executive Summary

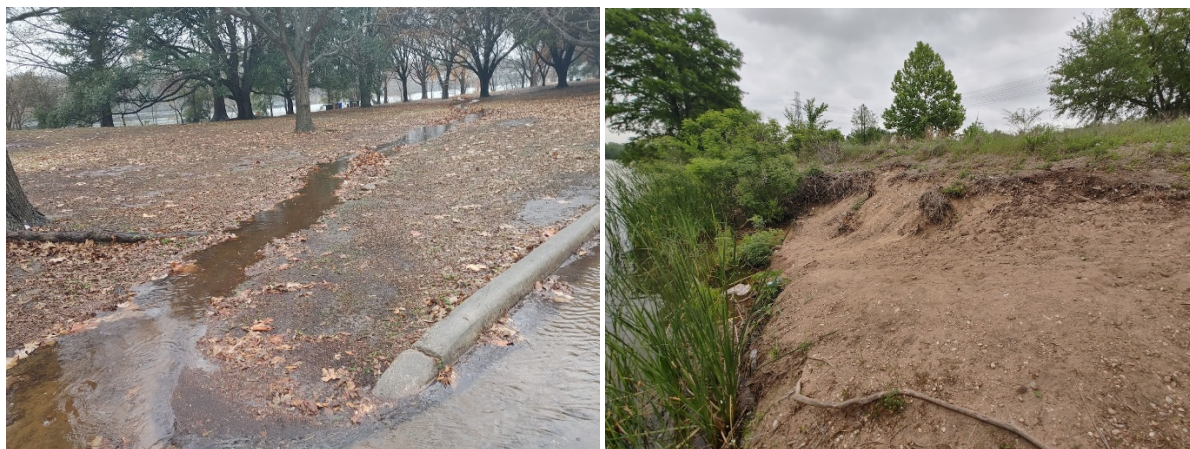
Photo taken at Festival Beach (LEFT) and Longhorn Shores (RIGHT)

Heavy seasonal rain events bring high velocity stormwater flows through the parkland and onto the Butler Trail when water is diverted from adjacent impervious surfaces and directed into Lady Bird Lake as part of Austin's drainage conveyance system. Hard armored surface drainage structures, including concrete channels, drainage pipes, and culverts, are installed around the Trail and adjacent parkland to manage the impact of stormwater. However, the decomposed granite trail surface along with erosive storm flows have created erosion issues for the Trail that can worsen without improvements to the Trail, surrounding parkland, and stormwater infrastructure. Additionally, the erosive conveyance of storm flows through riparian and wetland areas degrades the condition of those habitats.
