# Variance Presentation

Property Address: 1446 Rockcliff Rd.

Case Number: C15-2023-0048

Presenter: Jon Fichter, Aqua Permits

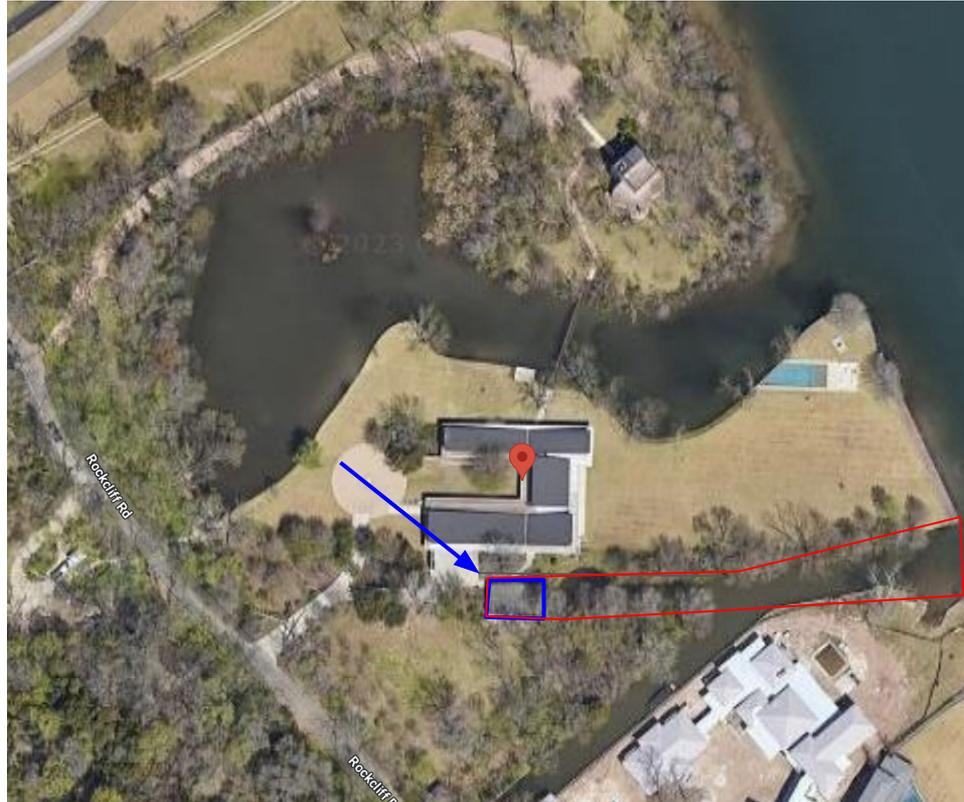
- Location of existing boat dock shown in blue
- Existing boat dock sits at the end of a 150 foot channel shown in red

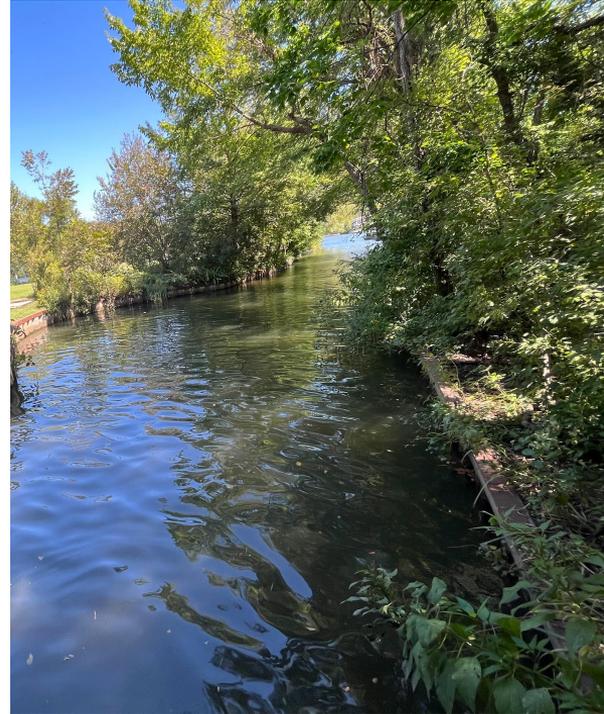
- The existing boat dock lies tucked away at the end of this channel.
- Navigating the channel is challenging with the natural boundaries; adding in years of sediment buildup coupled with the advancement of wetland environments has made it increasingly impassible.
- Additionally, the canopy of the trees along the channel poses a risk to harming the tree or the boat.
- These trees often drop branches into the channel as well.

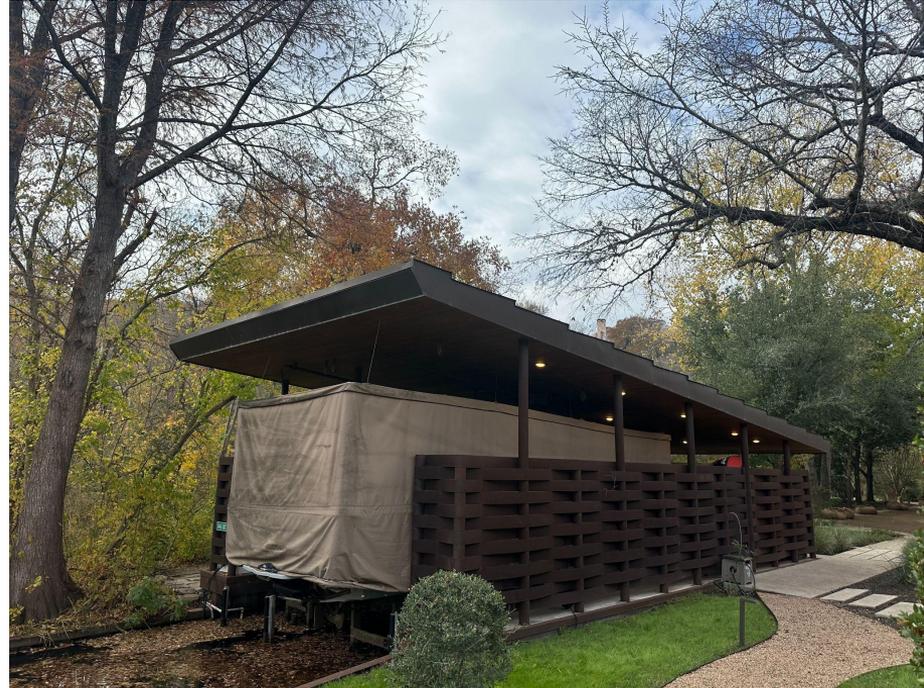
- The existing boat dock situated at the end of the channel
- Note the tree canopy overhanging the boat dock. Removal of the boat dock would pose disturbance to the canopy.
- The prior variance hearing for this property dealt primarily with the ecological effects of removing the boat dock. Per the council's request, we would like to show the existing dock and its current use/condition.
- While this structure does not have much use as a boat dock, it does function as storage for the property.

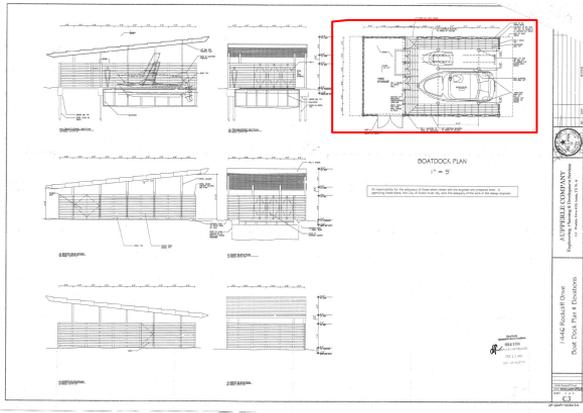
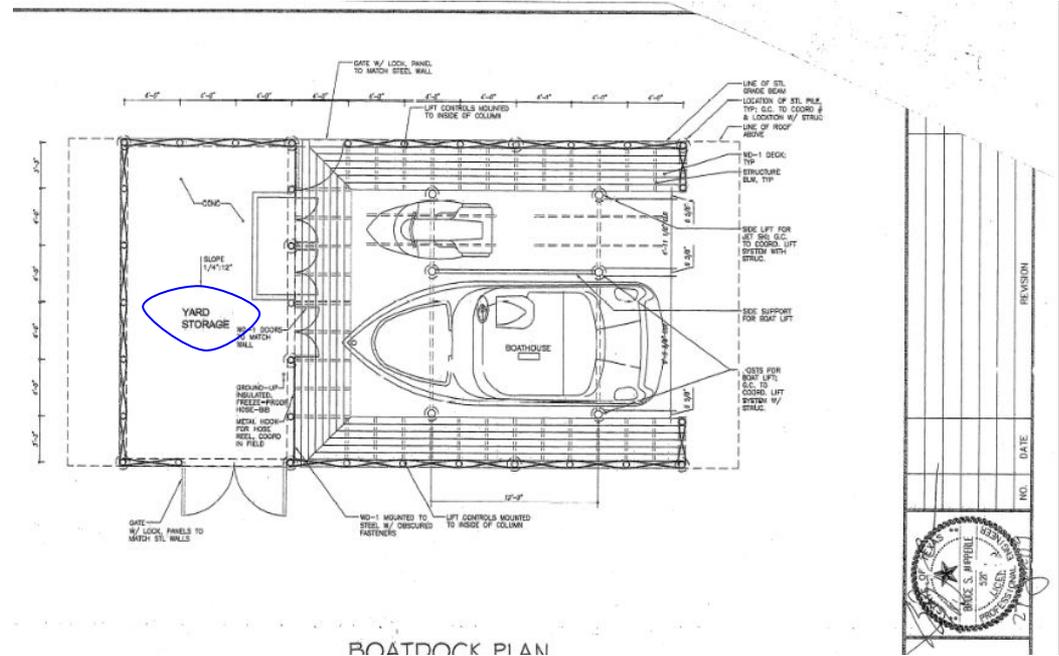
- This boat dock was built in 2005 alongside the new home construction using the same architectural team, and was legally permitted as-built by COA.
- This boat dock was originally permitted by COA and is unique to the property in that it allows for 1/3rd of the dock to be used as “Yard Storage”
- As it would have it, this has been the primary use of the boat dock since that time, due to the diminishing navigability of the channel.

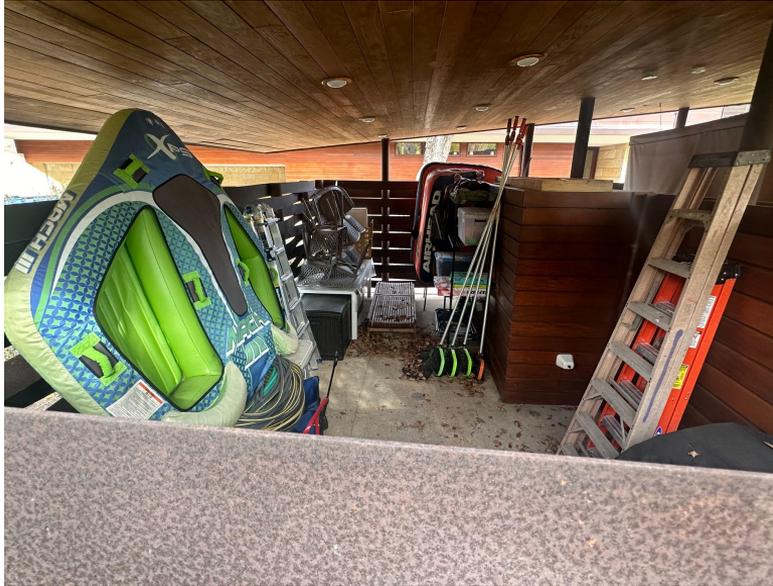
- The storage area of the boat house. Note that this area is completely over land and would be considered a shed if it were a freestanding structure.

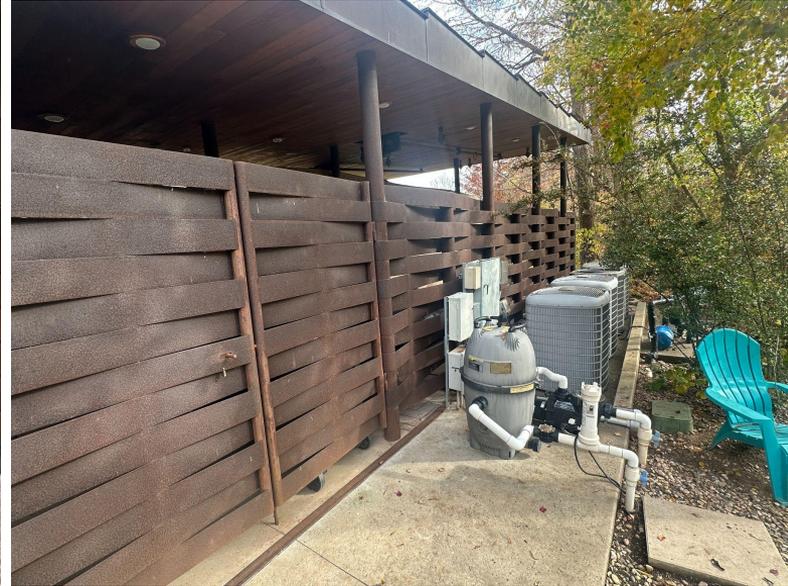
- The boat dock's foundation is also the pad for the home's HVAC units and other utilities.

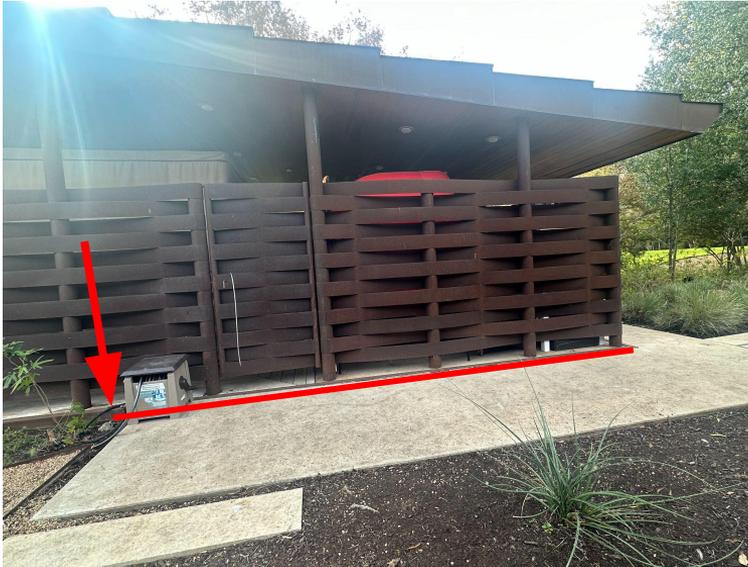
- The boathouse, seen here from an eastern-facing view. You can see the concrete slab in the forefront; the left edge denotes roughly the extent of the dock that sits on land and not over water (shown with red line).

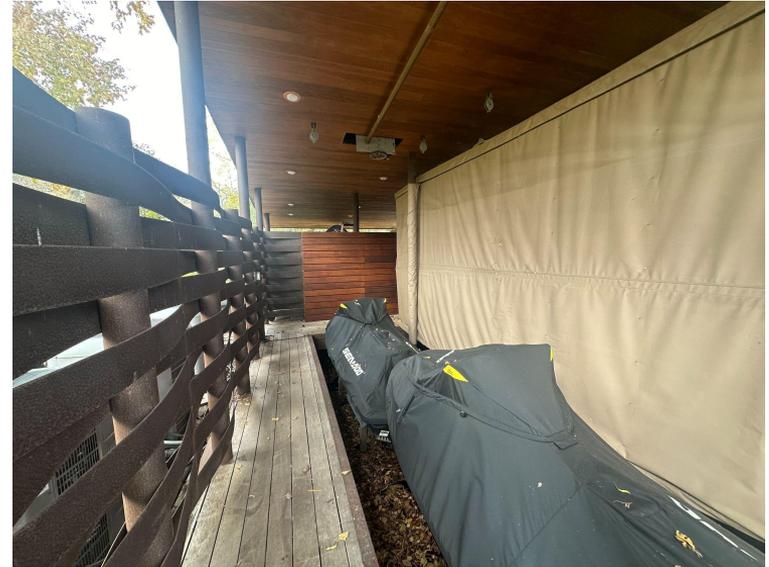
- The interior of the slip itself. Note the debris piling up in the jet-ski slip. These boats have been sitting for some time due to the channel's navigational issues.

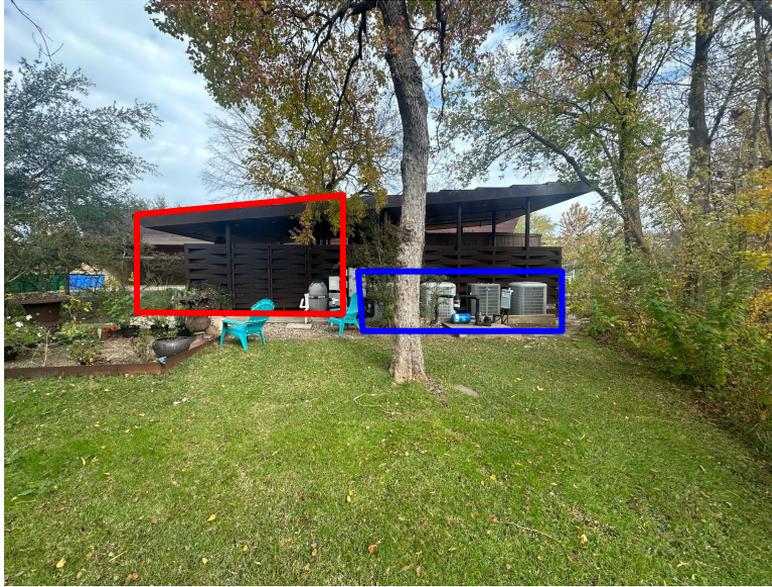
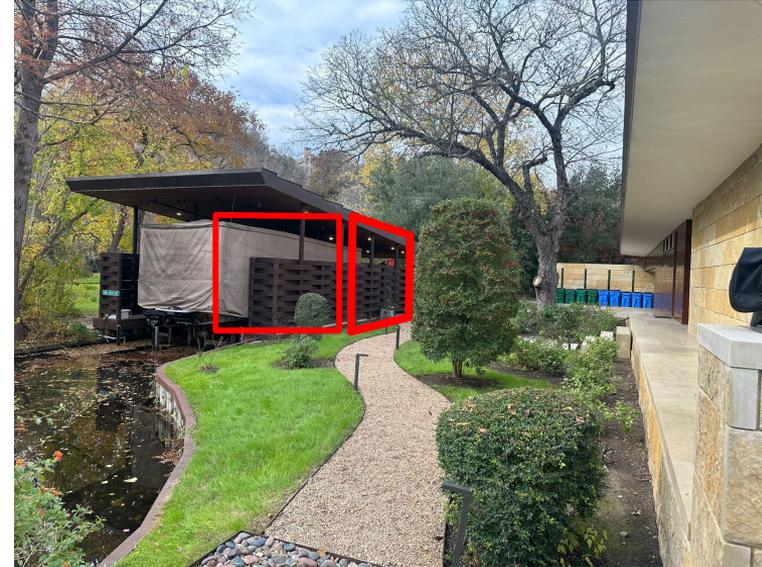
- Here is a general view of the boat dock from the north-east and south-east, respectively.
- The area highlighted in red is above water; having that area remain as storage is of great value to the homeowners.
- Additionally, the area in blue is where the HVAC and other utilities are located. Removing the boathouse would require relocating those units.

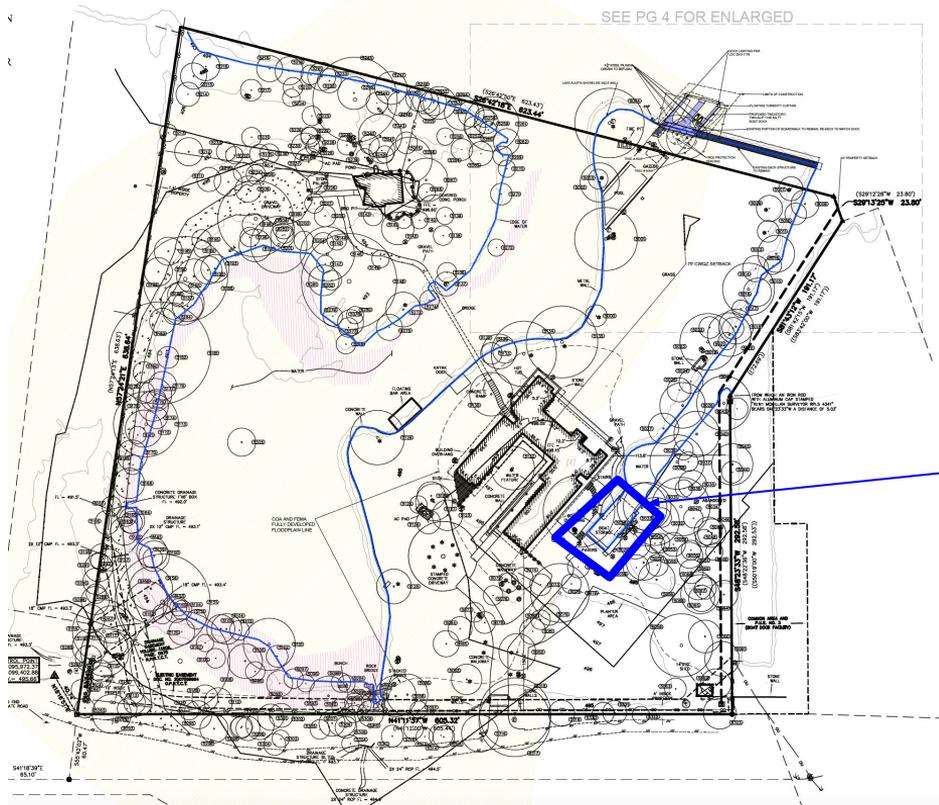
- The existing boat house is non-functional in its given use, and has been used as dry storage for some time.
- The existing boat dock is to be reconfigured as dry storage, and will have boat slips decked over as to prohibit its use as a functional boat dock.
- Demolishing this structure is not being proposed, as the boat house is integral to the functionality of utilities for the property as well as being useful storage.
- Reconfiguration of the structure from a boat house to a shed is the end goal of this building's use.
