Johnson & Johnson Grocery and House Center for Women & Their Work

Project Overview

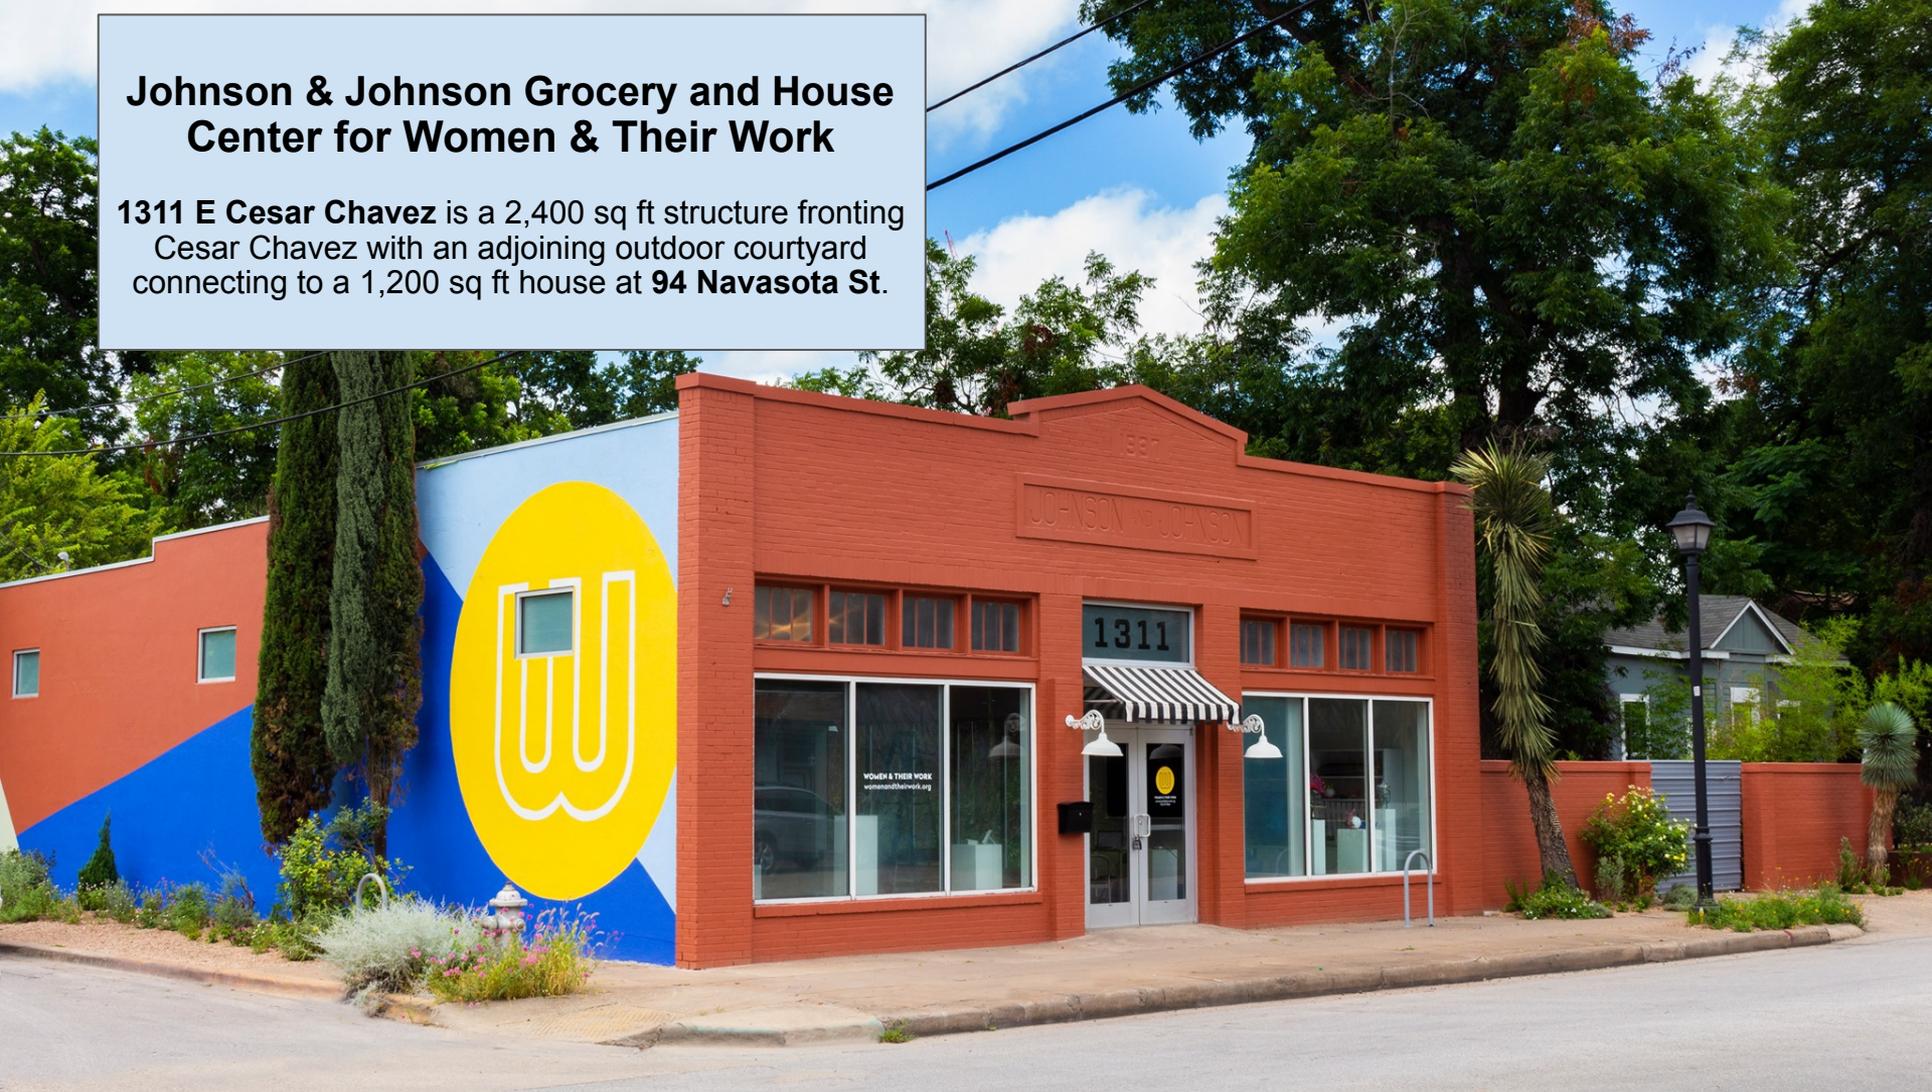
1311 E Cesar Chavez is a 2,400 sq ft structure fronting Cesar Chavez with an adjoining outdoor courtyard connecting to a 1,200 sq ft house at **94 Navasota St.**

1311 features a unique facade for what remains in its vicinity.

The building retains its historic appearance to a high degree in its original form, massing, symmetrical facades, fenestration pattern, transoms and sills, name and date panels, and tile coping along the secondary roof forms.

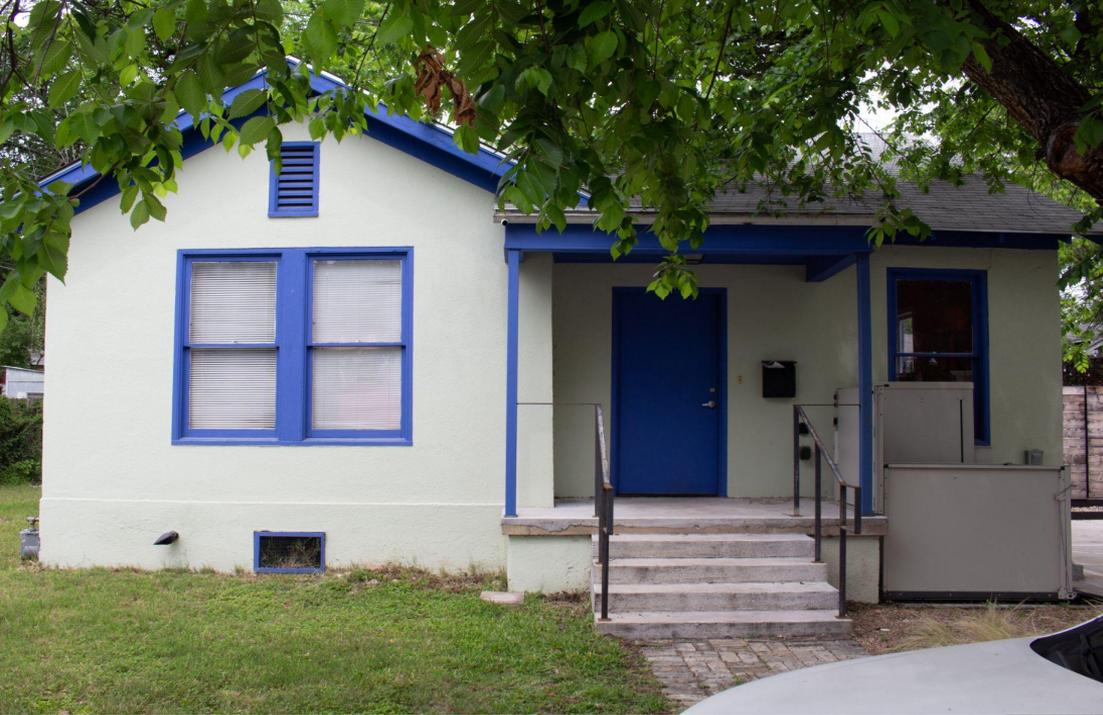
94 Navasota is a stucco building with wing and gable. Interesting elements include cedar posts that support the structure as well as wooden 2x4's in the attic measuring outside the modern standard, dating them to the late 1800's. Four doors exit to different sides of the building.

This house serves as our education space, called the **Learning Lounge**. It had very little preservation work done for many decades.

The historic building is supported by original cedar posts as well as cinder blocks that were added at a later date. To bring the building to code, the cinder blocks will be removed and a new pier and beam system will be installed. Cedar posts will be preserved alongside new supports.

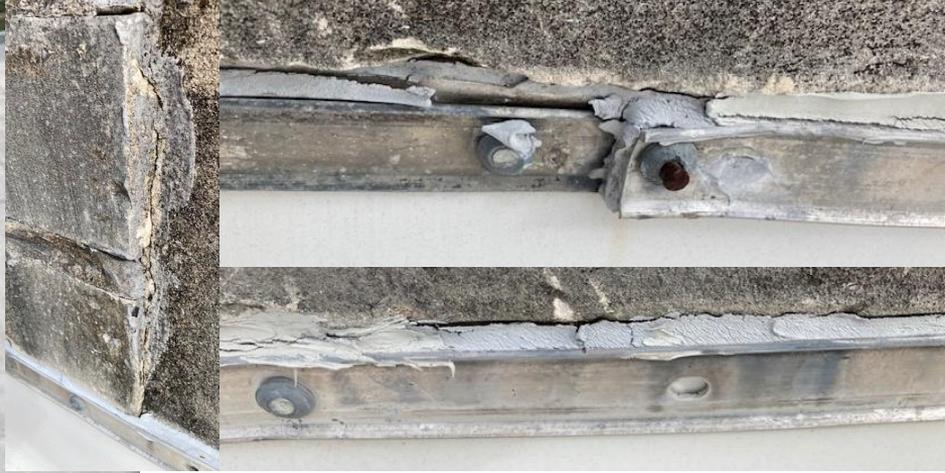
Preservation Priority 1: Roof Repair

- Cut out and remove existing roof membrane above leak location
- Inspect for hidden damages and replace as needed
- Remove existing flashing at front parapet wall
- Fully adhere 60mil TPO roofing membrane at front parapet wall location to extend out roof deck
- Hot air weld all field seams and provide t-patch at all applicable locations
- Custom fabricate and install 24GA Kynar parapet coping with 22GA galvanized wind cleat at front elevation
- General maintenance
- Probe all existing field welds and repair on as-needed basis

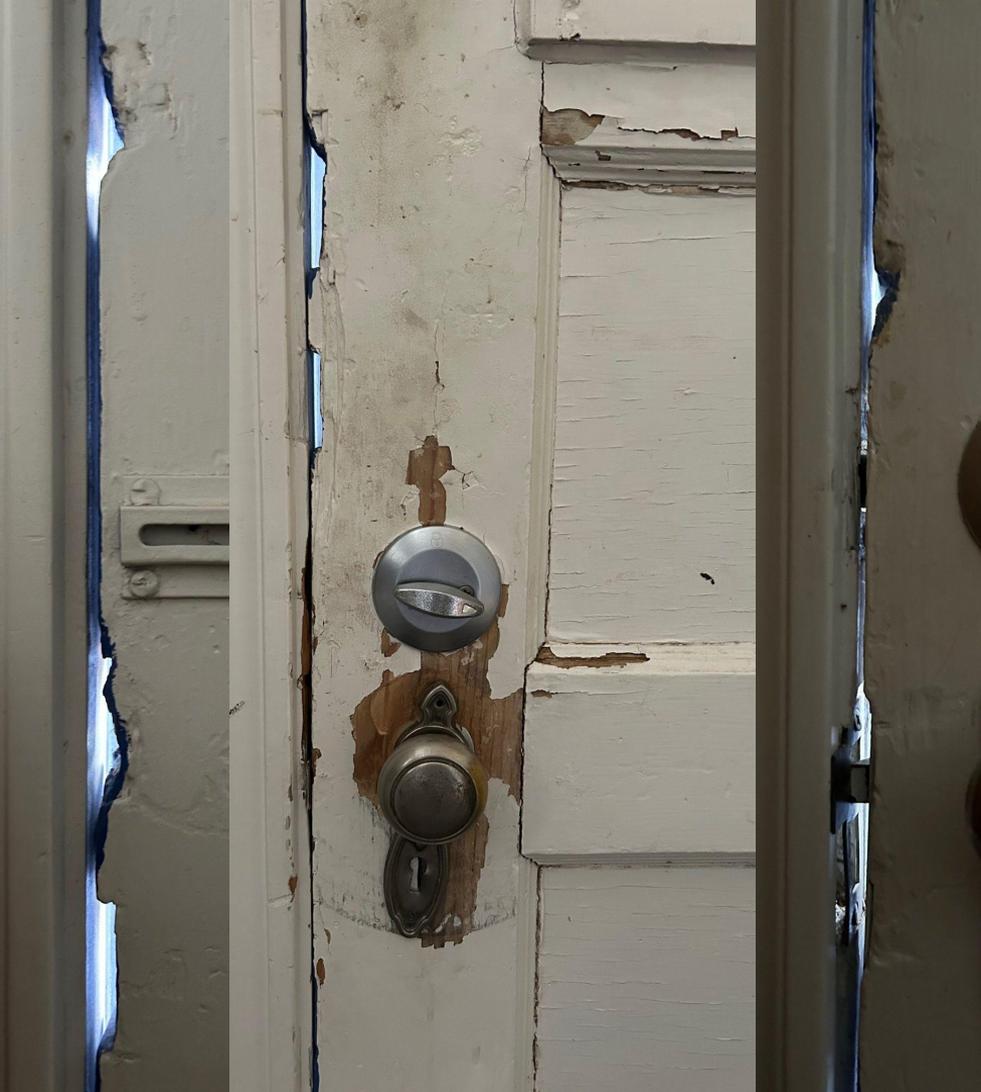
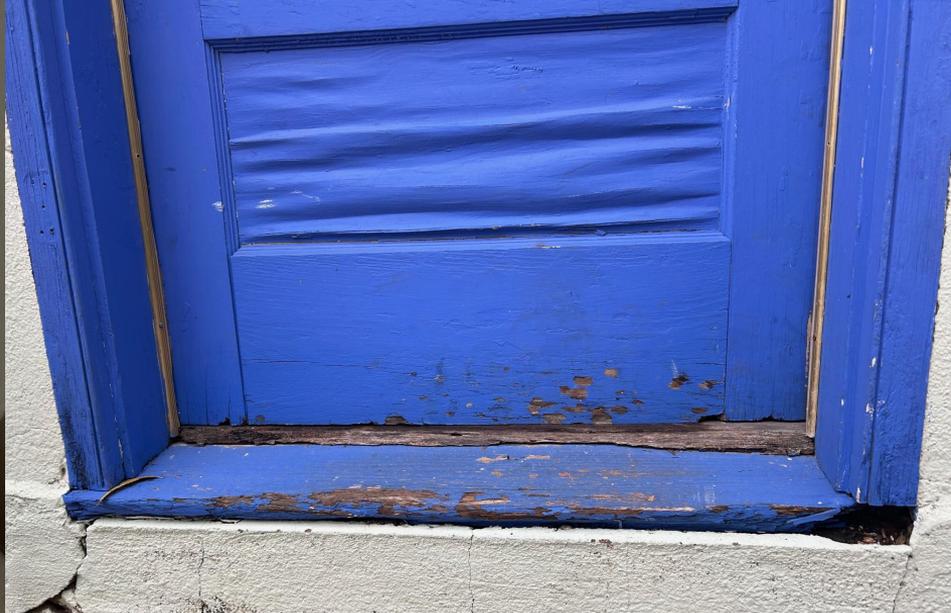
Preservation Priority 4: Repair Windows

Remove sashes, scrape jambs free of excess paint and repair small rot or damage, ensure pulleys are cleaned, tuned and functional, install Sampson Spot Cord to weights. Prime and paint jambs with 2 coats premium water-based paint, cover openings with plywood. Mill new parting bead and interior stop. Re-install sashes and ensure smooth operation.

Full containment set up before work begins. Remove glass, all existing putty and paint, sand smooth, repair all damage with epoxy or wood to match, prime with oil-based primer, clean and bed original glass & finish glaze with linseed oil putty. Apply 2 coats premium water-based paint. Bulb weatherstripping at meeting rail and lower sash as needed, caulk exterior parting bead and interior stop. Clean and lacquer existing hardware.
