ANN and ROY BUTLER HIKE AND BIKE TRAIL SITE ANALYSIS and RECOMMENDATION

Executive Summary

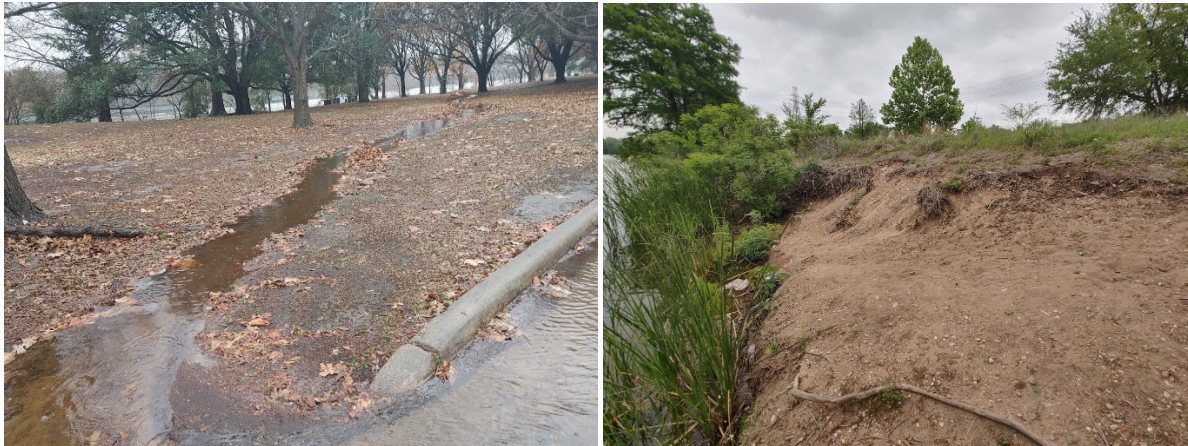
Heavy seasonal rain events bring high velocity stormwater flows through the parkland and onto the Butler Trail when water is diverted from adjacent impervious surfaces and directed into Lady Bird Lake as part of Austin's drainage conveyance system. Hard armored surface drainage structures, including concrete channels, drainage pipes, and culverts, are installed around the Trail and adjacent parkland to manage the impact of stormwater. However, the decomposed granite trail surface along with erosive storm

flows have created erosion issues for the Trail that can worsen without improvements to the Trail, surrounding parkland, and stormwater infrastructure. Additionally, the erosive conveyance of storm flows through riparian and wetland areas degrades the condition of those habitats.

Photo taken at Festival Beach (LEFT) and Longhorn Shores (RIGHT)
