ANN and ROY BUTLER HIKE AND BIKE TRAIL SITE ANALYSIS and RECOMMENDATION

Executive Summary

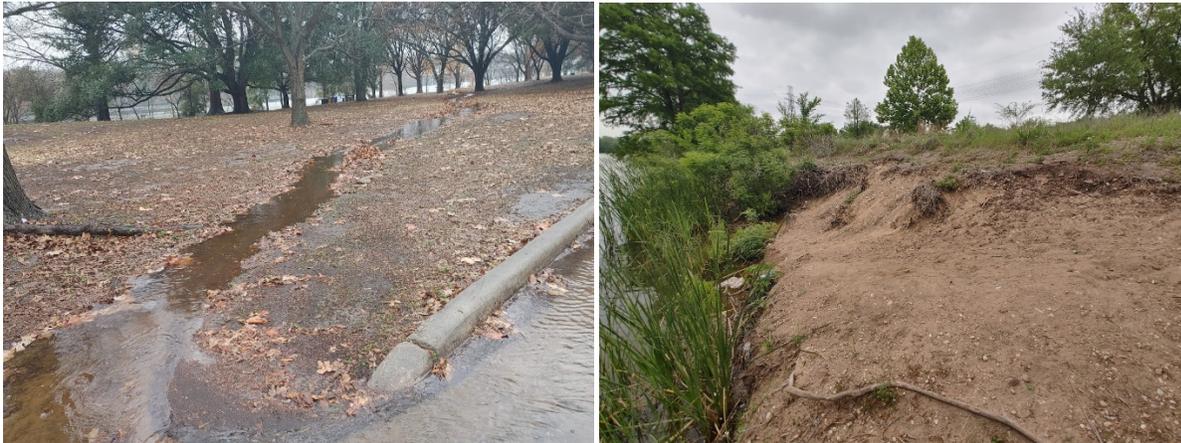
Heavy seasonal rain events bring high velocity stormwater flows through the parkland and onto the Butler Trail when water is diverted from adjacent impervious surfaces and directed into Lady Bird Lake as part of Austin’s drainage conveyance system. Hard armored surface drainage structures, including concrete channels, drainage pipes, and culverts, are installed around the Trail and adjacent parkland to manage the impact of stormwater. However, the decomposed granite trail surface along with erosive storm

flows have created erosion issues for the Trail that can worsen without improvements to the Trail, surrounding parkland, and stormwater infrastructure. Additionally, the erosive conveyance of storm flows through riparian and wetland areas degrades the condition of those habitats.

Photo taken at Festival Beach (LEFT) and Longhorn Shores (RIGHT)
