Western Hills Residence

HISTORIC LANDMARK COMMISSION MEETING

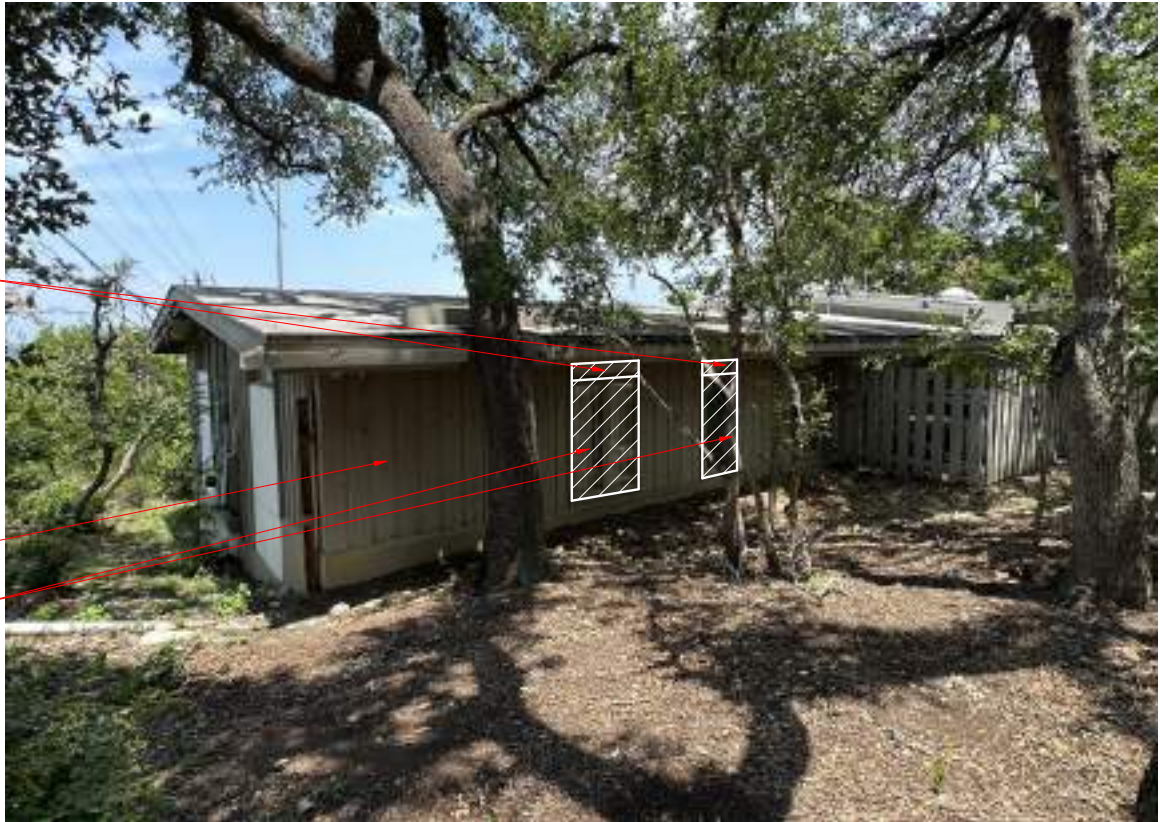
EAST ELEVATION - 1

REPLACING STUCCO WITH
WOOD BATTENS

ALL SIDING TO BE REPLACED,
SAME SIZE AND PROPORTION
AS EXISTING

REMOVING AND REPLACING
WITH NEW WINDOWS, RE:
1/A2.2

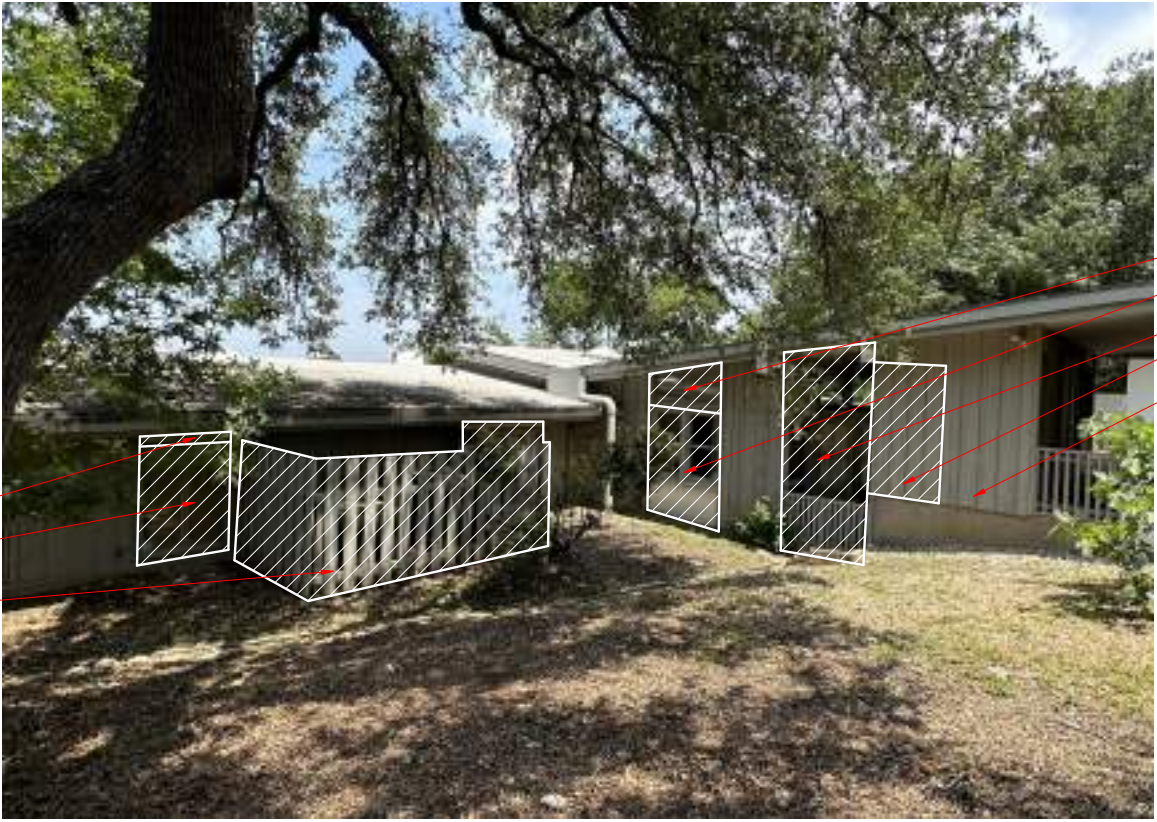
EAST AND SOUTH ELEVATION

REPLACING STUCCO WITH
WOOD BATTENS

REMOVING AND REPLACING
WITH NEW WINDOWS

REMOVING FENCE AND HVAC
PAD, HVAC PAD TO BE
RELOCATED

REPLACING WINDOW IN
EXISTING OPENING

REMOVING AND REPLACING
WITH WOOD BATTENS

INFILLING WITH EXTERIOR WALL

REMOVING FOR NEW EXTERIOR
DOOR

ALL SIDING TO BE REPLACED,
SAME SIZE AND PROPORTION
AS EXISTING

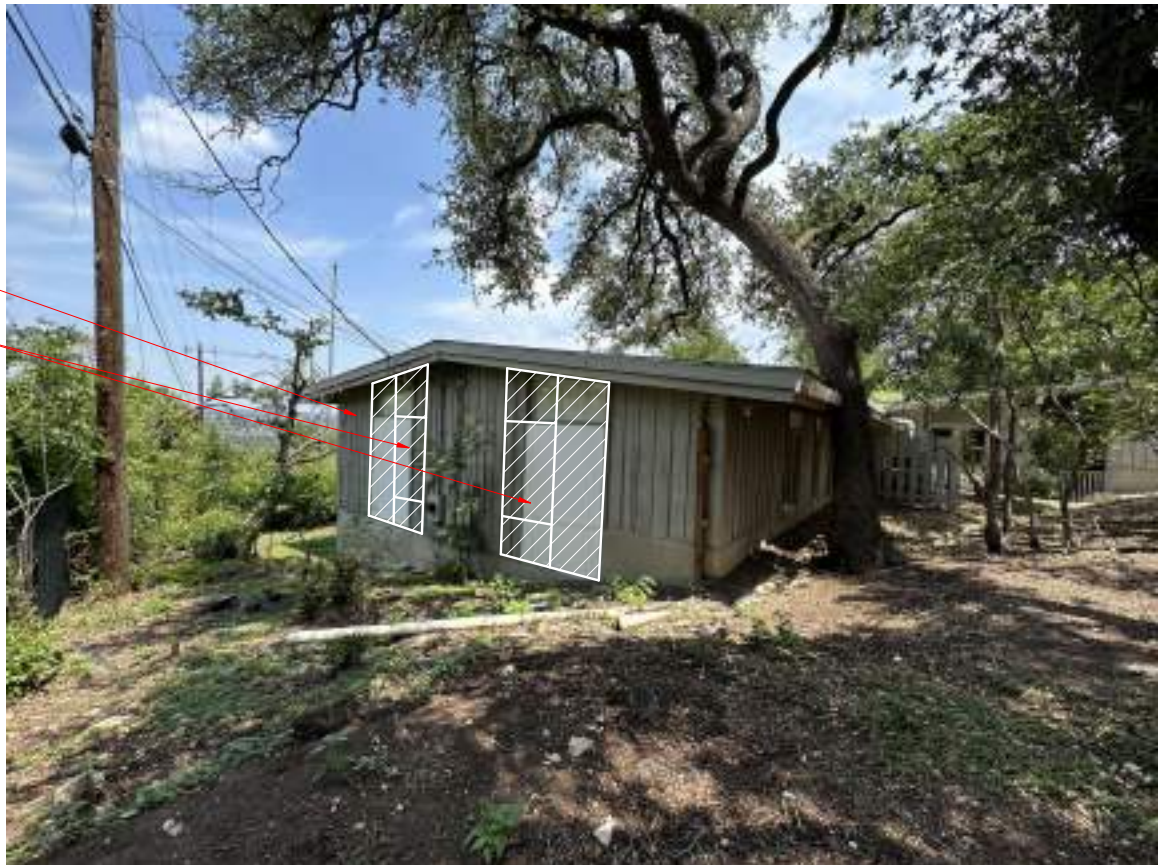
SOUTH ELEVATION - 2

ALL SIDING TO BE REPLACED,
SAME SIZE AND PROPORTION
AS EXISTING

REMOVING AND REPLACING
WITH NEW WINDOWS, RE:
1/A2.2

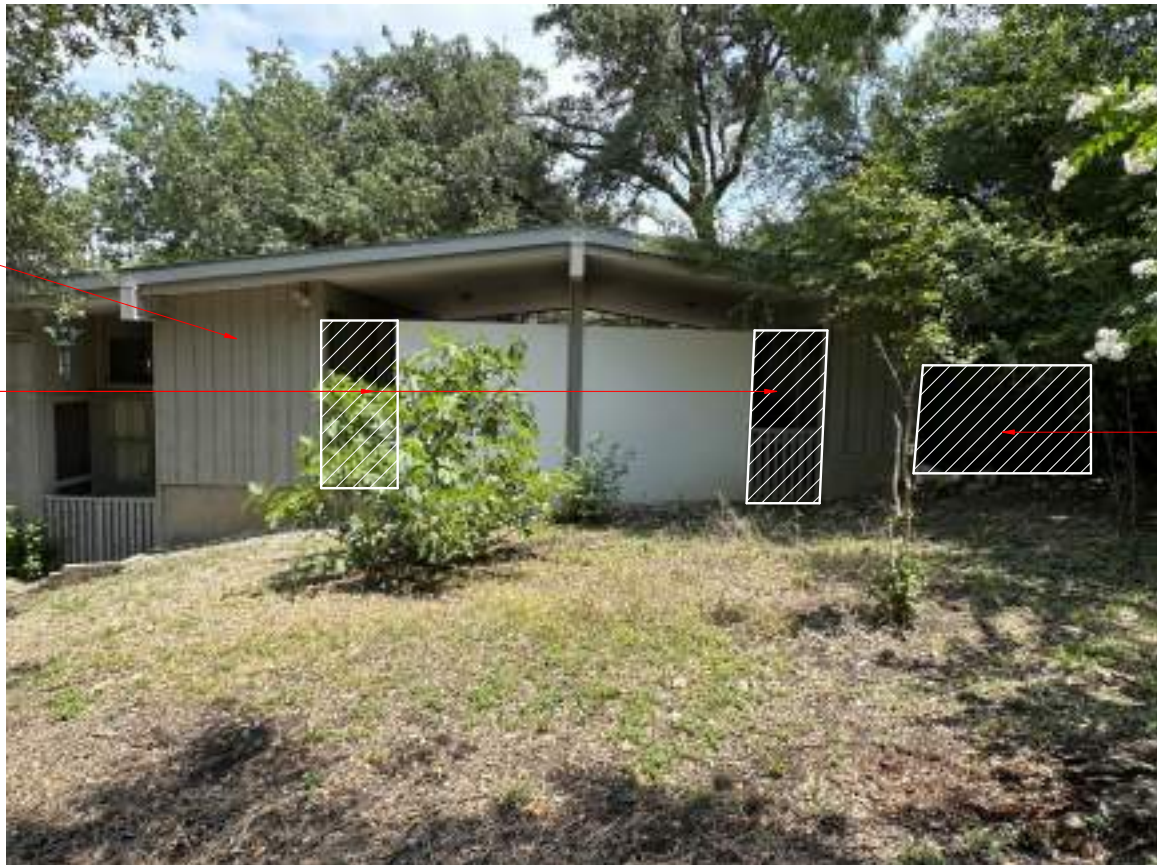
SOUTH ELEVATION - 1

ALL SIDING TO BE REPLACED,
SAME SIZE AND PROPORTION
AS EXISTING

INFILL STUCCO WALL TO
MATCH EXISTING

NEW WOOD GATE BEYOND
