3701 ROBBINS RD  
#C15-2024-0013

BOA VARIANCE REQUEST  
PRESENTATION

# 3701 ROBBINS ROAD

- 1. A REQUEST FOR A VARIANCE FROM 25-2-1176 (A)(3)- SITE DEVELOPMENT REGULATIONS FOR DOCKS, MARINAS, AND OTHER LAKEFRONT USES for a side yard setback of 10 ft. (Required) to 0 ft. (proposed) to allow for a new boat dock to be built where an existing boat dock already is within the setback on the side property line.

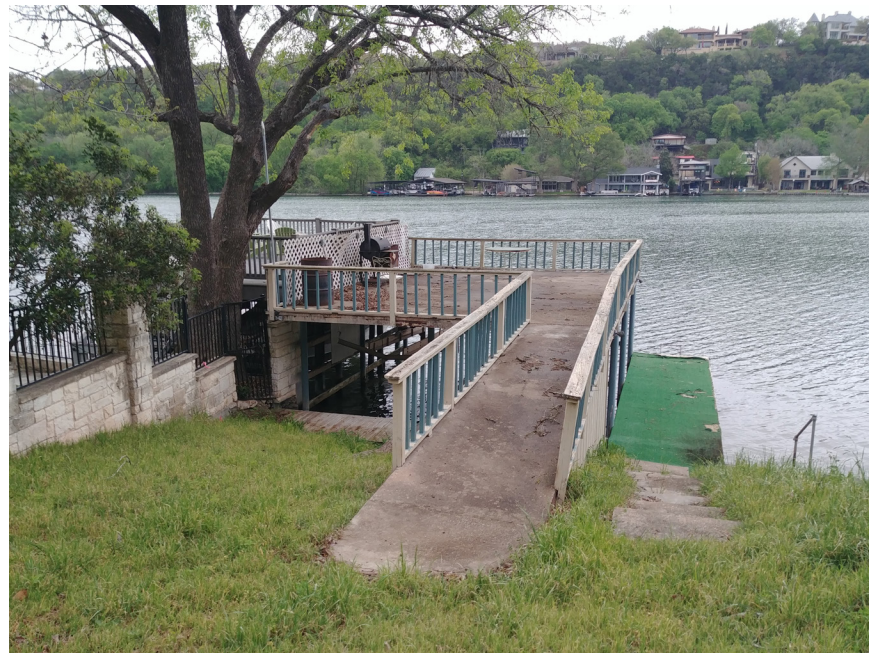
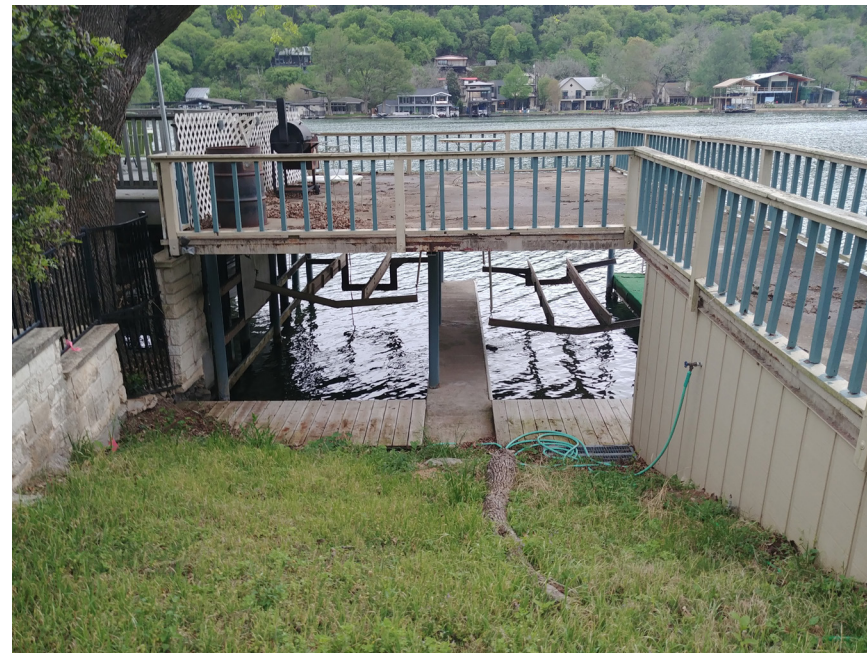
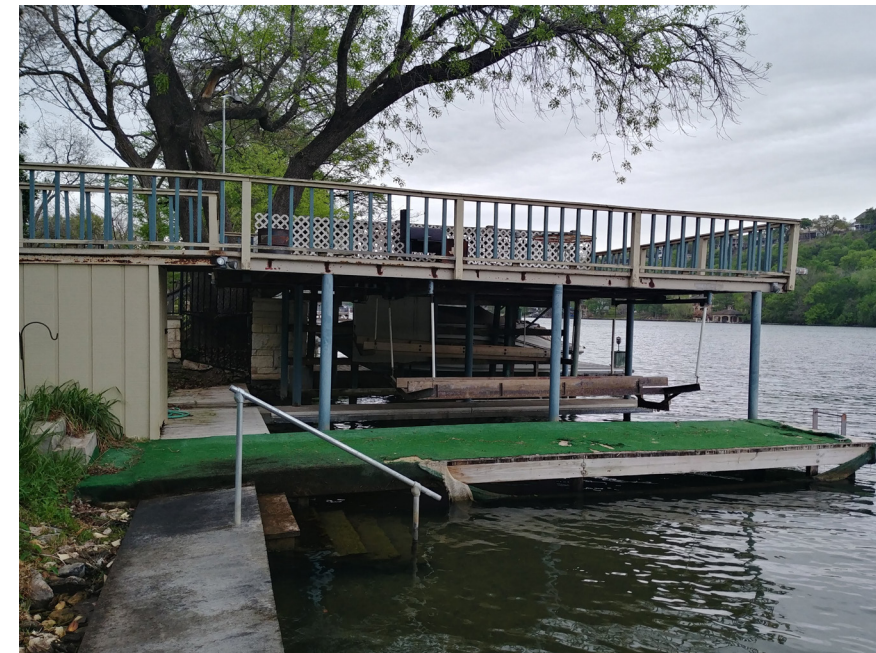
## EXISTING CONDITIONS & DESIGN CONSTRAINTS

SITE PHOTOS- Taken March 2021 after site was mowed

1. The existing boat dock was erected before 1984, and needs to be replaced. The current dock does not have enough clearance above the waterline to accommodate modern boats. Rebuilding the dock with an increase in height will allow a reasonable use enjoyed by other homeowners on the lake.
2. There are established wetlands. Relocating the boat dock would directly impact the wetlands and cause further disruption to the shorefront ecology and the lakebed.
3. There is a large green ash present on the property line adjacent to the boat dock. Rebuilding in the current location will avoid further damage to the CRZ.
4. The neighbor also has a boat dock built on the shared lot line.

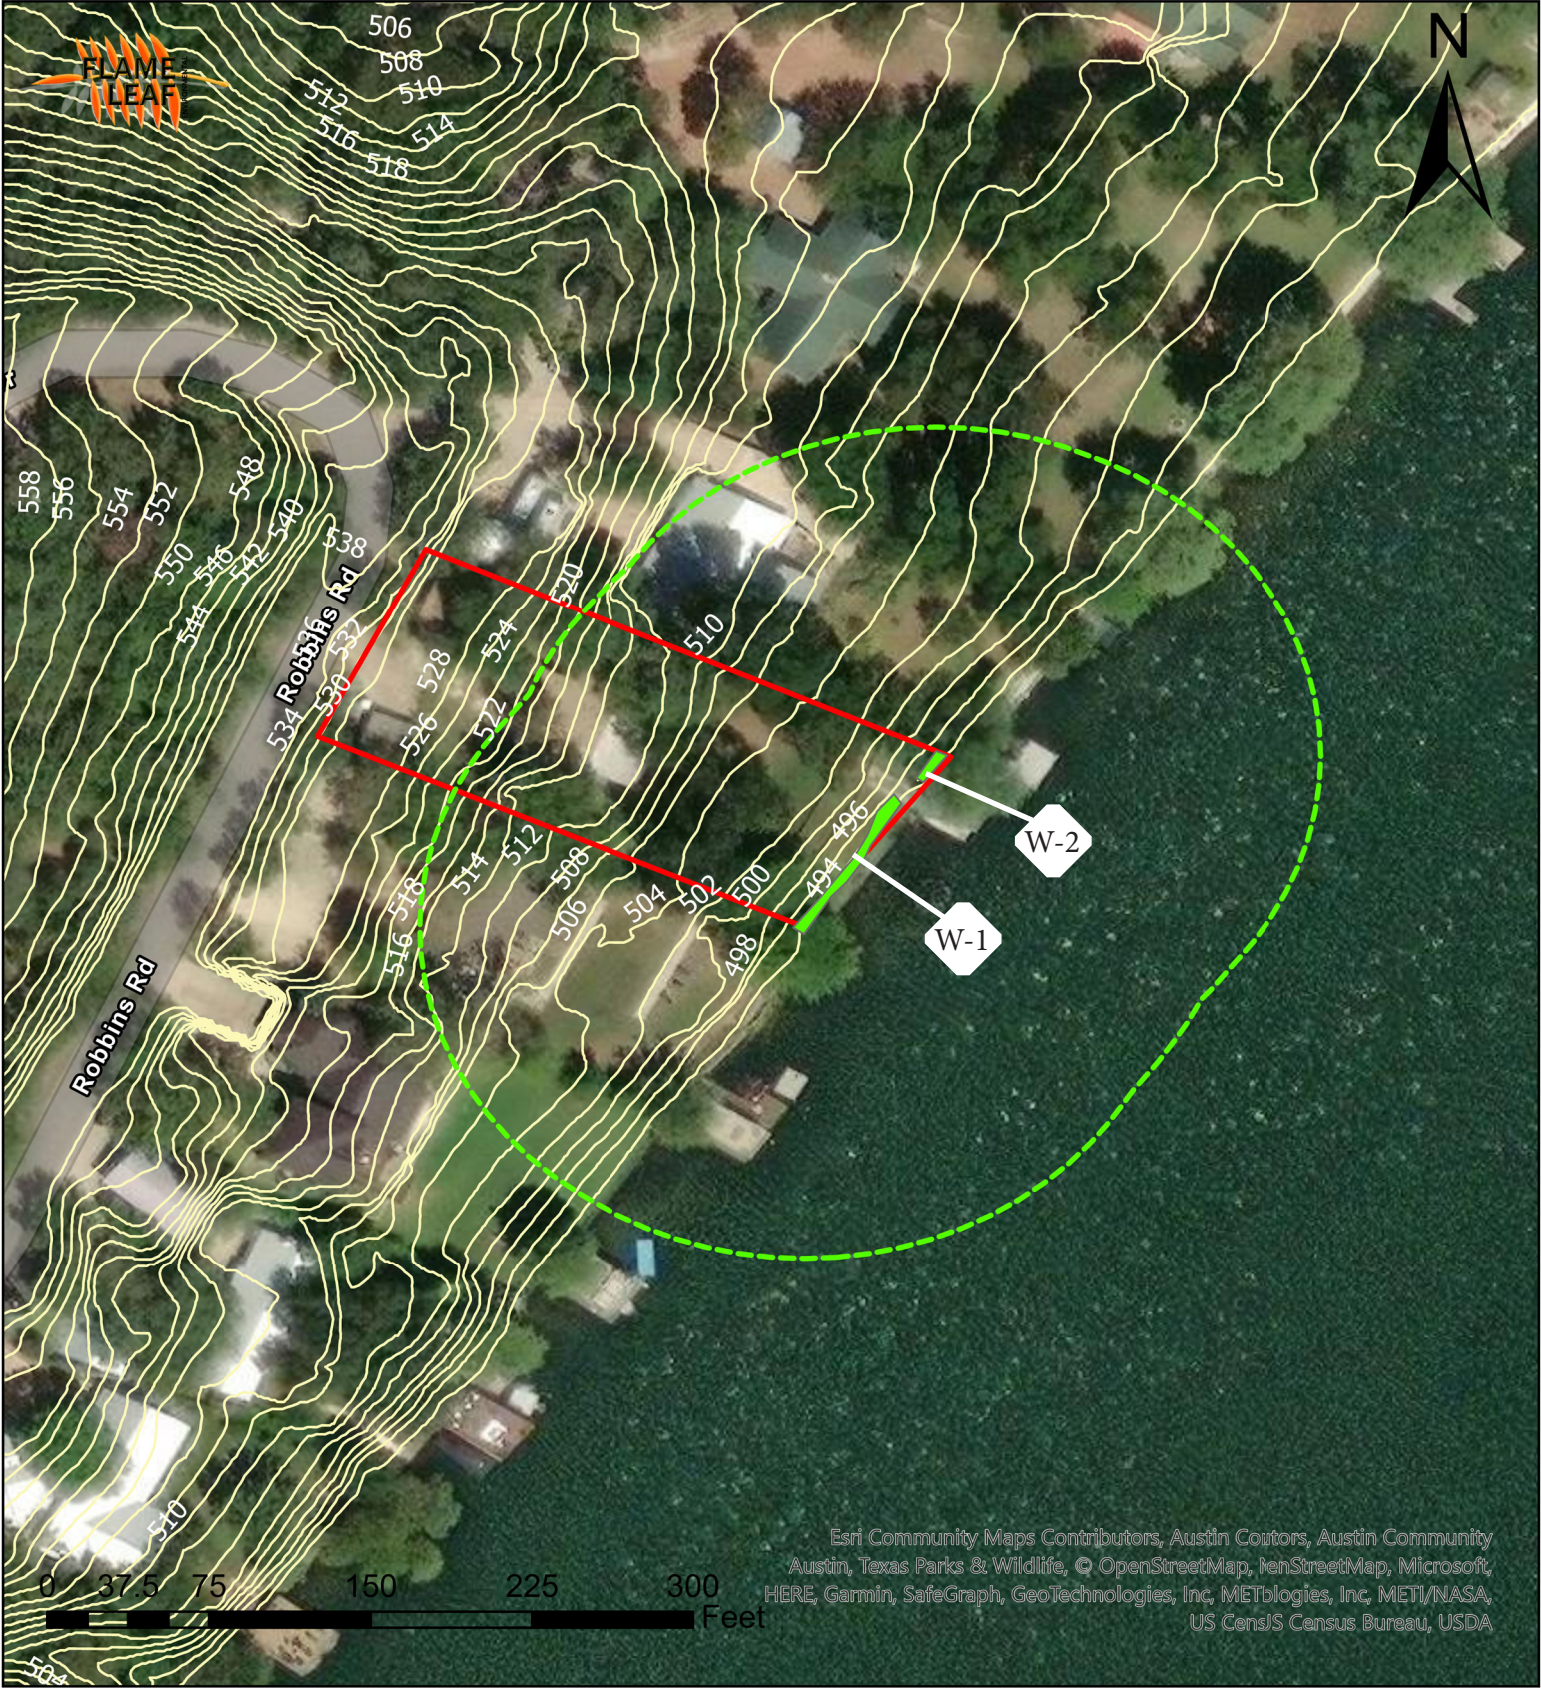
CRITICAL ENVIRONMENTAL FEATURE MAP

A small City of Austin wetland was present behind the bulkhead that was dominated by Elephant Ear, Mexican Primerose-willow, and Water Hemlock.

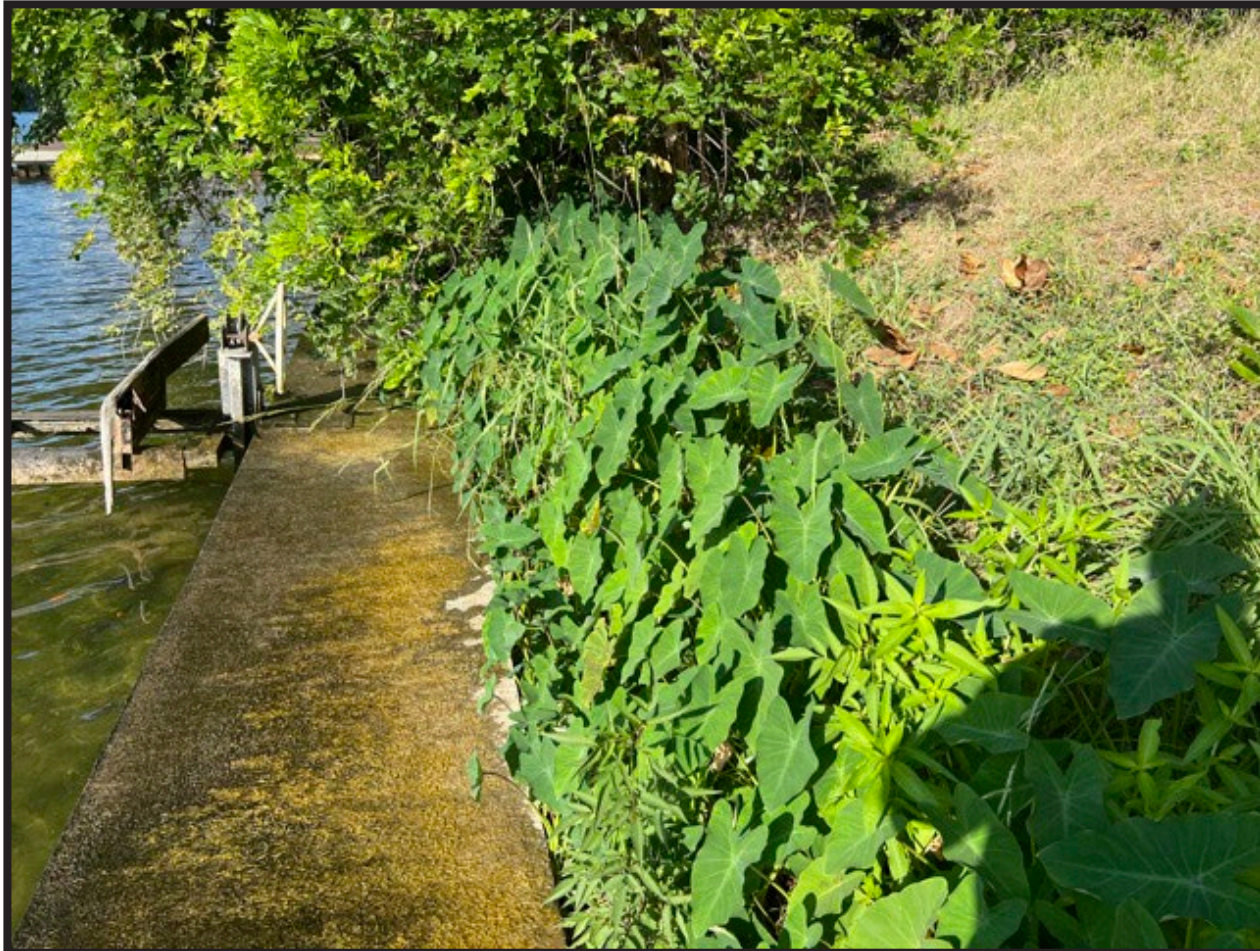
Photograph 1

This photograph documents a view facing south along the existing bulkhead on-site. There was a dominance of hydrophytic (wetland) vegetation behind the bulkhead that met the requirements for the a City of Austin defined wetland. Dominant wetland vegetation in this photograph included Elephant Ear (*Colocasia esculenta*) and Mexican Primerose-willow (*Ludwigia octovalvis*). Photograph was taken within Wetland W-1.

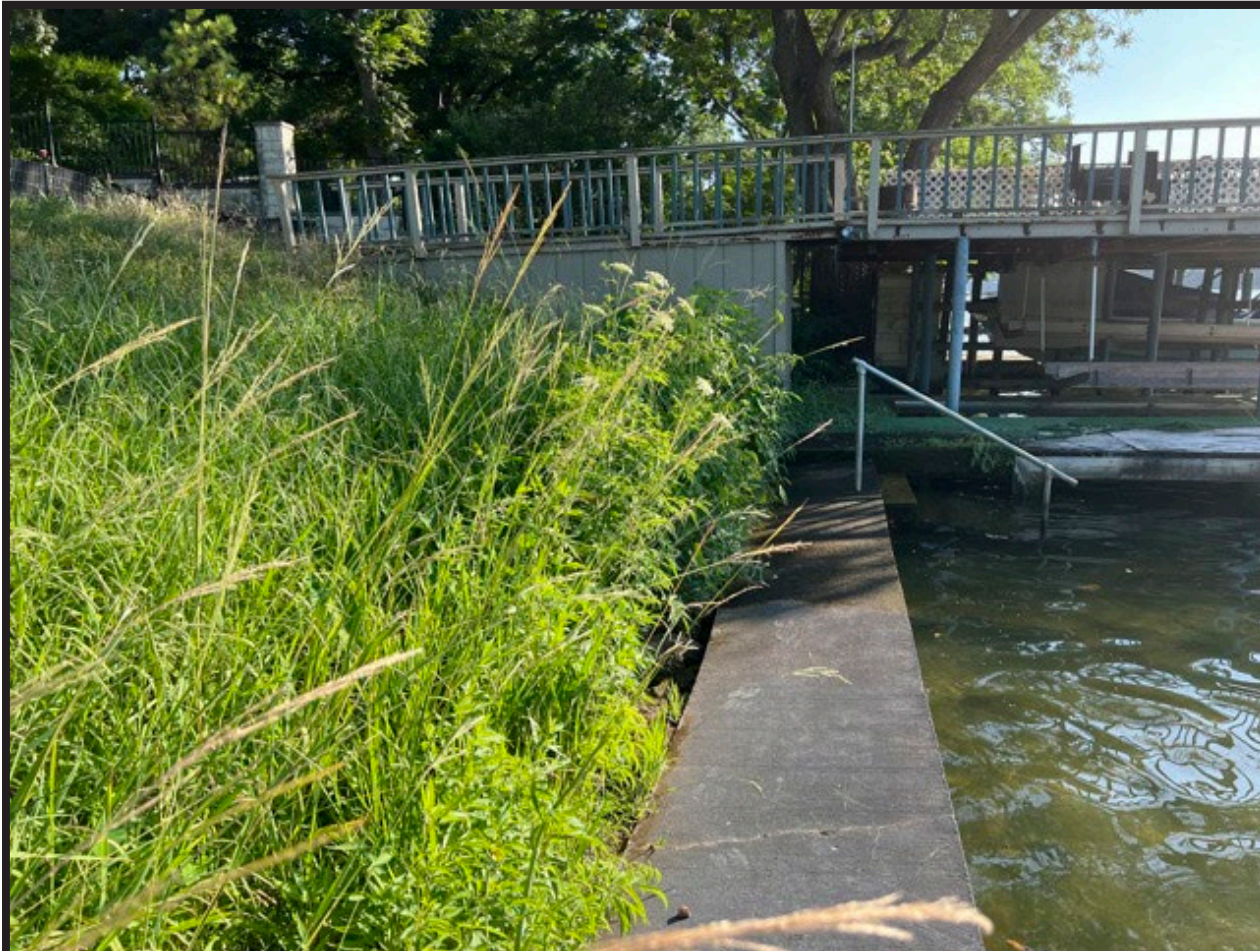
Photograph 2

This photograph documents a view facing north along the existing bulkhead on-site. There was a dominance of hydrophytic (wetland) vegetation behind the bulkhead that met the requirements for the a City of Austin defined wetland. Dominant wetland vegetation in this photograph included Elephant Ear, Mexican Primerose-willow, and Water Hemlock (*Cicuta maculata*). Dallisgrass was present and dominant behind the City of Austin wetland. Photograph was taken within Wetland W-1.

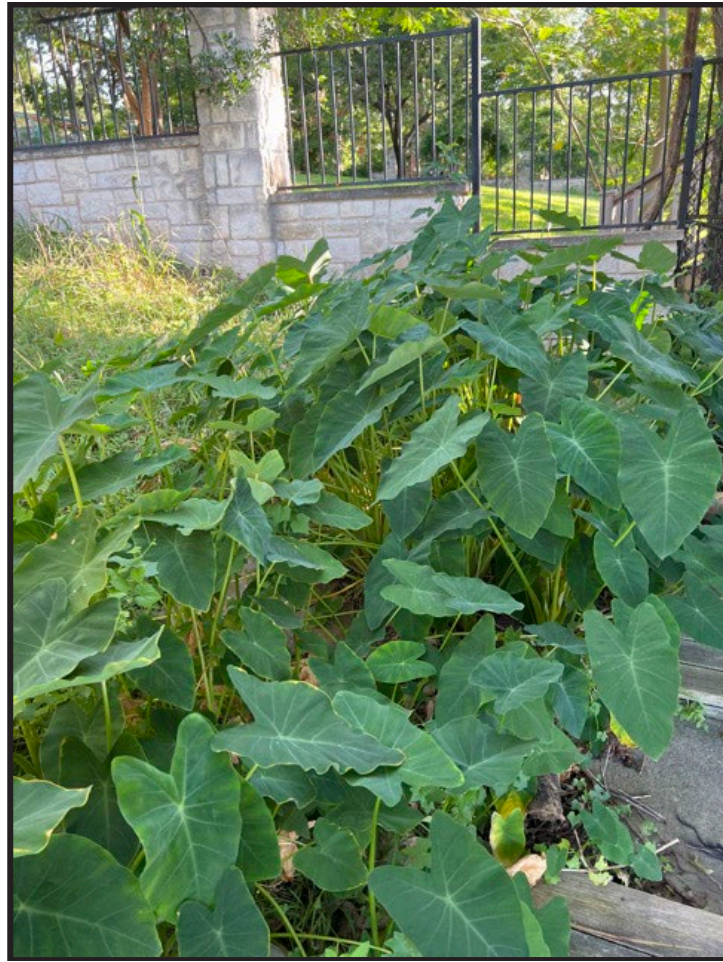
Photograph 3

This photograph documents a small City of Austin Wetland (W-2) adjacent to the existing boat dock on the northern corner of the Project Area near Lake Austin. Elephant Ear (*Colocasia esculenta*) was the dominant species in this City wetland.

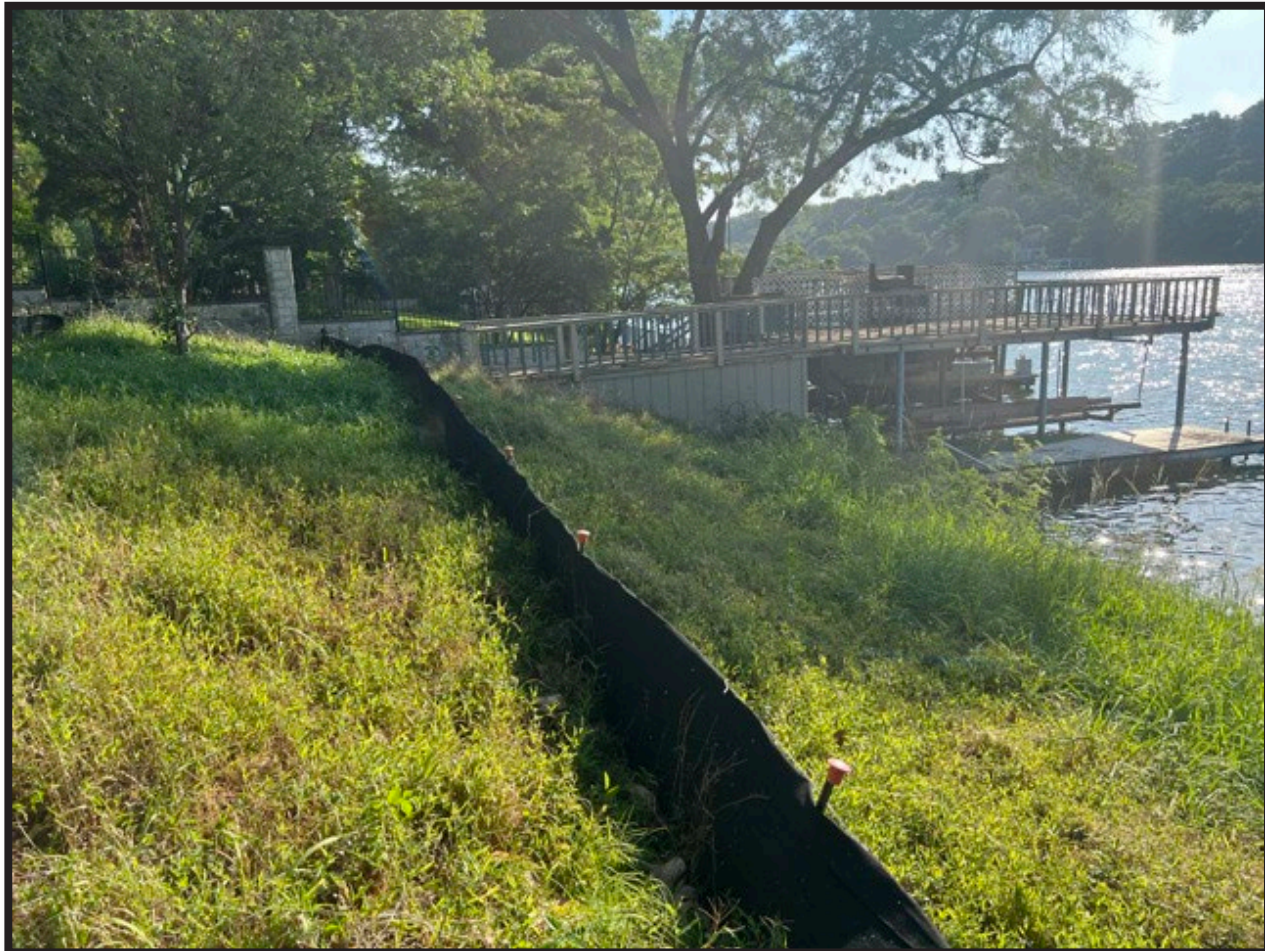
Photograph 4

This photograph documents a general view of the site condition near Lake Austin. Ground cover species visible in this photograph include Dallisgrass (*Paspalum dilatatum*), Bermuda grass (*Cynodon dactylon*), Virginia wild-rye (*Elymus virginicus*), and Whitemouth dayflower (*Commelina erecta*).

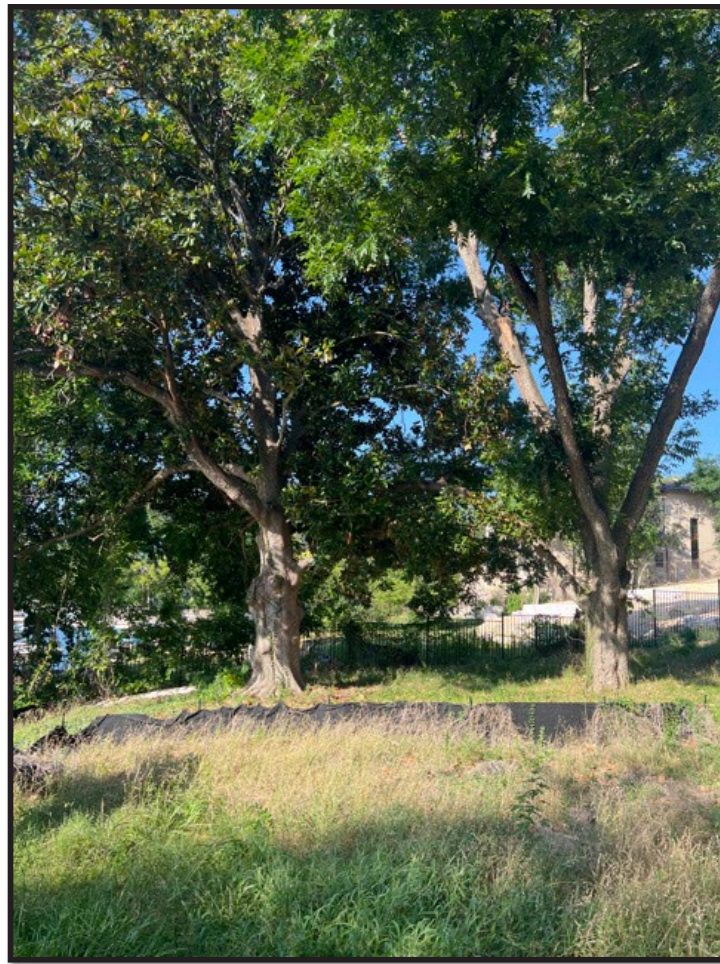
Photograph 5

This photograph documents the Southern Pecan (*Carya illinoensis*) and Southern Magnolia (*Magnolia grandiflora*) that were present within the Project Area.

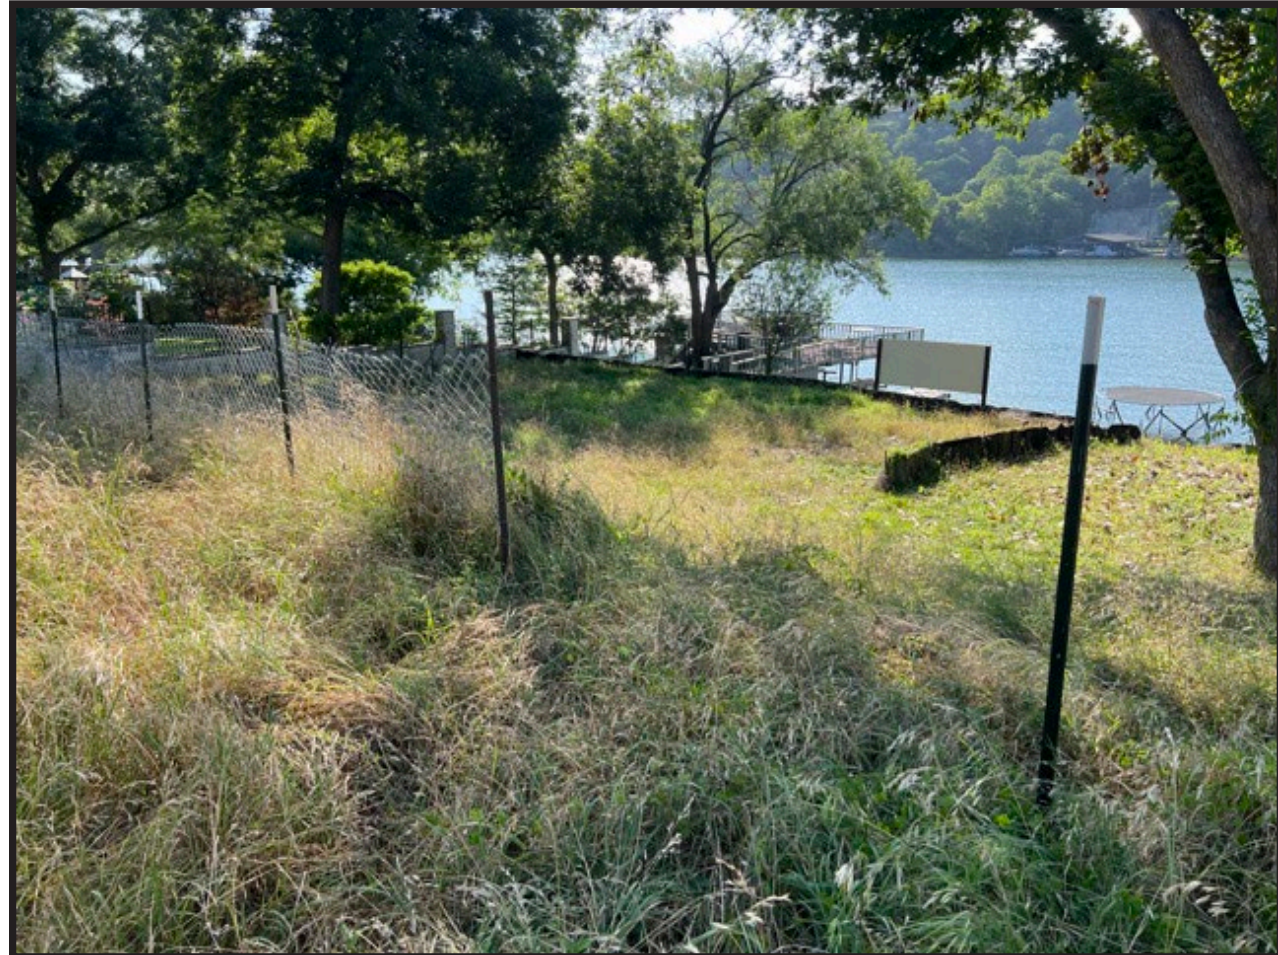
Photograph 6

This photograph documents an additional general view of the Project Area near Lake Austin. The Green Ash (*Fraxinus pennsylvanica*) that is present on-site near the existing boat dock is visible in this photograph.

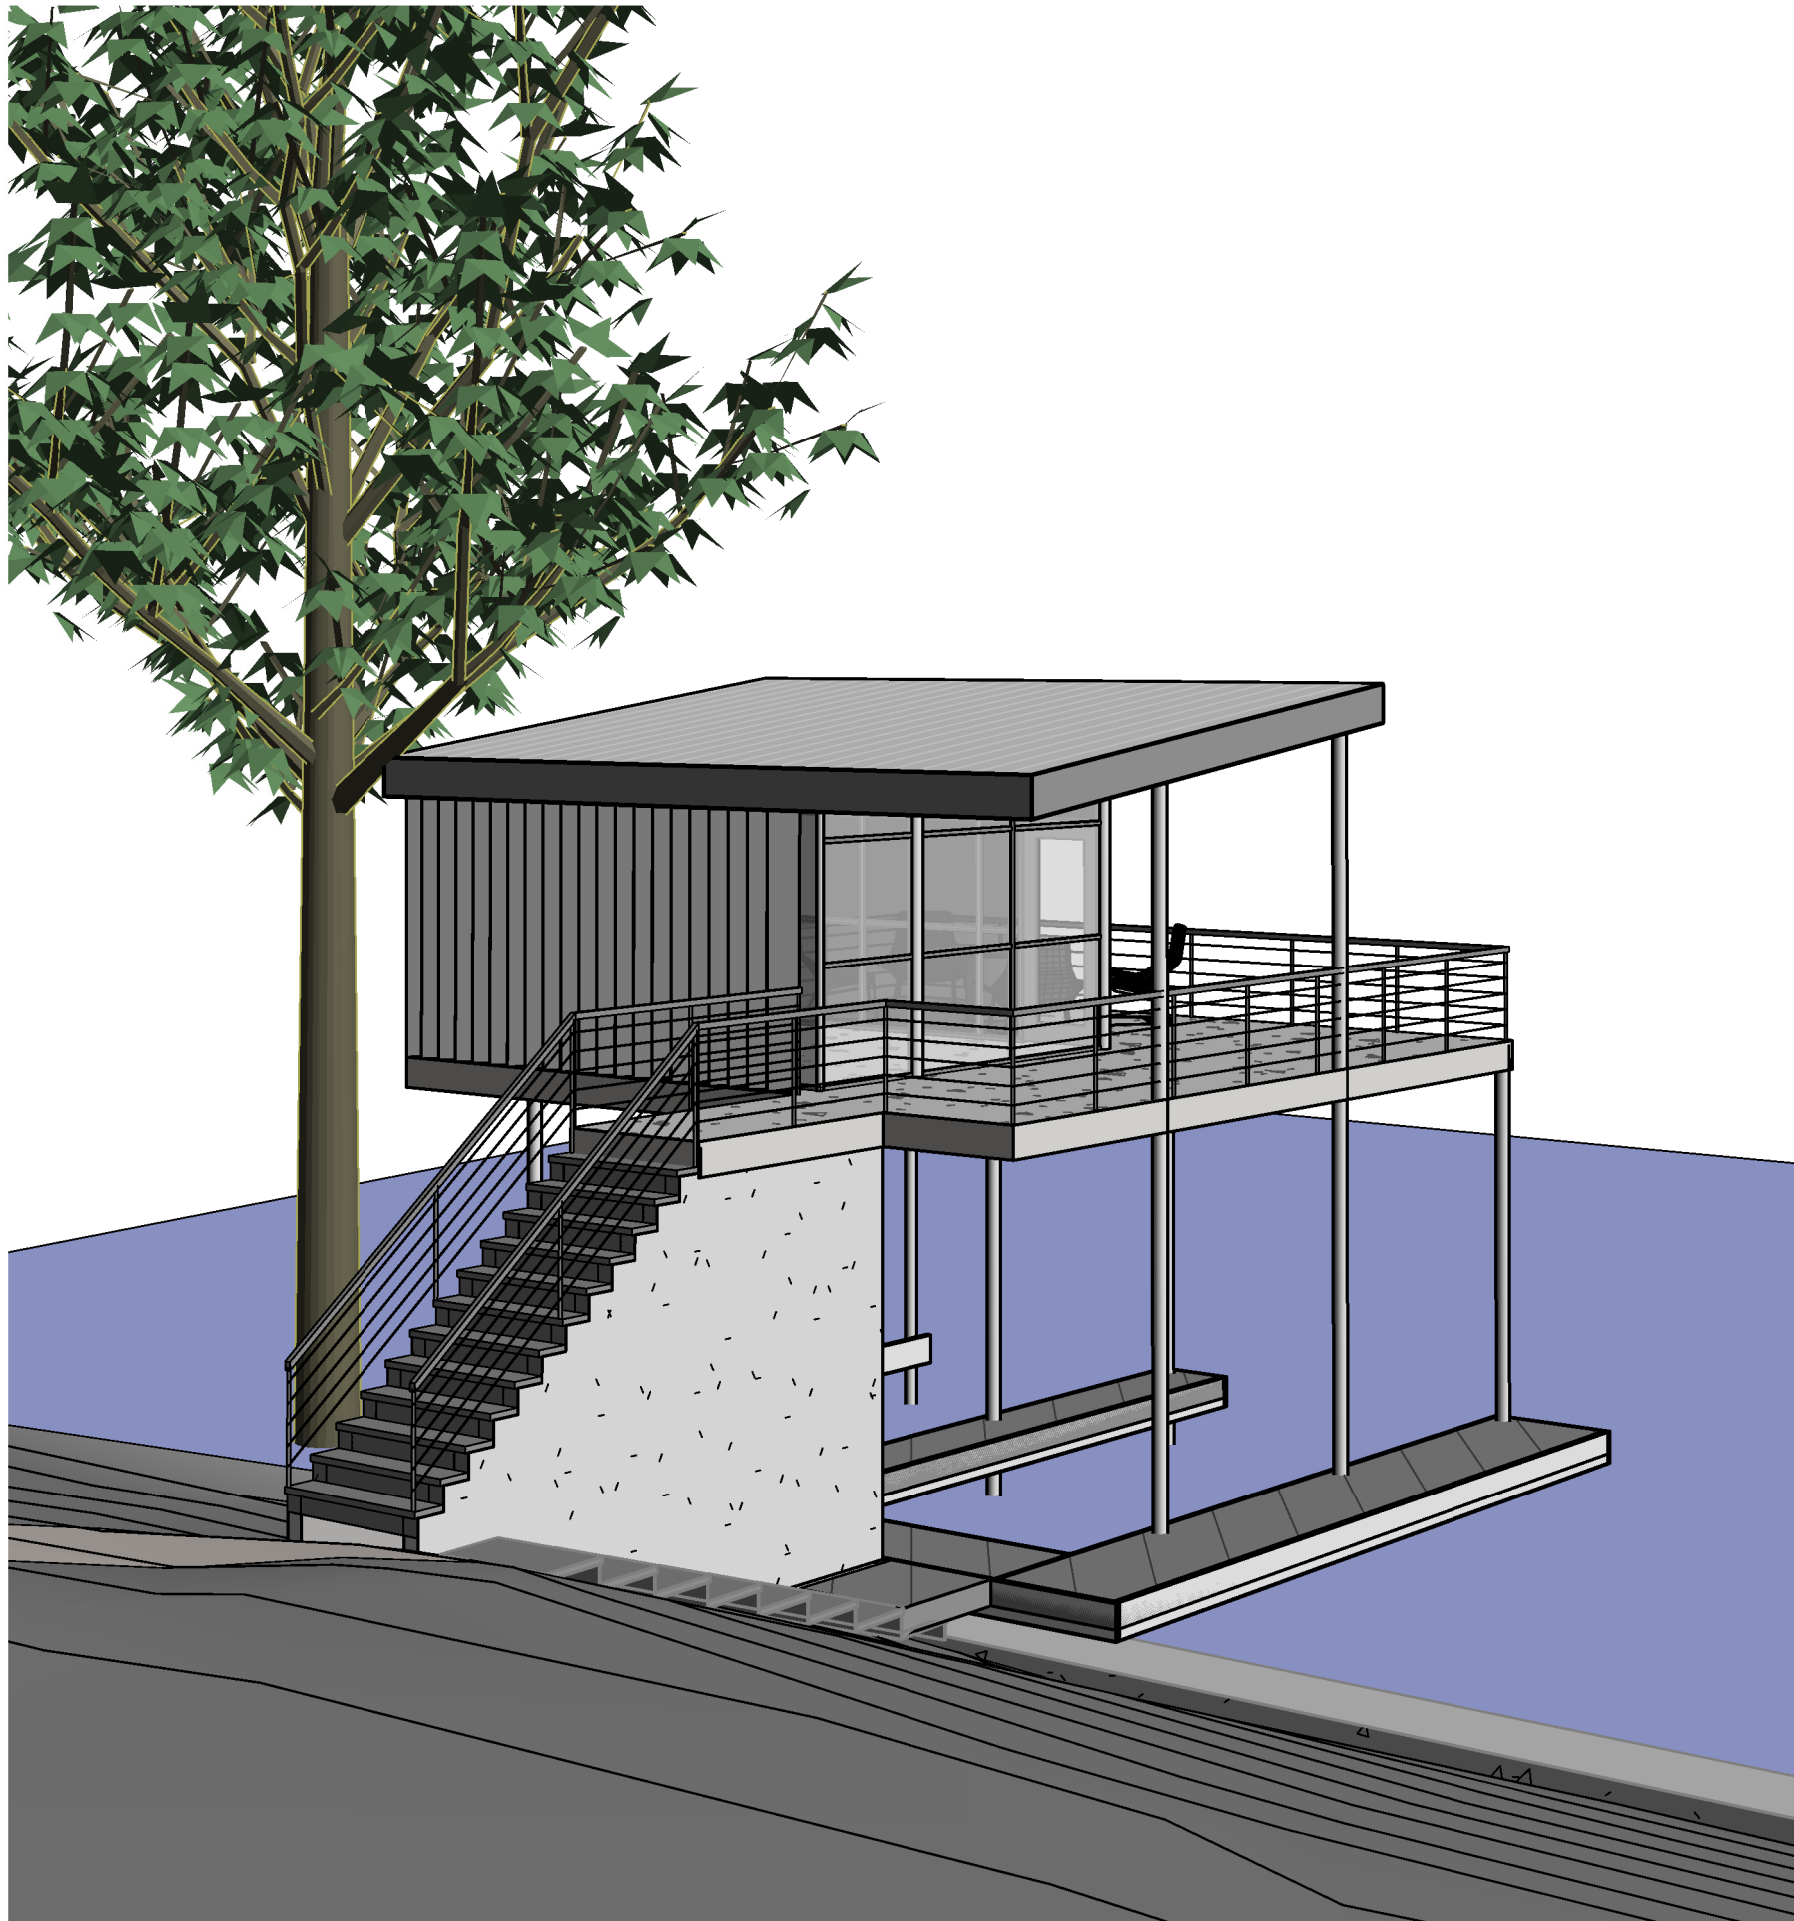
Rigid metal screening on metal framing will provide protection from mosquitos without obstructing the view to the lake or restricting air flow. Setbacks are meant to prevent overcrowding and promote a feeling of openness in our neighborhoods. The design of this new deck accomplishes those objectives while remaining in its existing location within the setback.

While the dock is built within the setback, it still provides privacy for the homeowner and their neighbor by using metal "fins" turned at an angle. This allows air to flow through the screened area while creating a visual barrier.

EXTERIOR FINISHES TO  
PROMOTE OPENNESS  
AND PROVIDE PRIVACY
