TUCKER engineering

Regarding
Reference Number 43070
Issued May 22, 2026
Inspected May 19, 2026
1006 Shelley Avenue
Austin, Texas 78703

Structural Inspection Report

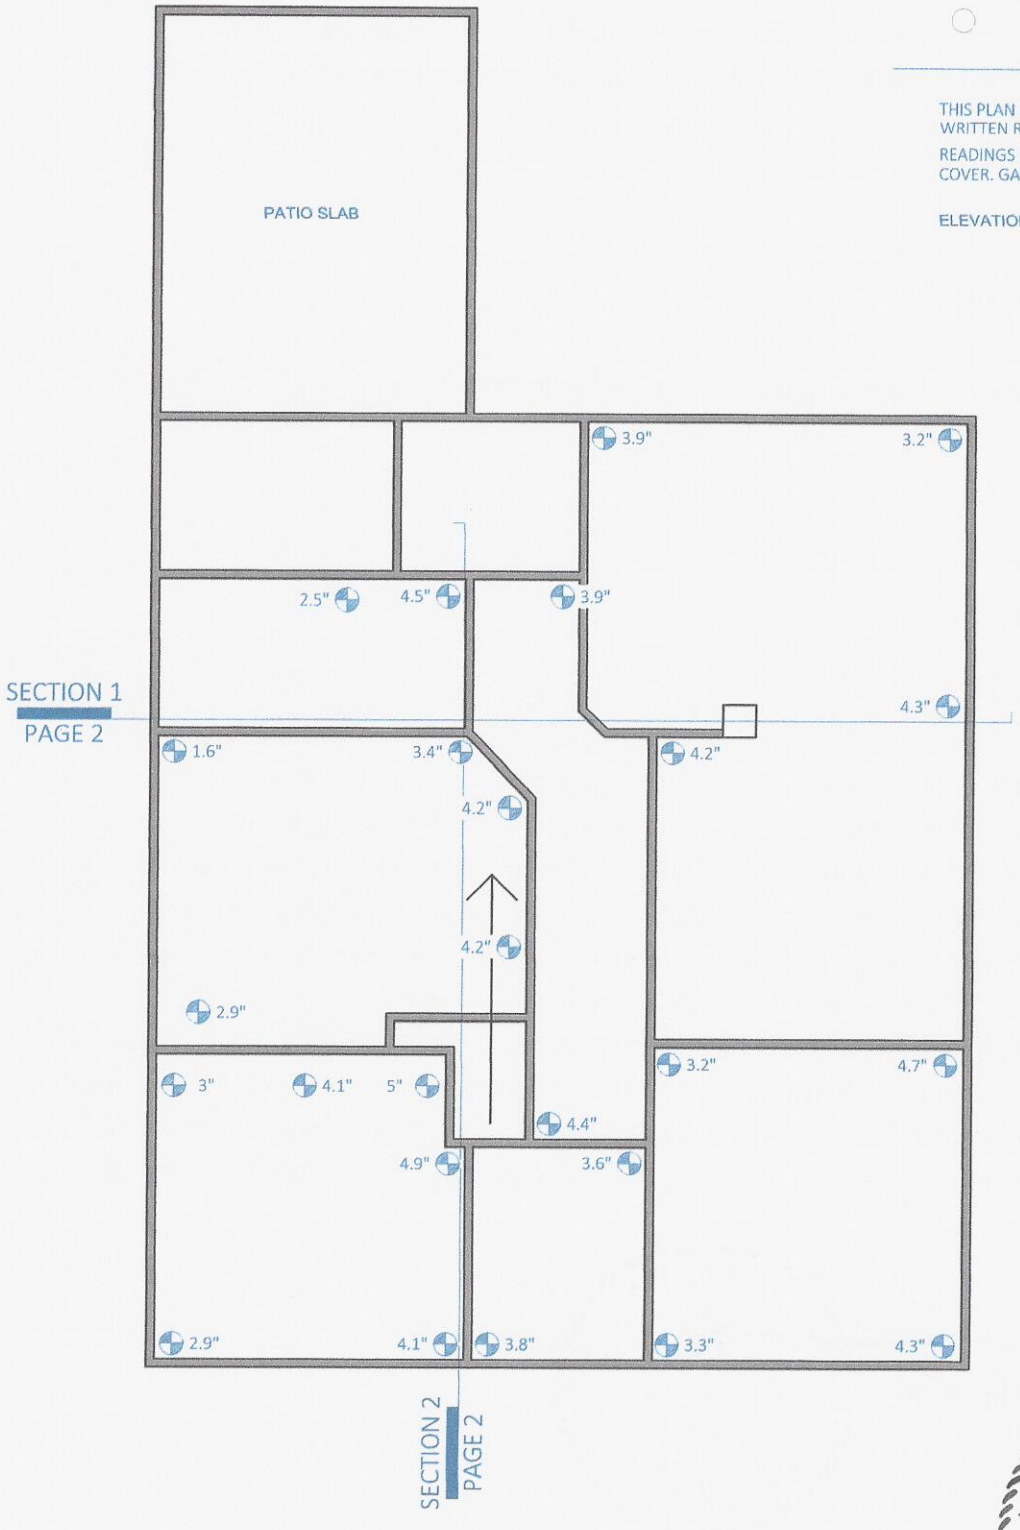
Elevation Readings

Measurements were taken inside the house as shown in the enclosed diagram. It was determined that the foundation had significant humps and dips throughout. Cross sections of the foundation were analyzed as shown in the enclosed diagrams. The utility was originally constructed as exterior space with a slope built into the floor and was excluded from the elevation readings.

The foundation has experienced movements with deflections and damages as previously described. The magnitudes of the deformations are somewhat beyond allowable tolerances. However, the foundation is structurally intact and the house is safe and livable.

The beams and floor systems may be lifted off the existing piers and fixed in a more level position.

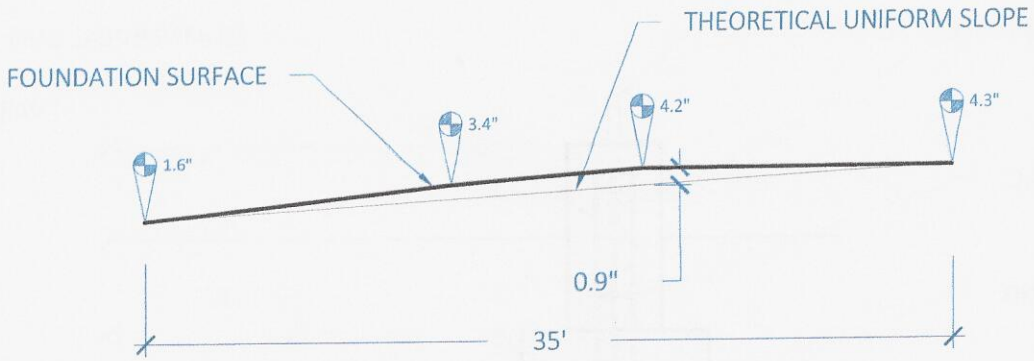
1 FOUNDATION CROSS SECTION

MEASURED UNIFORM SLOPE:	2.7"
ALLOWABLE UNIFORM SLOPE (1%):	4.2"
MEASURED BENDING DEFLECTION:	0.9"
ALLOWABLE BENDING DEFLECTION (L/360):	1.2"

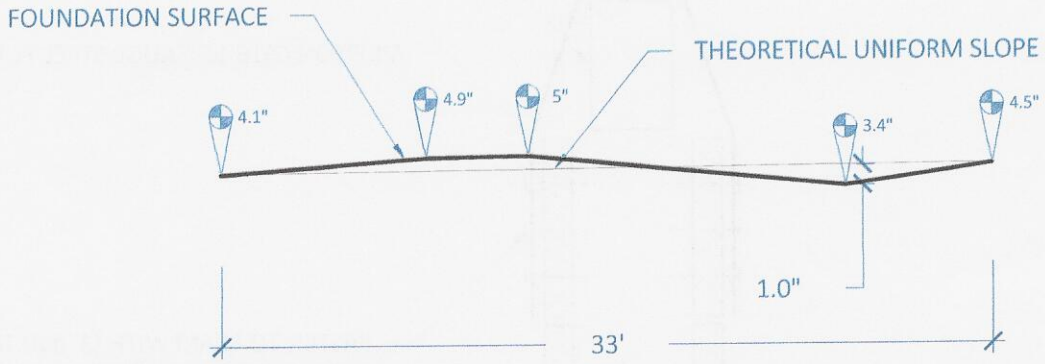
2 FOUNDATION CROSS SECTION

MEASURED UNIFORM SLOPE:	0.4"
ALLOWABLE UNIFORM SLOPE (1%):	4.0"
MEASURED BENDING DEFLECTION:	1.0"
ALLOWABLE BENDING DEFLECTION (L/360):	1.1"

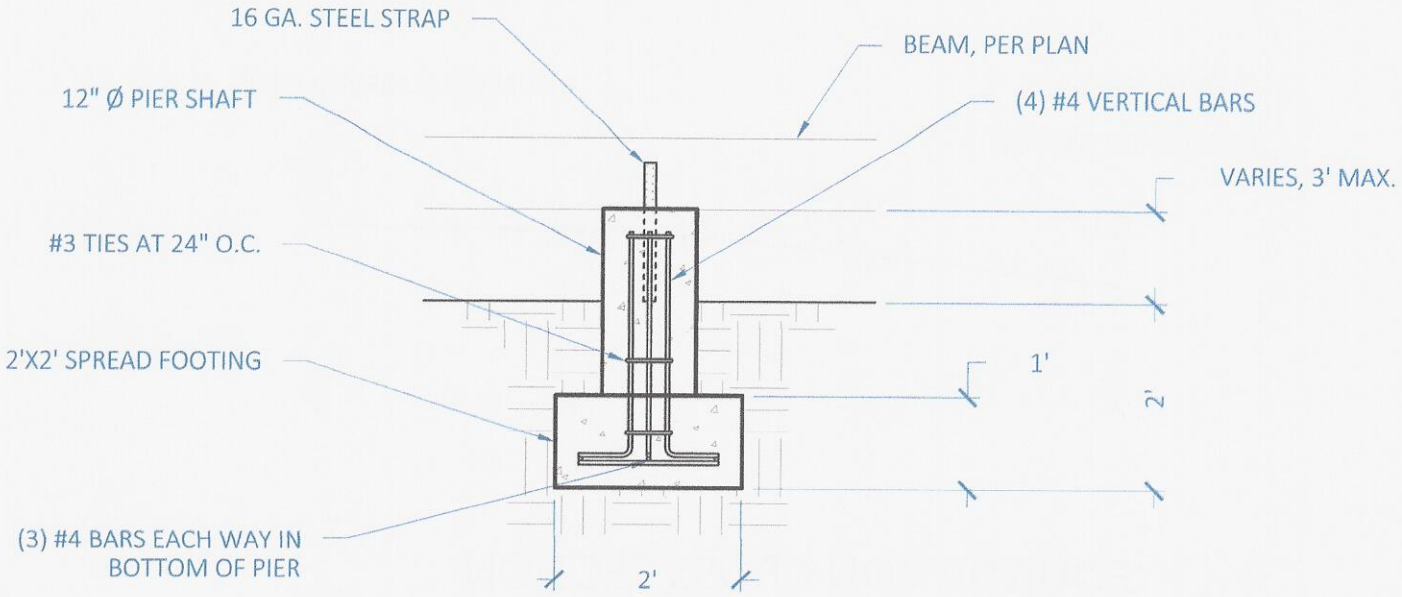
1 SPREAD FOOTING / PIER DETAIL

There was a dry-stacked cinderblock pier at the front-right corner of the porch which was precariously stacked.

I recommend that the dry-stacked cinderblock pier be replaced with a new spread footing constructed as shown in the enclosed details. I also recommend that the beams be positively anchored to the grouted cinderblock piers as shown in the enclosed details.
