MEMORANDUM

SUBJECT: Investigation of Bull Creek Tributary 4 near Spicewood Springs Road

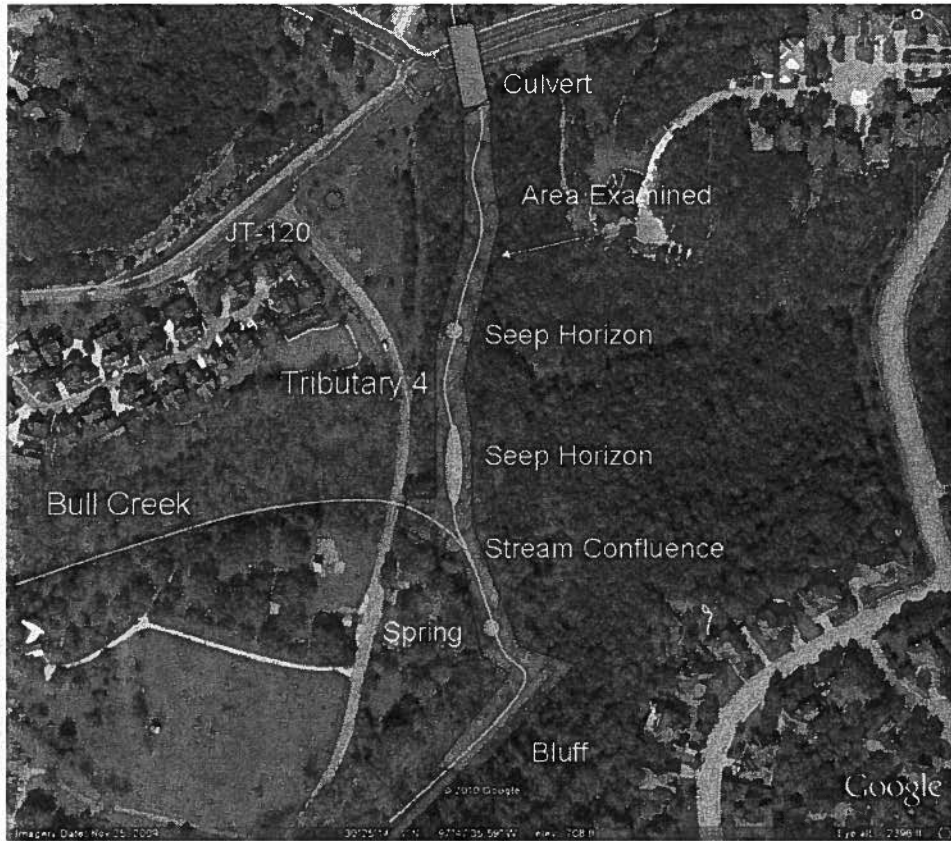
Watershed staff examined the reach of Bull Creek Tributary 4 from the crossing with Spicewood Springs Road to the confluence with the main stem of Bull Creek (Photo 1). The reach is adjacent to a potential shaft site (PARD site) for the Jollyville transmission main. We walked approximately 900 feet of the tributary channel examining the area geology, checking for spring discharge, and looking for Jollyville Plateau Salamanders. Flow at the upstream end of the culvert under Spicewood Springs Rd. was approximately 10 gpm on August 24, 2010 and had not changed significantly prior to our visit.

Photo 1. Aerial image showing Tributary 4, Bull Creek, area examined, and features discussed in this memo.
