PROJECT NAME: Robertson Hill Multifamily Development

**ADDRESS** 813 East 11th Street

TREE PERMIT: 10597946

SUBJECT: Tree Permit for Robertson Hill Multi-Family

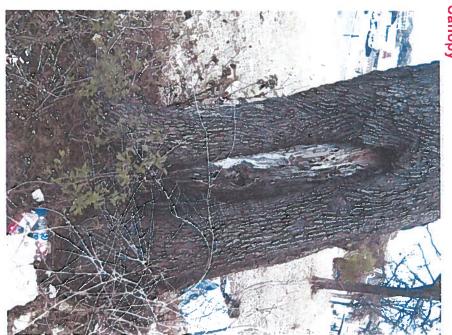
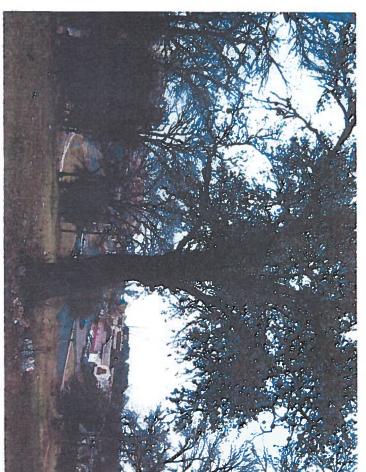
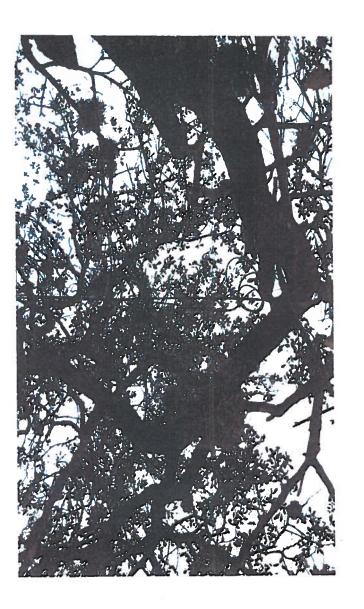
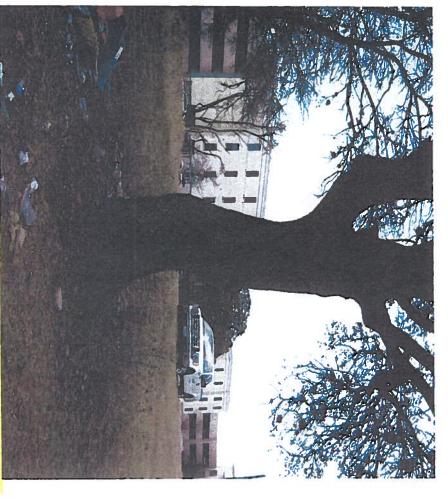
Dear Mr. Neslund,
Thanks you for the opportunity to inspect the second section of the above-mentioned property. I noted the larger 28 inch Live oak tree # 4279 has a severe cavity and freeze damage along with signs of drought stress. See photo's below

# Thin Canopy
