Table of Contents for Bowie Street Tree Permit
Heritage Tree Variance Package

PROJECT NAME: 311,313,315 Bowie Street

TREE PERMIT: 10617196

Tree Assessment Report

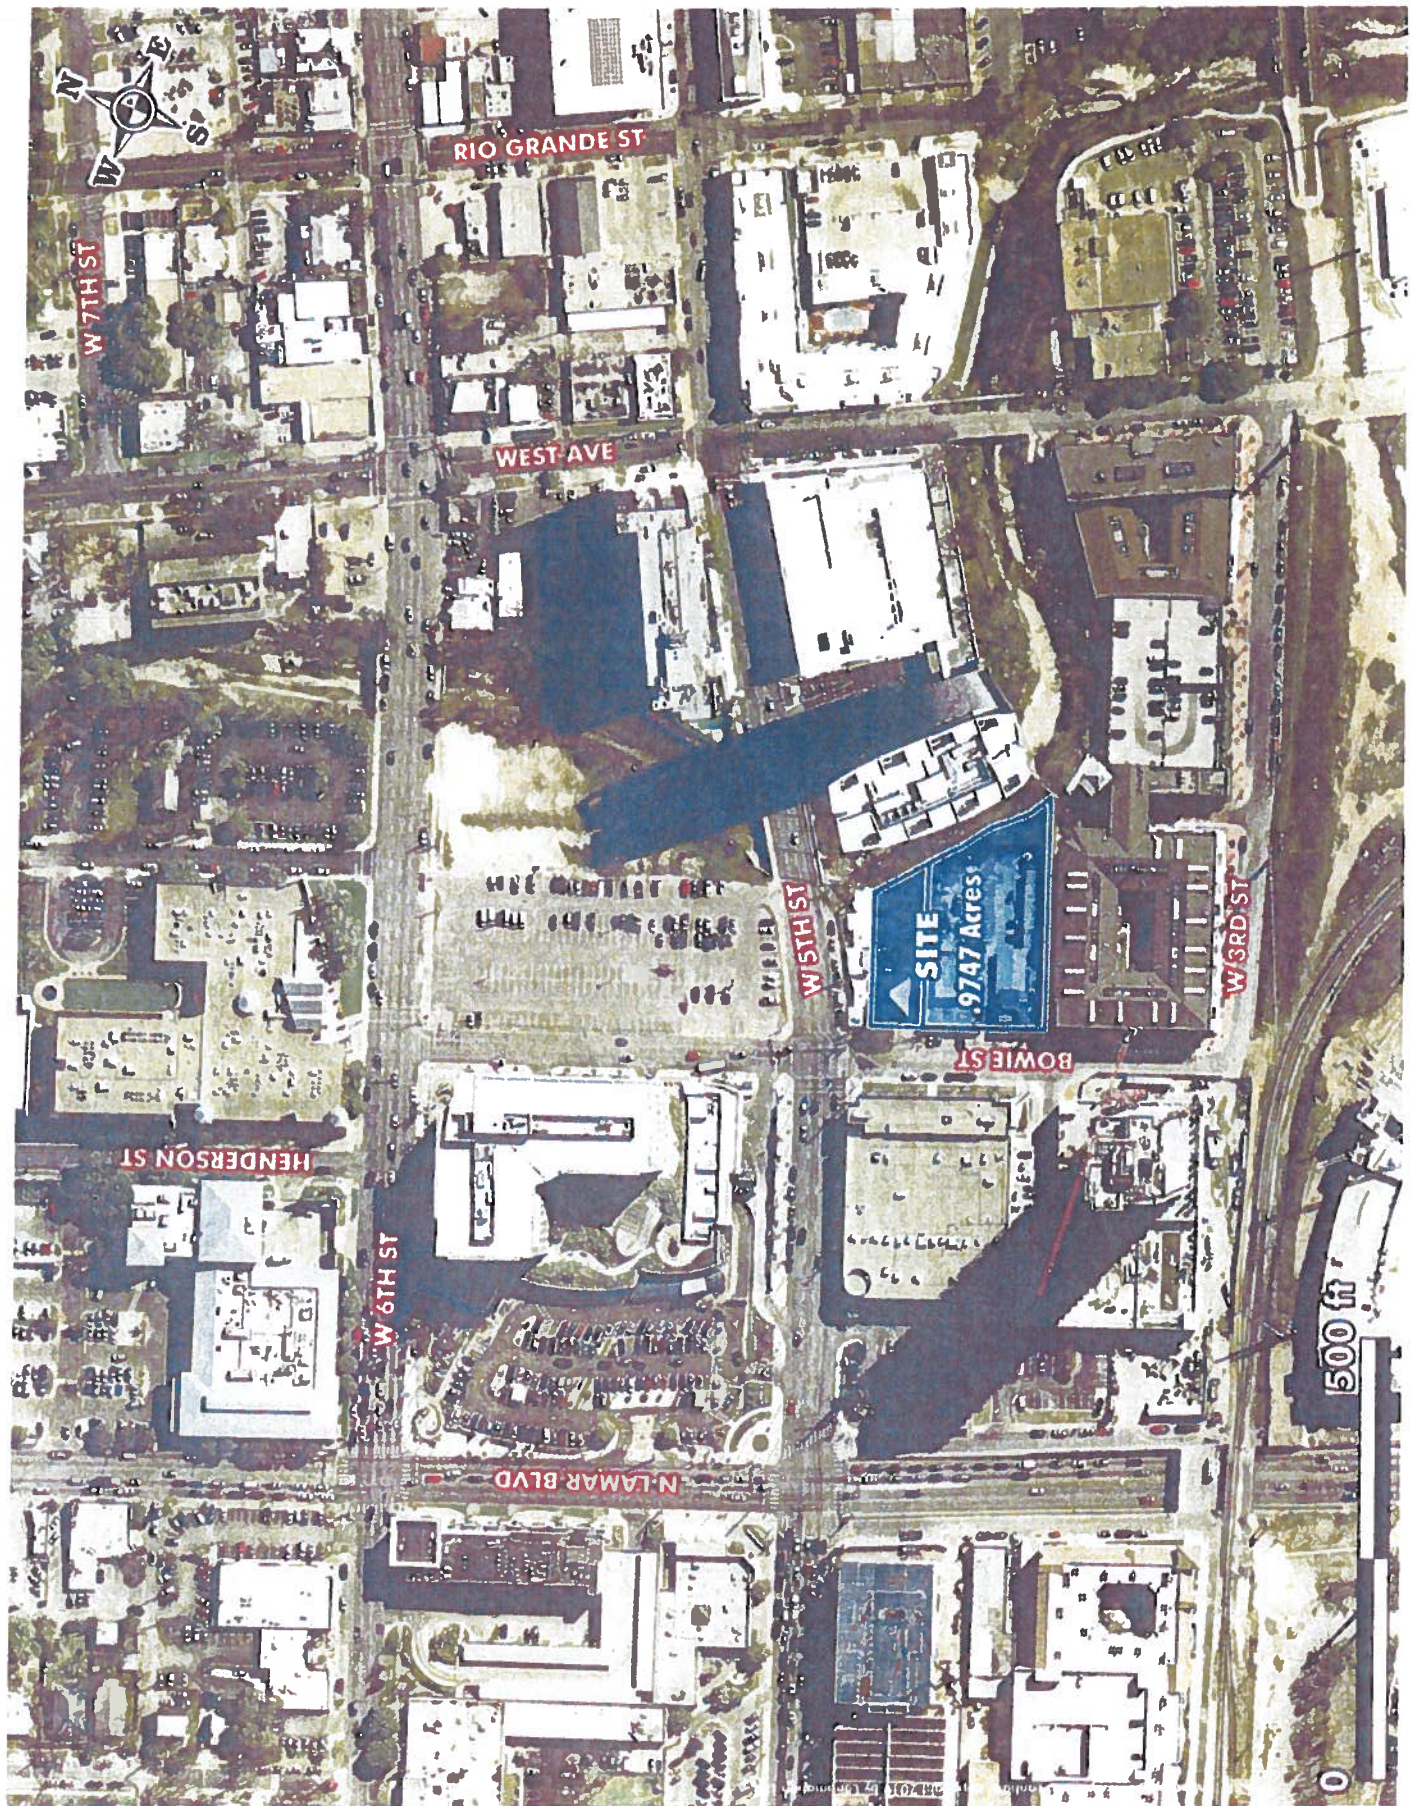
Left photo – view of exposed root collar on the south side of Tree #6806.

Right photo – view of fill depth (32 inches) over the root collar of Tree #6806.
