Table of Contents for Bowie Street Tree Permit
Heritage Tree Variance Package

PROJECT NAME: 311,313,315 Bowie Street

Tree Assessment Report

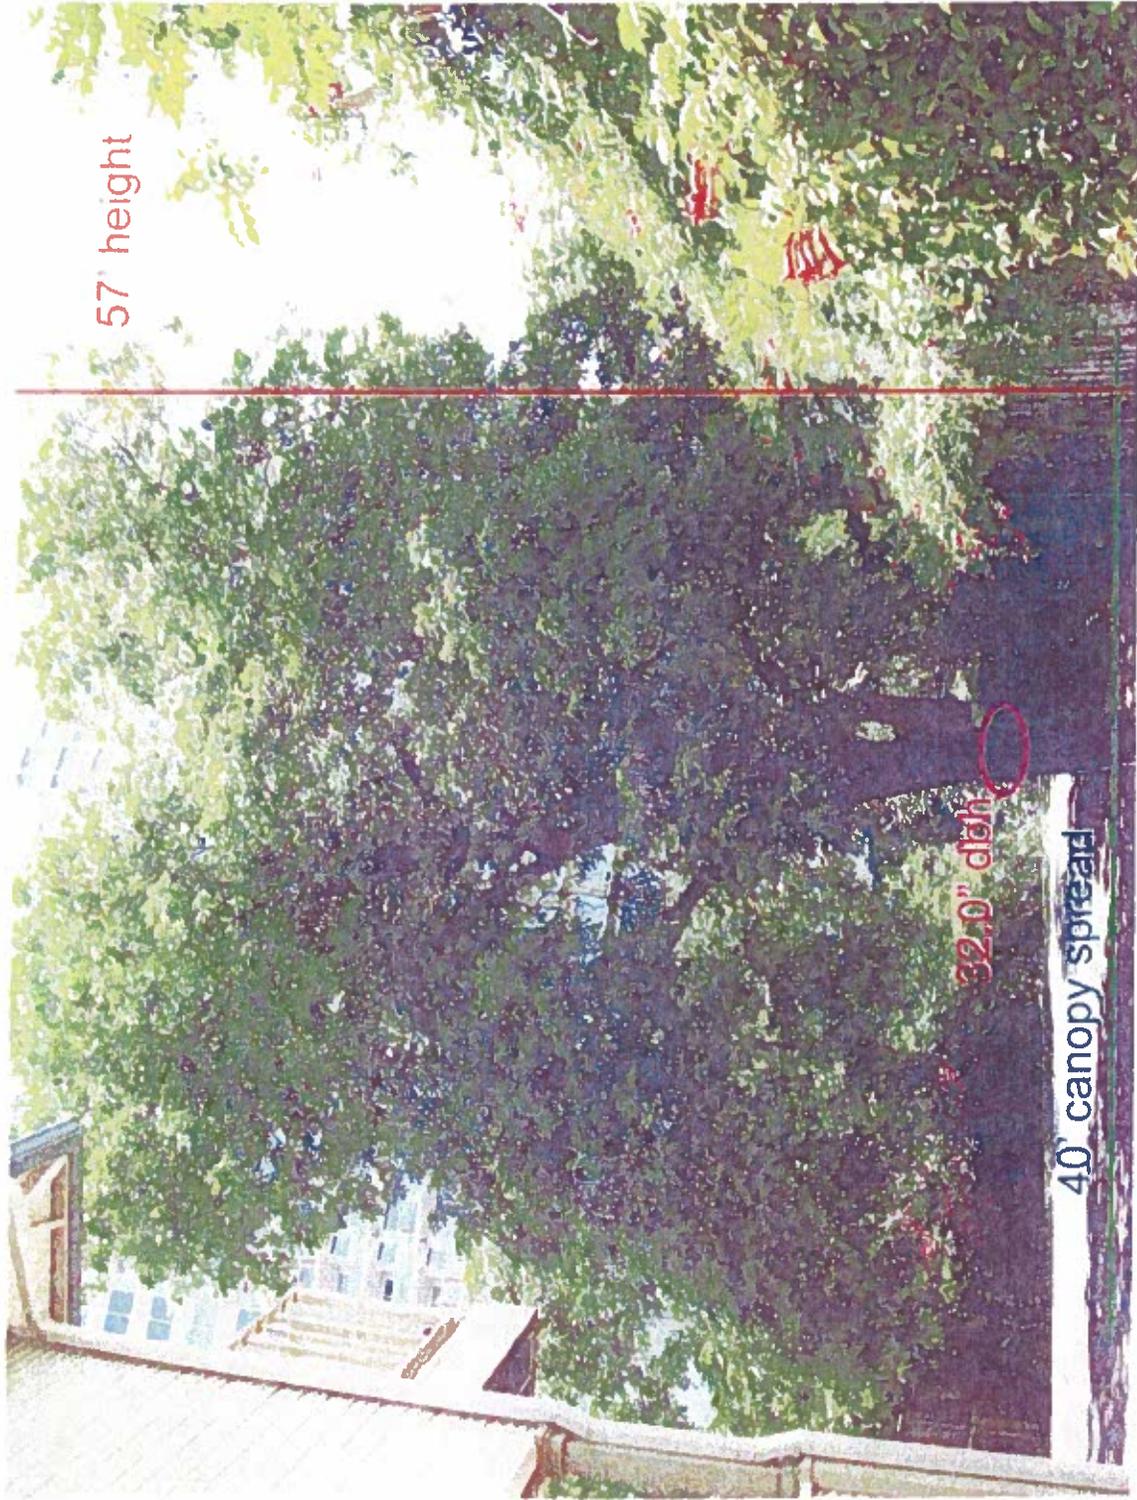
Exhibit 2

Dense, heavy branch
ends prone to failure
