HISTORIC LANDMARK COMMISSION
AUGUST 22, 2011
APPLICATION FOR A CERTIFICATE OF APPROPRIATENESS
C14H-1978-0033
Littlefield Building
106 E. 6th Street

Littlefield Building
Window Replacement

106 East Sixth Street
Austin, TX

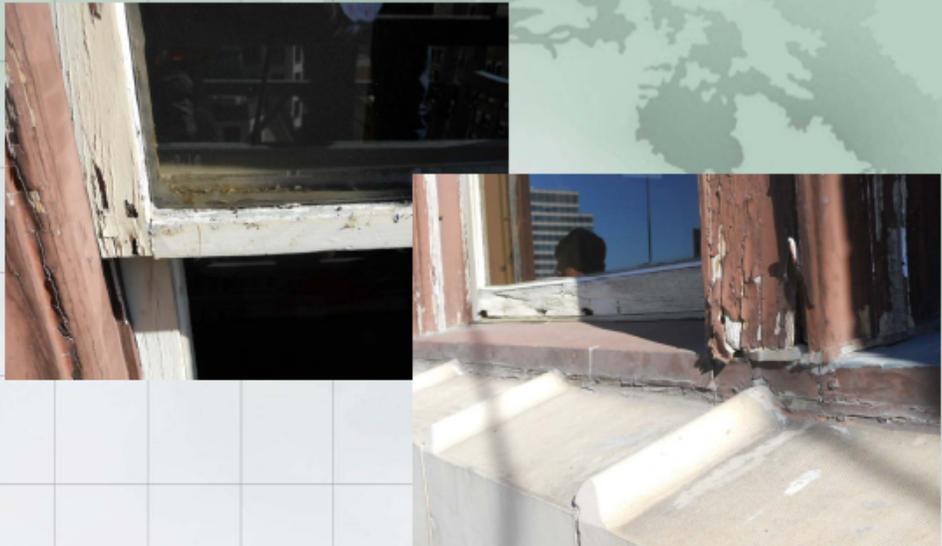
Framing Deterioration

This slide displays two photographs of wood framing deterioration. The top-left photo shows a close-up of a window frame with peeling paint and rotting wood. The bottom-right photo shows a corner of a room with significant wood rot and structural damage. The text "Framing Deterioration" is centered in white on a green bar at the bottom. A logo consisting of stylized green and black lines is positioned in the bottom right corner.
