**Table of Contents for 2818 Rio Grande Tree Permit**  
**Heritage Tree Variance Package**

**PROJECT NAME:** 2818 Rio Grande

**TREE PERMIT #:** 10827869

**SUBJECT:** 2818 Rio Grande

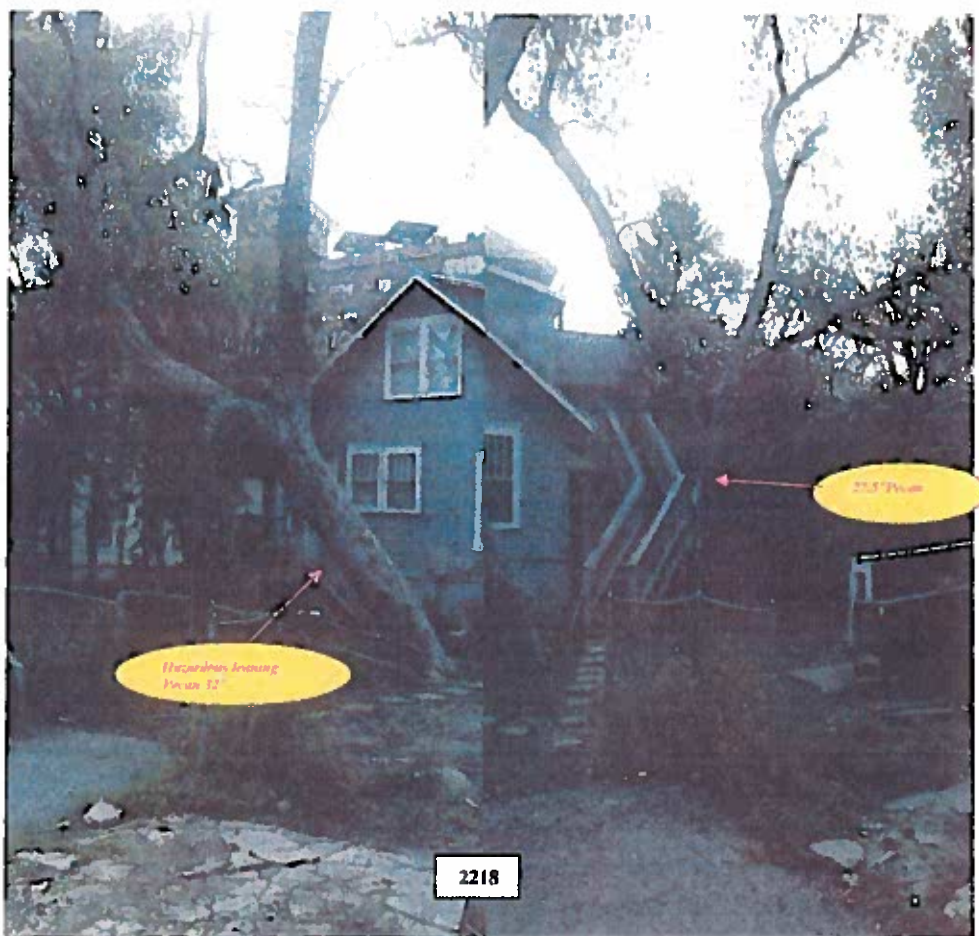
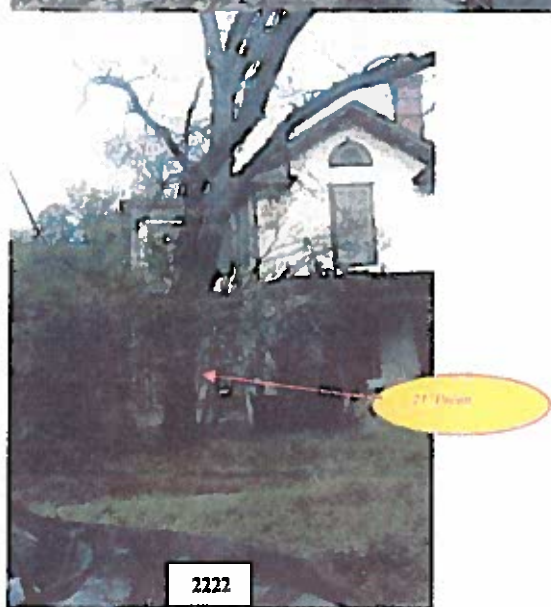
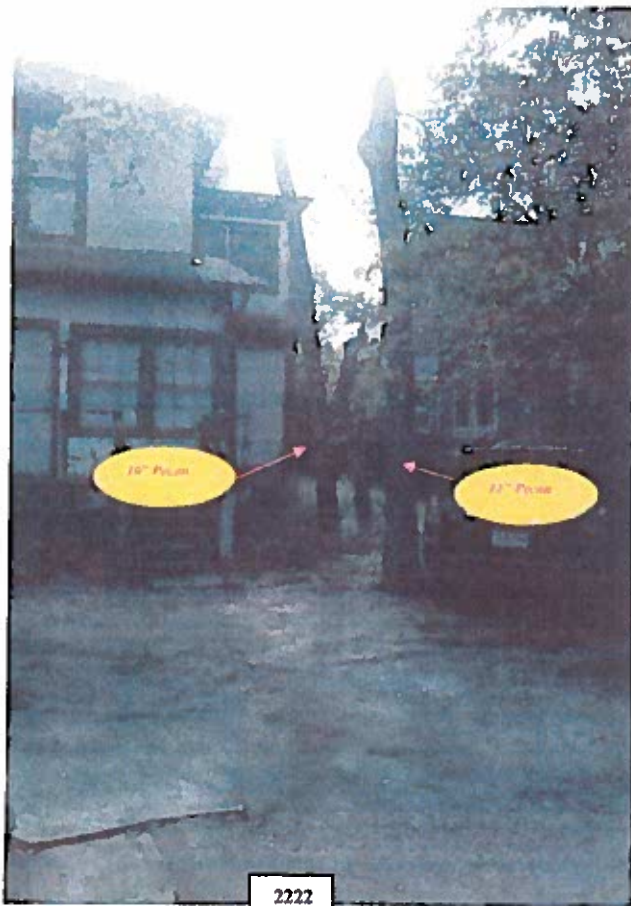
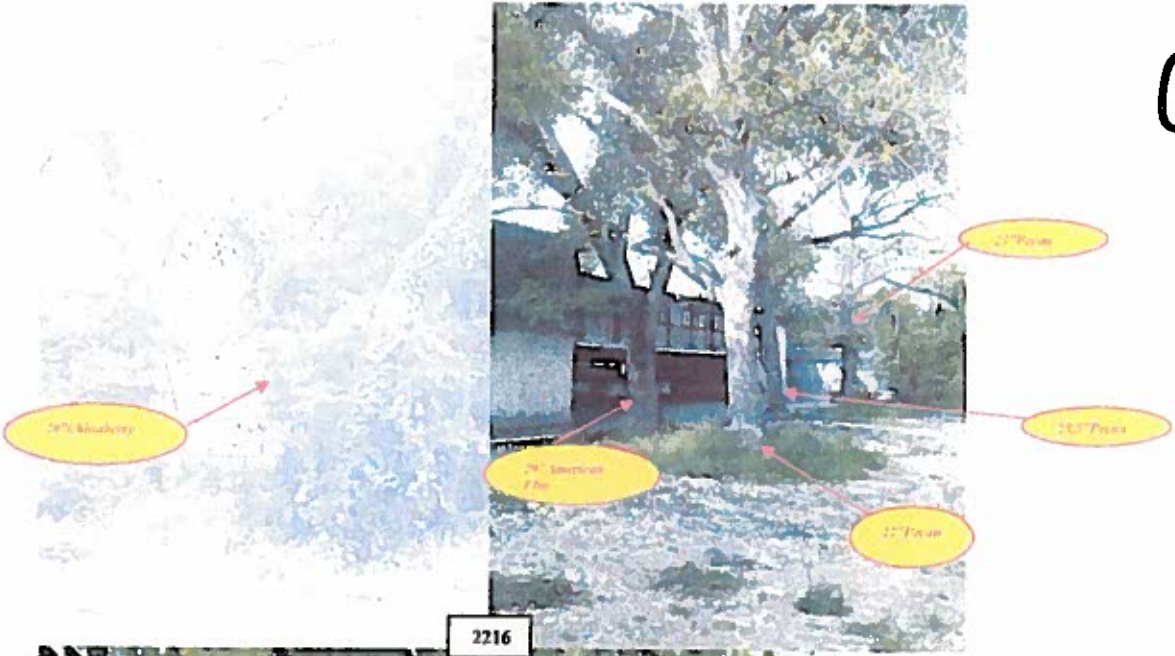
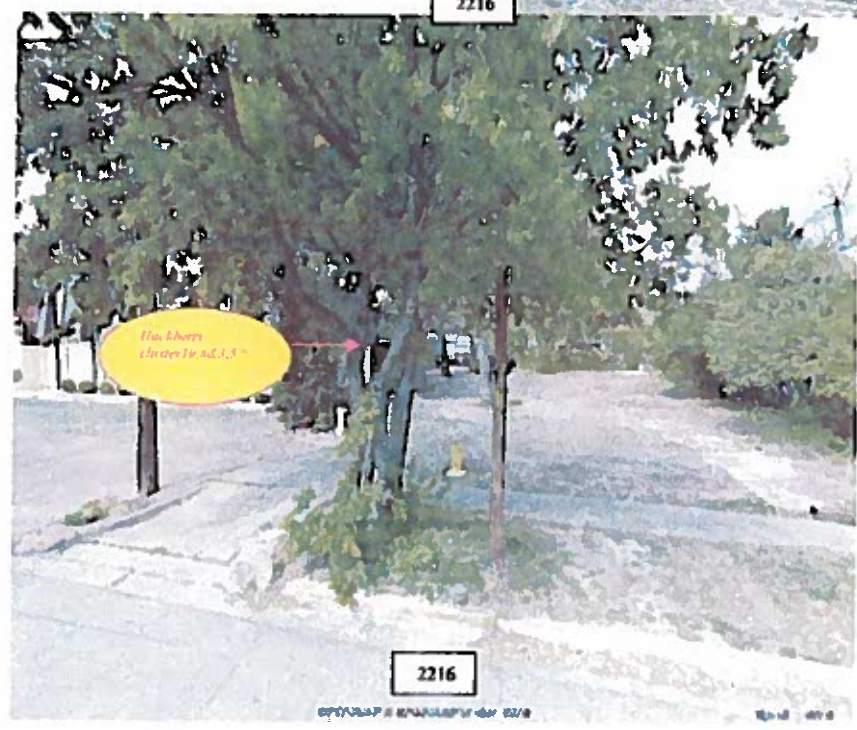
\*See photos below

- ❖ American Elm Tree 29" (*Ulmus americana*) is considered Average-in-condition.
- ❖ All Pecan Trees (*Carya illinoensis*) are in Above Average-to-Excellent in condition; \*With the exception of the 32" on lot 2218, NOTE: it is leaning at a 45 degree angle and is very top heavy. This Pecan tree needs to be removed. Due to the liability, it is Poor in condition, (see photo).
- ❖ Cluster of Common Hackberry Trees (*Celtis occidentalis*) in City right-of-way, are weak and considered Poor-in-condition.
- ❖ Chinaberry Tree 20" (*Melia azedarach*) is considered an invasive species
- ❖ Remaining Trees and shrubs are less than 8" can be removed without tree permit.
