**Table of Contents for 507 W. 23<sup>rd</sup> Street Tree Permit**  
**Heritage Tree Variance Package**

**ADDRESS  
OF PROPERTY:** 507 W. 23<sup>rd</sup> Street

**TREE PERMIT #:** 10884861

**SUBJECT:** 507 W. 23<sup>rd</sup> Street Heritage Tree Removal

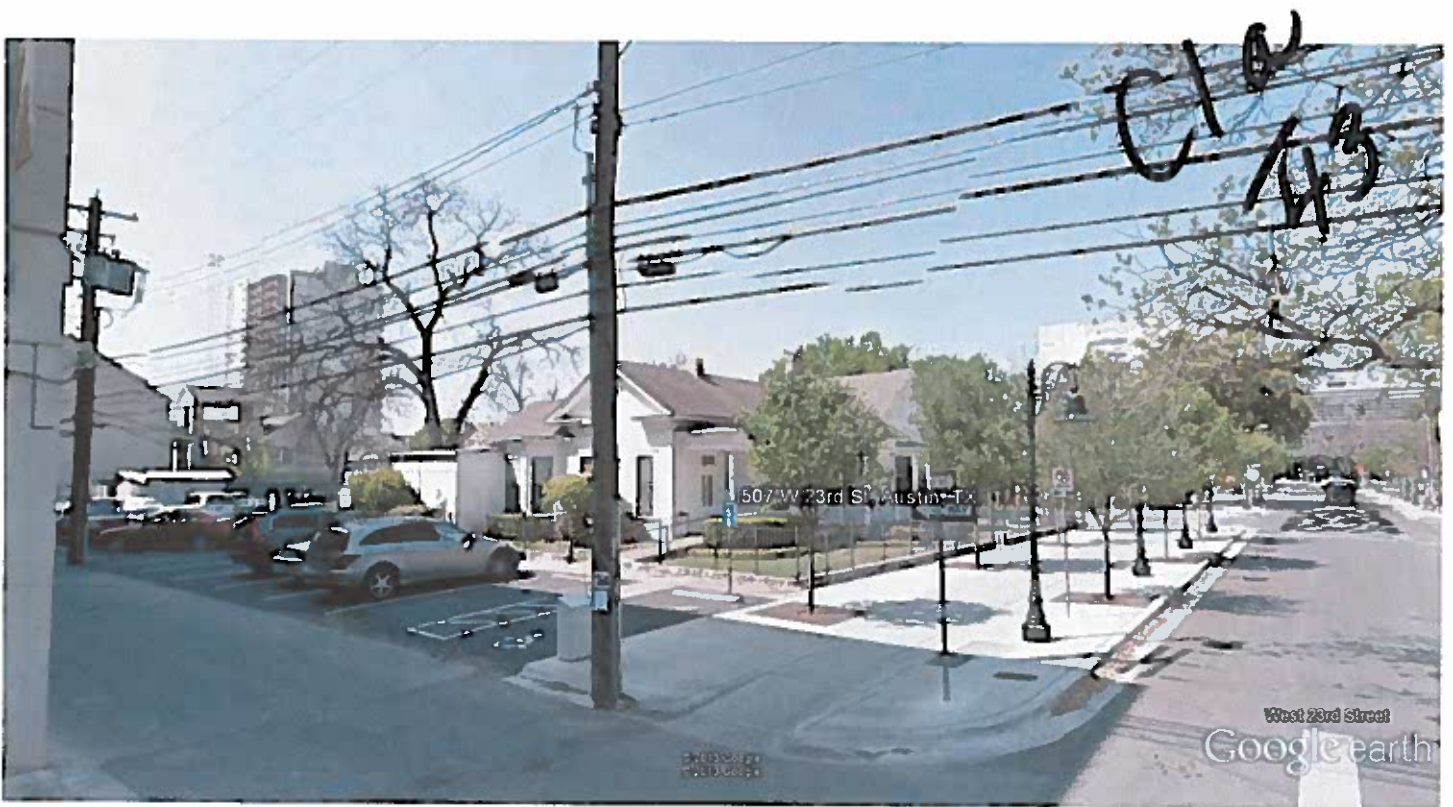
View FROM 23<sup>rd</sup> STREET AT ALLEY Looking  $\nwarrow$  W.  
 21 RD IN DISTANT BACK GROUND  
 Subject TREE IN MIDDLE  
 UTILITY LINES IN ALLEY  
 PEDESTRIAN STREETS ~~ARE~~ ON SOUTH SIDE OF 23<sup>rd</sup> STREET.
