# Aquatic Facilities Needs Assessment

## Appendix I - Qualitative Assessment

City of Austin, Texas

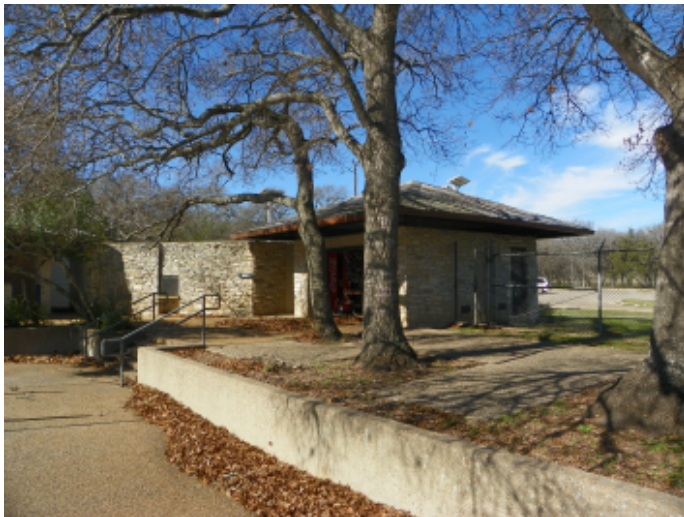
Pool House

BUILDINGS	Num	Size (Estimated)	Unit	Condition Level			Estimated Values of Repairs	Priority			Comments
				Good	Fair	Poor		H	M	L	
<b>POOL HOUSE</b>		s.f.	s.f.								
Repair Estimate - Restrooms		550				X	\$110,000	X			Recommend total renovation of area, bringing up to ADA compliance.
Repair Estimate - Vending		300				X	\$18,000	X			Recommend moderate maintenance repairs.
Roof Replacement Estimate - Vending		300					\$4,500	X			Recommend replacement of roof, gutter system/ fascia.
Repair Estimate - Guard/ Admissions Area		400				X	\$24,000	X			Recommend moderate maintenance repairs.
Roof Replacement Estimate - Admission Area		400					\$6,000	X			Recommend replacement of roof, gutter system/ fascia.
Separate from pump room?											Yes
Restrooms	1M					X					No mirrors; tile chipping (recommend replacing all tile); replace missing lens on ceiling fixture
	1W					X					No mirrors; wall tile chipped (recommend replacing all tile); missing spindles for toilet paper dispensers; minor cracking of glazed CMU

Inside pool fence? In park?											Inside pool fence
Exterior walls					X						Stone masonry (needs power washing)
Interior walls											
Roof						X					Gutter is rusted (rusted all the way through, in some places has good sized holes) and at end of life (recommend replacing); galvanized corrugated roof is
Doors											None entering restrooms - others listed in their areas
Floor/Drainage					X						Pebble finish concrete with area drains
Ceiling											
Lighting/Power						X					All restroom lighting is old, at end of life (recommend replacement)
Office					X						Currently used as a Help Area; top of counter 44"/ 36"(36" max per ADA); exposed wiring under counter; shelves under counter are painted plywood (recommend painting); 2'-8" wide door leading into storage room (electrical panel cover in here rusted, new shower seat stored in here, bare light bulb ceiling mounted)
Guard Room

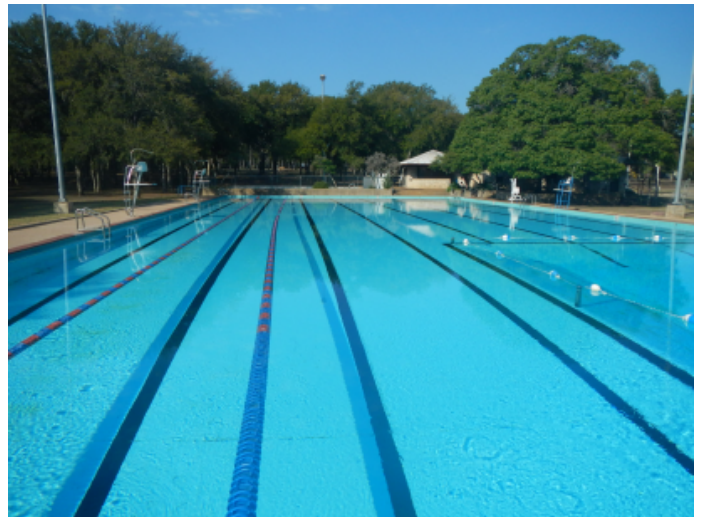
SWIMMING POOLS	Num	Size	Unit	Condition Level			Estimated Values of Repairs	Priority			Comments
				Good	Fair	Poor		H	M	L	
Opening Date							Closing Date				
<b>MAIN POOL - LAP POOL</b>			s.f.								
Water source											Municipal
Volume		550,000	gal.								Per APARD Records
Pool Perimeter		480.00	ft								
Surface Area		12,275.00	sf								
Turnover Rate		1600	GPM								
Turnover Time		5.73	hrs								
Shape		65' x 162' Rectangle									
Depth (min. - max.)		3' - 12'	ft								
Lap Lanes	8	50	M								
Cross Lanes	N										
Pool floor											Concrete
Appearance				x			\$98,200				Painted, peeling and flaking
Pool walls											Concrete
Appearance				x			\$20,160				Painted, peeling and flaking
Coping		12" clay tile				x	\$14,400				Red tile mortar joints cracking, tile fallen off; raised 2" above deck.
Pool deck		8114		x			\$162,280				8' wide. Sunken on bathhouse side of pool.
Tiles/Waterline				x							Tiles in Gutter coming loose

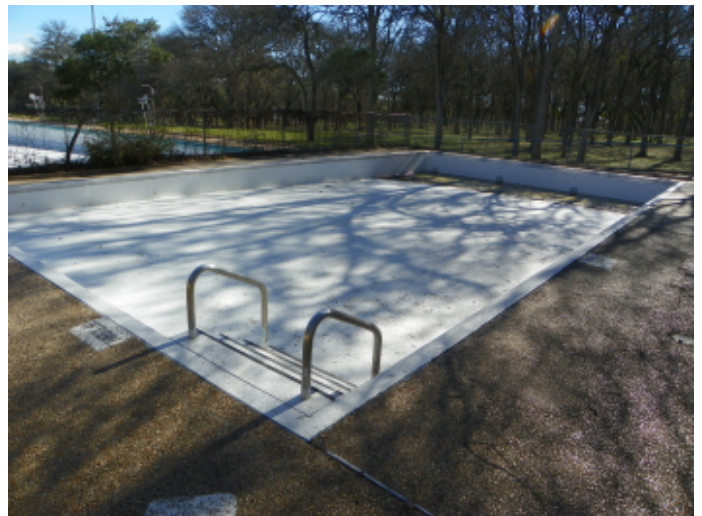
Wading Pool

**ADA/ TAS Compliance:** Existing configuration of toilet fixtures with slight modifications to comply with ADA. The ramp leading from the wading pool down to the main pool needs a landing added and available length should suffice in adding this landing.

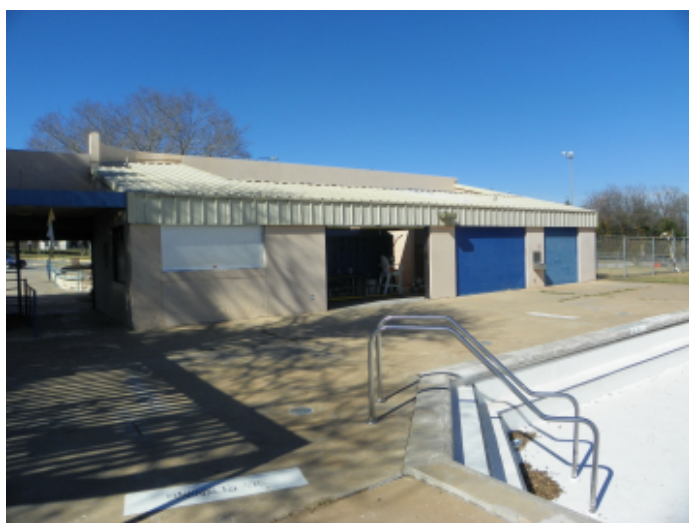
Pool House

BUILDINGS	Num	Size (Estimated)	Unit	Condition Level			Estimated Values of Repairs	Priority			Comments
				Good	Fair	Poor		H	M	L	
<b>POOL HOUSE</b>		s.f.	s.f.								
<b>Repair Estimate</b>		2185					\$327,750				Recommend total renovation of restroom/ shower areas along with performing other moderate maintenance/ repairs.
<b>Roof Replacement Estimate</b>		2185					\$32,775				Recommend immediate roof replacement.
Separate from pump room?											Yes
Restrooms	1M					X					HM frame/ door to plumbing chase is rusted/ deteriorated; water leaking inside chase; door swing for HC toilet is incorrect (hinge side should be opposite from grab bars/ toilet); steep rise/ bump up in floor to access non-HC toilet stall
	1W					X					CMU was partially removed to install HC controls in shower and patched back (not painted, holes around fixtures too big/ gaping); steep rise/ bump up in floor to access non-HC toilet stall

Inside pool fence? In park?											Inside pool fence
Exterior walls						X					Stucco w/ exposed fastener wall panels up high (wall panels need to be replaced - end of life)
Interior walls						X					CMU; all paint peeling
Roof						X					Exposed fastener metal roof (has been repainted/ repaired in the past) and is badly bent (bulging down in spots) and has pin holes (poor condition - recommend replacing); structural steel is rusting (needs cleaning/ painting)
Doors											
Floor/Drainage											Concrete w/ area drains
Ceiling											Open air, restroom area covered by exposed to structure roof
Lighting/Power											No lighting inside toilet/ shower area, wall mounted area light over changing area for each restroom (recommend replacing existing lighting and installing more in areas without lighting)
Office											None
Guard Room					X						Shares with the ticket area; repaint; 2 smaller coiling doors rusting and peeling (need to be painted); 1 new coiling door (good); ADA level counter (36" AFF, 38" max); open to struct.; storage room adjoining this area accessed only through this room

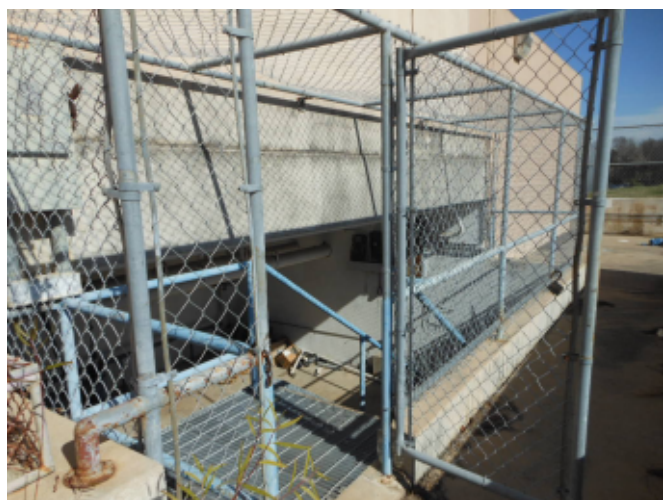
Pump House

<b>PUMP ROOM</b>											
<b>Repair Estimate</b>		0					\$0				No pump building
Chemical Storage Room											
Pump/Filter Room											
Electrical system											
Grating											
Sump pump											
Storage											
Work area											
Ventilation					X						Open air - not enclosed
Eye wash											None
Safety					X						Exterior wall mounted lighting for this area; 4' chainlink fence protecting entry level from pit area below; chainlink enclosure (walls & top) protecting pit below grade
Pit access											
Roof											
Floor/Drainage											
Walls						X					Located behind back concrete wall of diving area; door to this outdoor area is HM door/ frame very deteriorated (eaten though holes - recommend replacing both); edges of concrete @ opening falling apart, chipped/ cracked and steel rusting
<b>TOTAL</b>							<b>\$360,525</b>

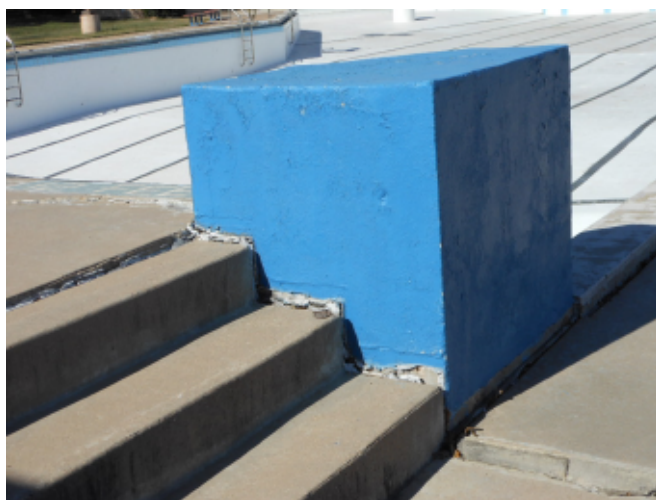
Deck / Stairs Moving away from pool

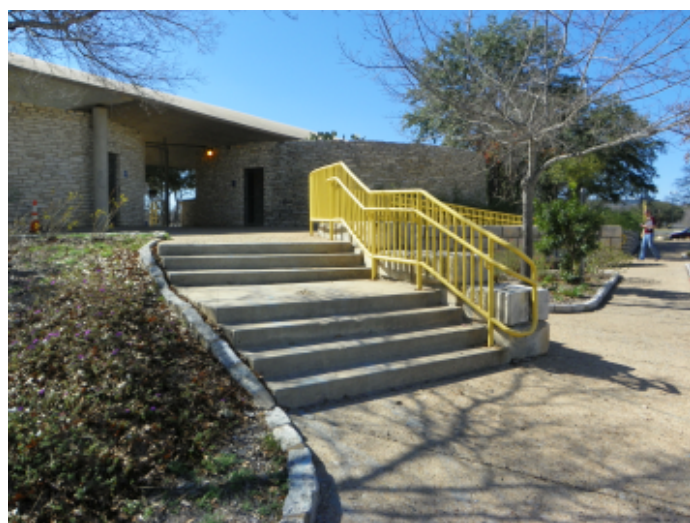
Pool House

Structural	Num	Size	Unit	Condition Level			Estimated Values of Repairs	Priority			Comments
				Good	Fair	Poor		H	M	L	
<b>Pool House</b>											
Walls				x							
Roof					x		\$5,000				Corrosion of framing, decking
Slab					x		\$5,000				Slab cracks

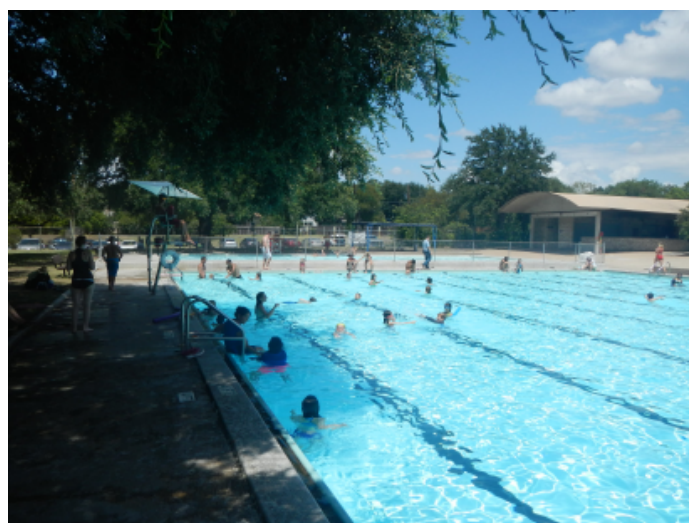
Pool

<b>Main Pool</b>											
Floor				x							Only minor cracking visible
Coping						x	\$5,000				Separation of coping from flatwork, cracks at dowels, expansion joints
Joints				x			\$5,000				separation at many locations
Deck					x		\$20,000				cracking, vertical discontinuity, separation of caulked joints, some deck should be replaced
<b>Pump Room</b>											
Walls				x			\$10,000				Severe corrosion at portholes, efflorescence at walls
Foundation				x							
Hoist Beam					x						
Slab						x					Some cracks, pitted concrete
<b>TOTAL</b>							<b>\$50,000</b>

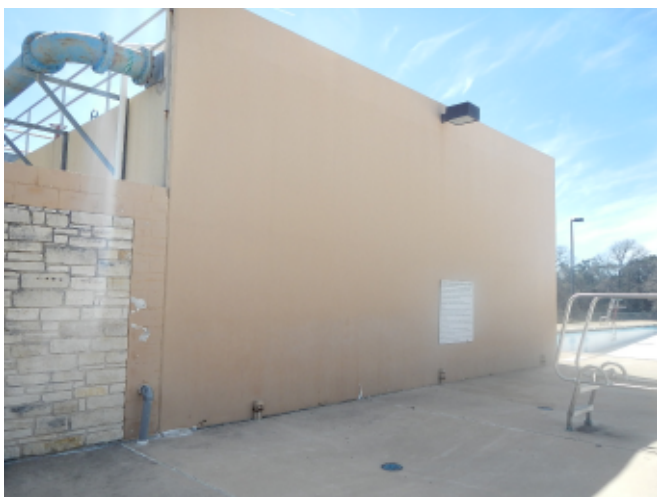
Pump House

Structural	Num	Size	Unit	Condition Level			Estimated Values of Repairs	Priority			Comments
				Good	Fair	Poor		H	M	L	
Pump Building											
Walls					x		\$3,000				Some effluence at outside of walls, some pitting of concrete near pipe connection, missing and cracked concrete at grate attachment on top
Foundation				x							Nothing noted
Slab				x							Some minor cracking
Restroom											
Walls				x							Some cracks in walls
Roof				x							Some rotted beams and roof deck
Slab				x							Some small cracks
Pool											
Floor					x		\$7,000				Many cracks, some major near deep end
Coping					x		\$3,000				Several cracks, some large chunks missing,
Joints					x		\$3,000				Many cracks between pool and deck
Deck					x		\$15,000				Many cracks
Site											
Chemical storage area					x		\$5,000				Structural beams and roof rusting
TOTAL							\$36,000

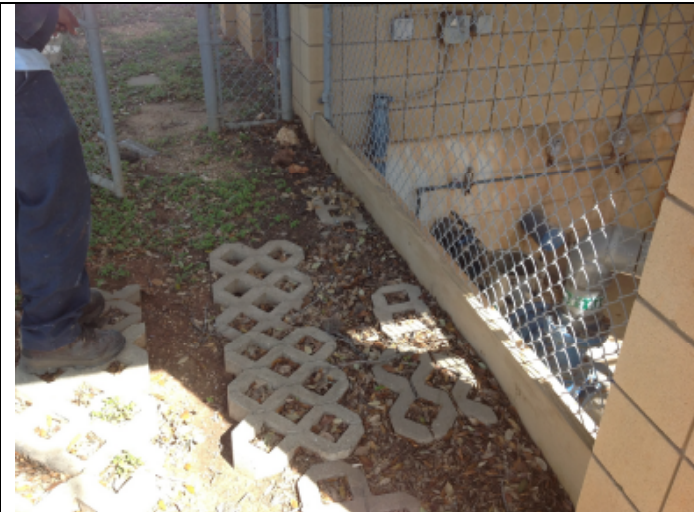
Grade issues at pump pit

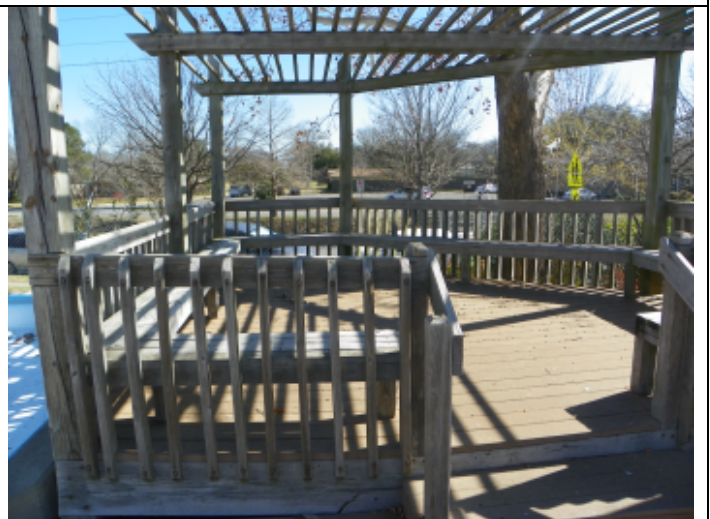
Structural	Num	Size	Unit	Condition Level			Estimated Values of Repairs	Priority			Comments
				Good	Fair	Poor		H	M	L	
Pump House											
Walls				x							Some Pitting due to chemicals
Foundation				x							Some Pitting due to chemicals
Slab				x							Some Pitting due to chemicals
Restroom Outbuilding											
Walls					x		\$2,000				Cracks in walls.
Slab				x							No obvious issues
Pool											
Floor					x						Difficult to determine slab condition due to swimmers in pool
Coping					x						Minor cracking
Joints					x						Differential movement obvious
Deck						x					Many large cracks
Site											
Walks					x		\$5,000				Several cracks
Standing water near entry											Standing water near pool entry
Pergola					x		\$10,000				Aging
TOTAL							\$17,000

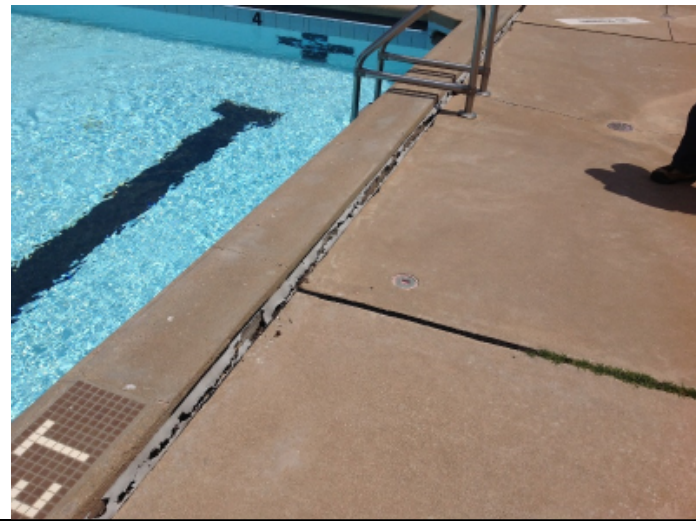
Deck Pulling back from pool

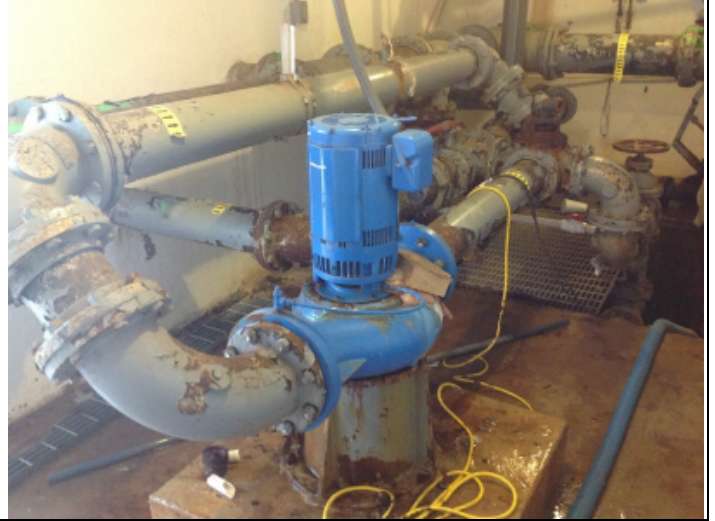
Old piping and Valves

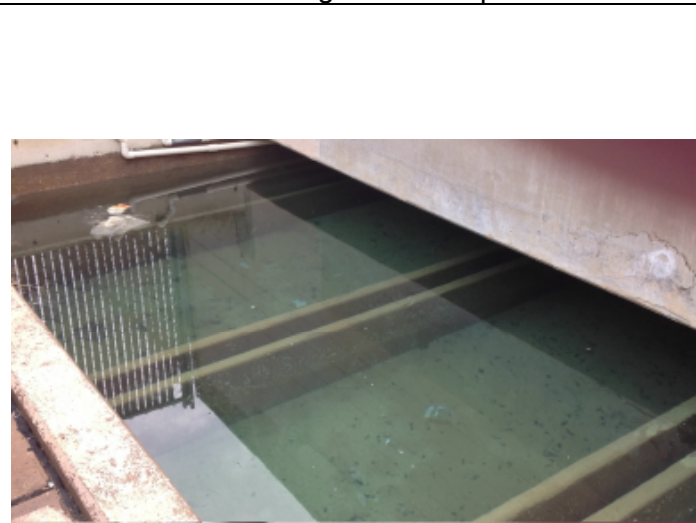
Sand is returning to pool from filters

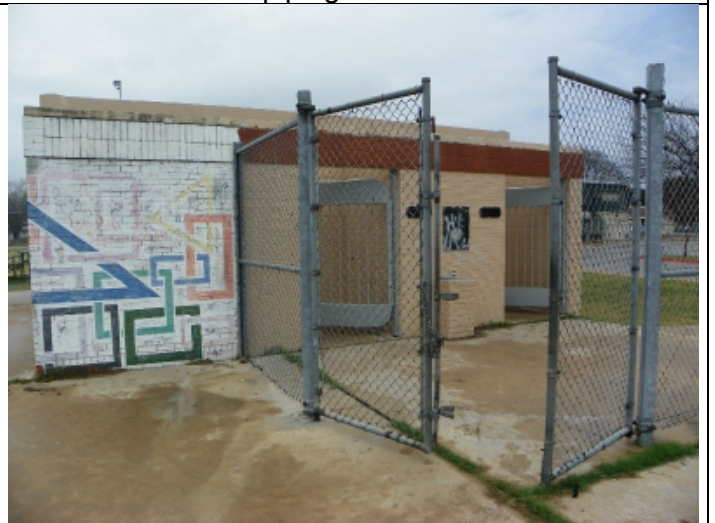
Restrooms outside of fence

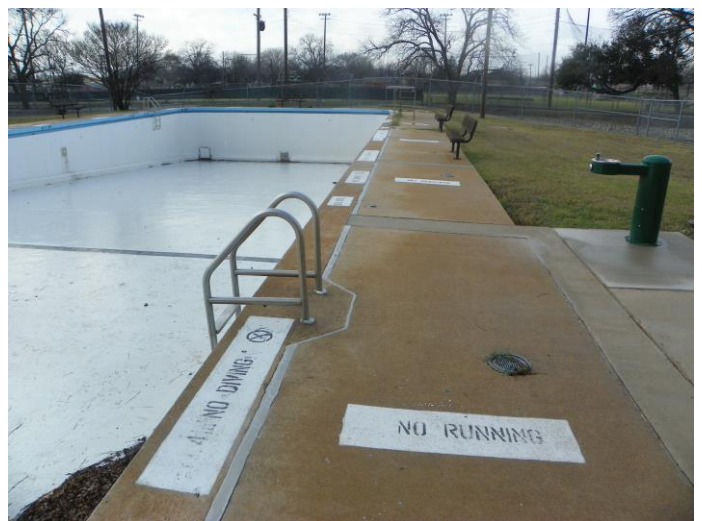
Pool leaks - Dropped 13" in 3 days at fill lines.

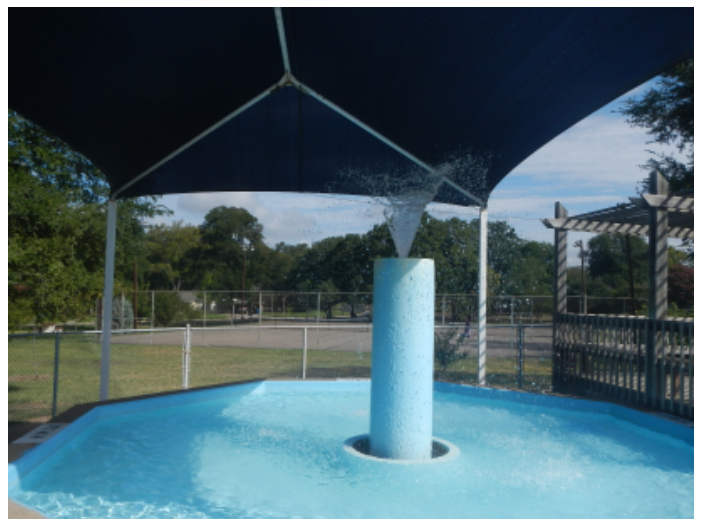
Wading Pool

Splash from fountain and runoff from pool deck has caused soil erosion on north side of wading pool. Concrete edge has been undermined. Regrade area and add soil stabilization or concrete on north side of wading pool.  
 Ponding occurs at the pump house near the pool deck. Regrade area. May be able to add french drain to improve drainage.

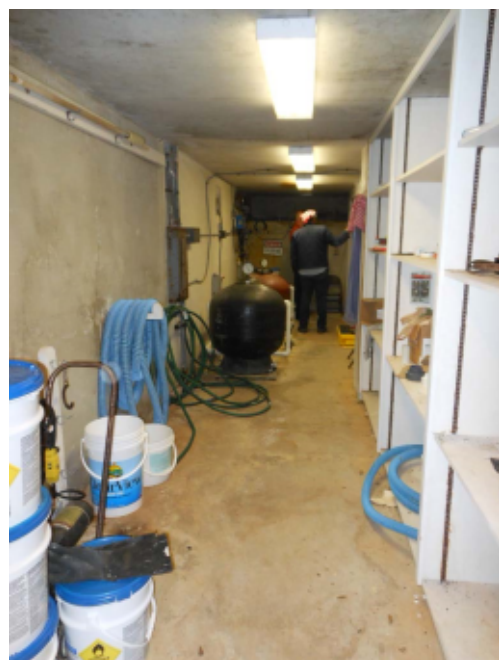
Pump Room

<b>Pump Structure</b>				x							No defects noted
