Table of Contents for 504 East 8th Street Tree Permit
Heritage Tree Variance Package

ITEM FOR ENVIRONMENTAL COMMISSION AGENDA

ADDRESS
OF PROPERTY: 504 EAST 8TH STREET

SUBJECT: 504 East 8th Heritage Tree Ordinance Variance

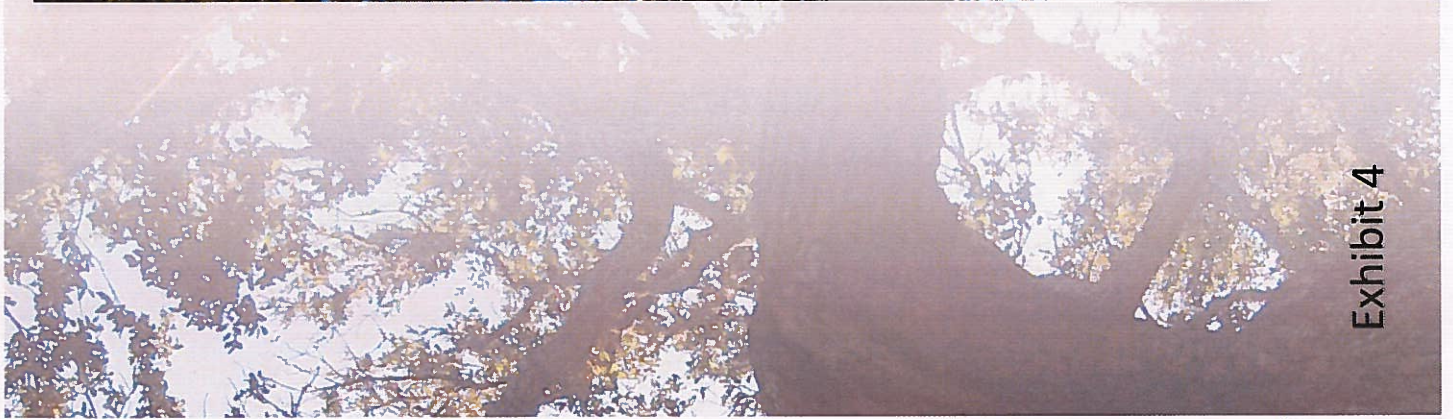
Exhibit 3

The canopy architecture displays minor asymmetry (Exhibit 1). Storm damage is evident in the canopy as the main leader has been damaged (Exhibit 2). Extensive epicormics growth is apparent (Exhibits 3 and 4). Epicormic growth is generally associated with the tree's response to stress likely related to the root system (see below).
