I. EXECUTIVE SUMMARY

This study examines the feasibility of various improvements to grounds and facilities in the Barton Springs Pool area of Zilker Park which has been recognized for generations as the soul of Austin. The recommendations in this study incorporate the goals of the 2008 Barton Springs Pool Master Plan (BSPMP) and the challenges of the numerous environmental, historical and local regulations that apply to this area.

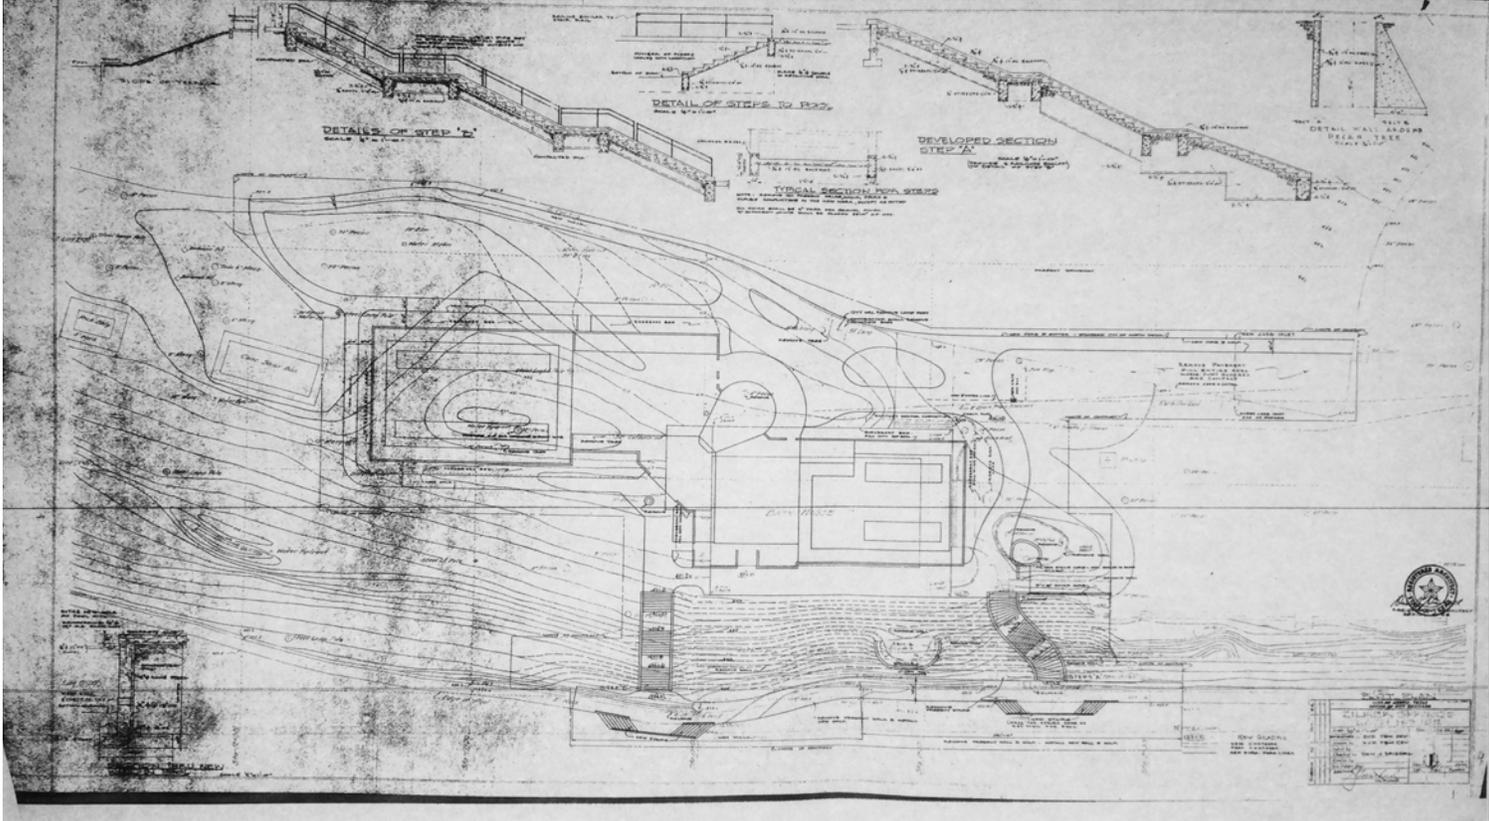
Pool Enclosure: Emergency egress from the pool enclosure is through the Spectators' Gallery. This is a very narrow pathway given the potential number of people within the pool enclosure.

Pool Enclosure and Bathhouse: Original Construction Plan dated 1945. Of note are the fact that the fence enclosing the pool was not included in the original design, that the present Spectator's Gallery is a legacy of the preceding bathhouse (and preserves intact a portion of the foundation of that destroyed building), and that the reconfiguration of the northeast corner of the existing parking lot was anticipated in the design of the current building.

At present, the number and location of emergency exits from the north side of the pool are conspicuously deficient with respect to the requirements of the Building Code. Per visitor data provided by PARD, the north side of the pool should be provided per code with not less than four means of egress, with a total width of not less than 25'. Current egress from the north side of the pool, consisting in terms of clearly identified exits of a single turnstile at the main entrance with a clear egress width of less than three feet, is dangerously deficient.

The City Building Official confirmed that the provision of appropriately sized means of egress from the Bathhouse and from the entire enclosed area of pool, would be required for any modifications to the existing facility that necessitate Building Plan Approval. Present conditions such as padlocked access gates pose obvious hazards to the safety of pool visitors, and should be rectified at the first opportunity. The minutes of this meeting are attached hereto as Appendix A.

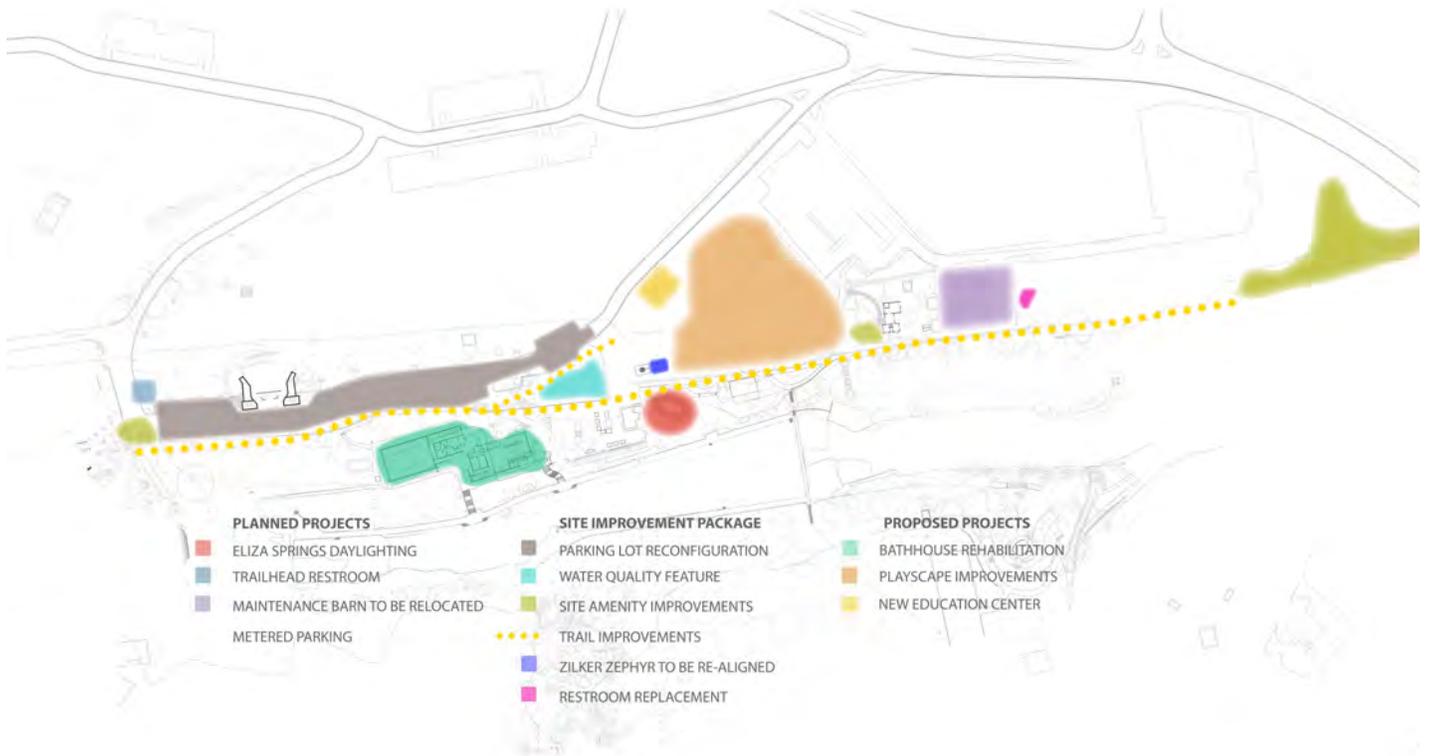
Potential Projects within the Bathhouse Zone: This plan suggests a number of potential projects intended to be implemented in a coordinated effort to achieve the objectives of the Masterplan.

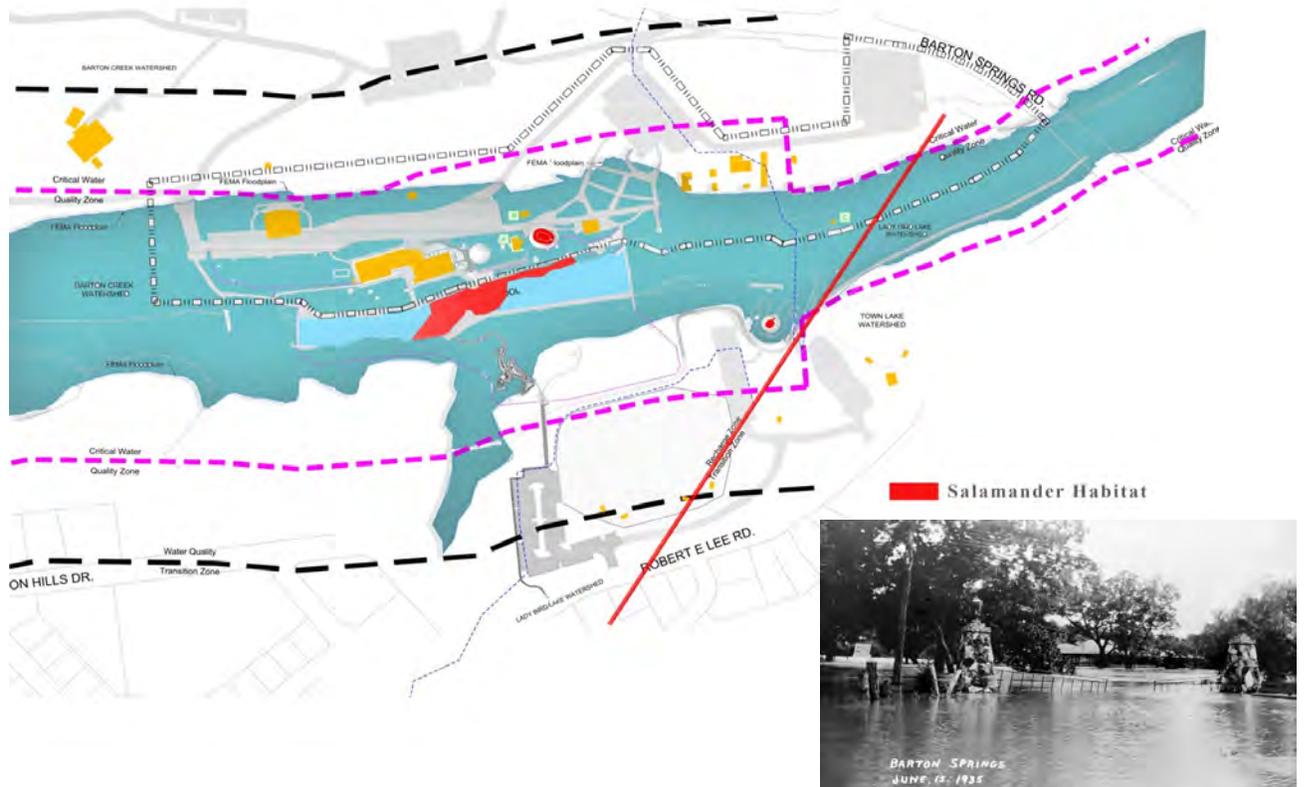
Constraints: The Bathhouse Zone is subject to City, State, and Federal regulations including, but not limited to, those pertaining to the protected habitat within the Zone, the existing historical resources, the FEMA-designated floodplain of Barton Creek, the Edwards Aquifer Recharge Zone, the heritage trees existing within the Zone, the SOS Ordinance, and the current Building and Land Development Codes. Any work undertaken within the Zone must take all of these regulations into consideration.
