ENGINEERING REPORT

DATE: November 16, 2016

RE: Engineering Foundation Inspection @ 1808 Treadwell--Austin, Texas 78704

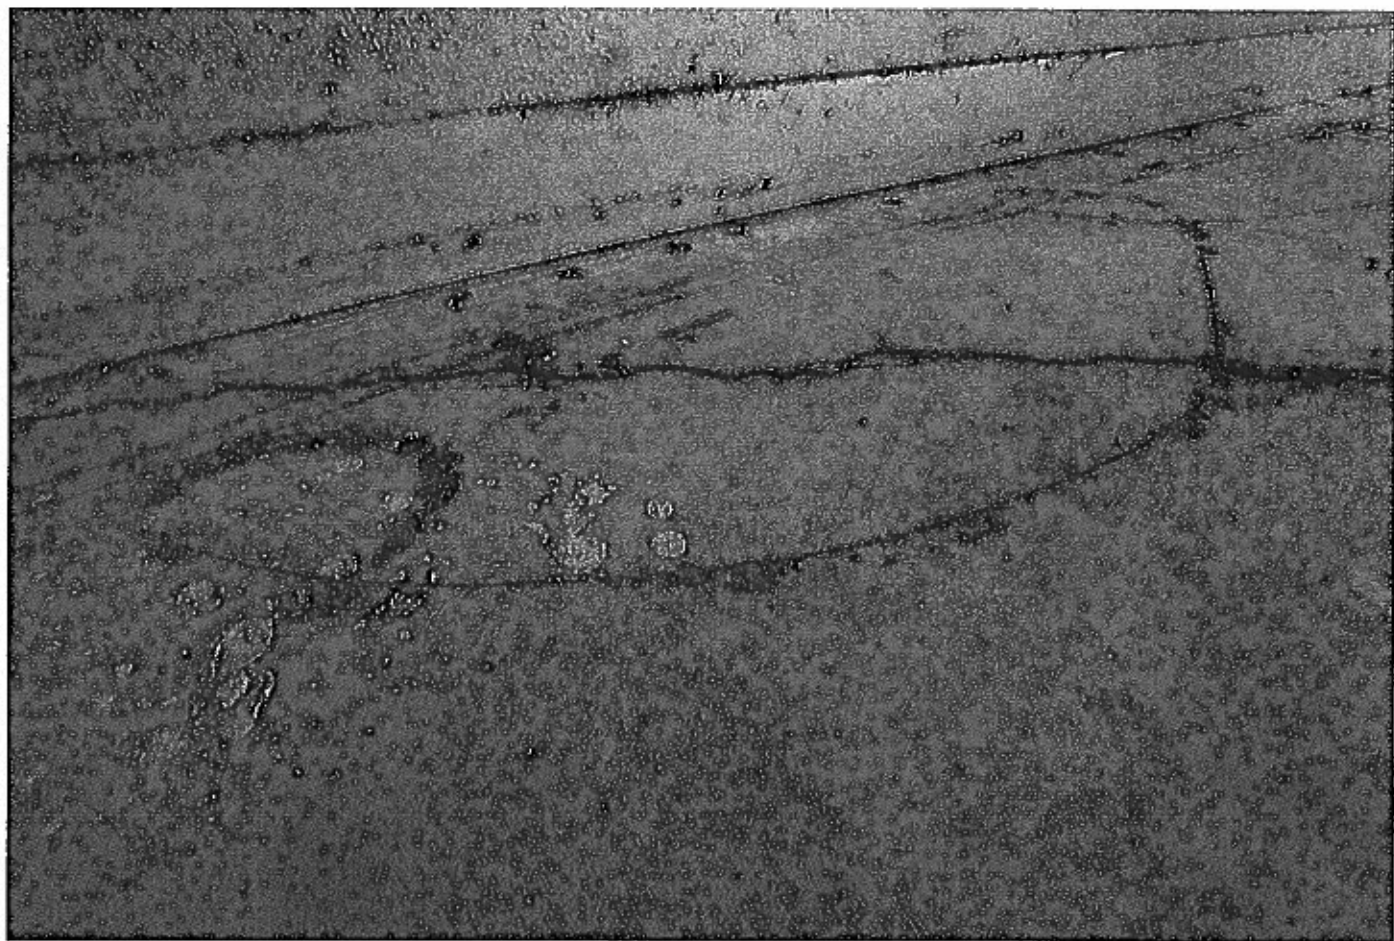
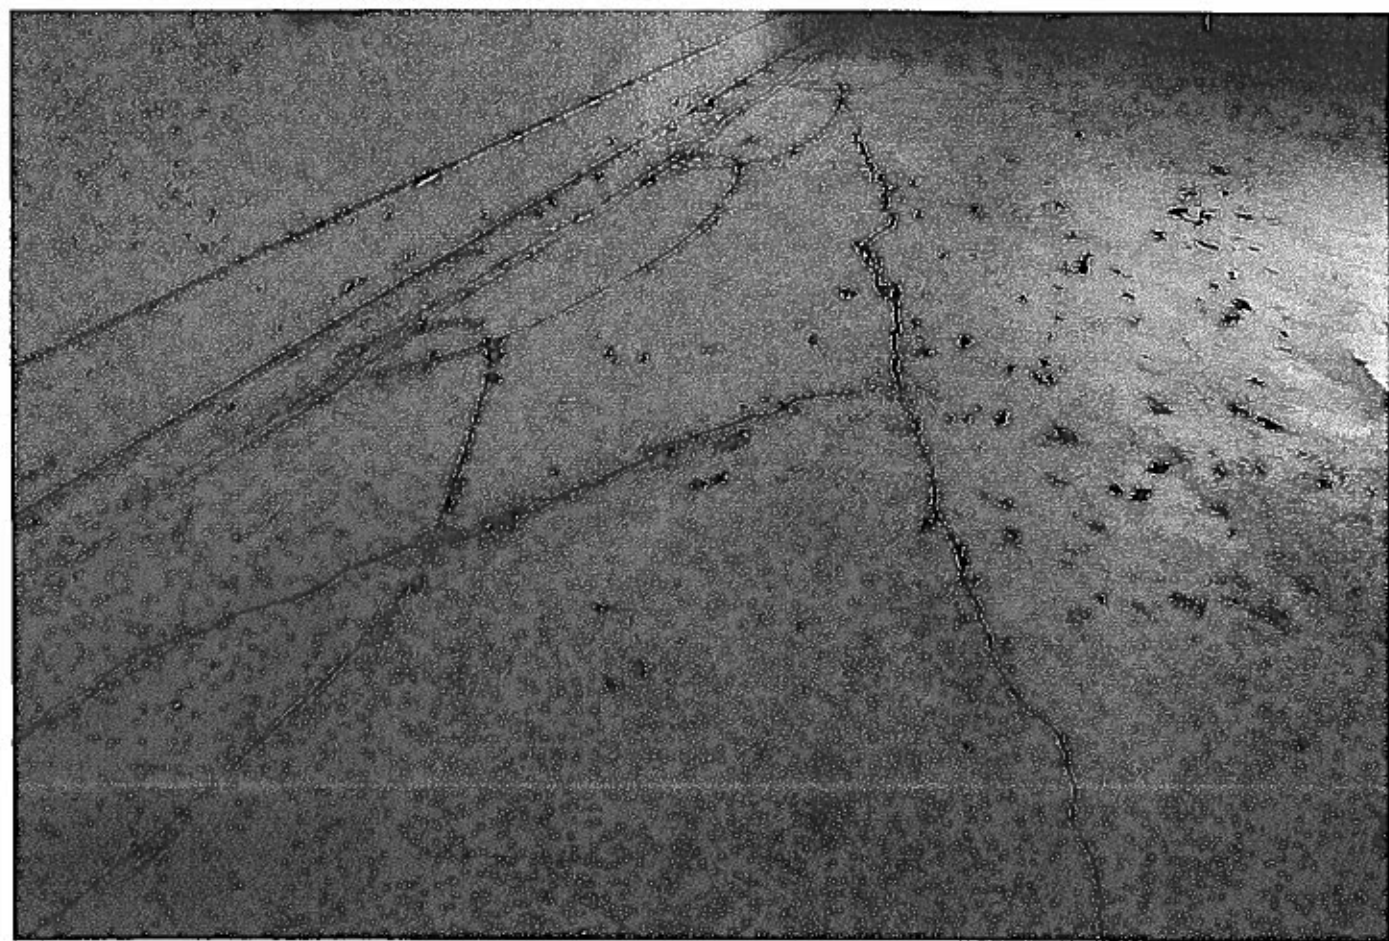
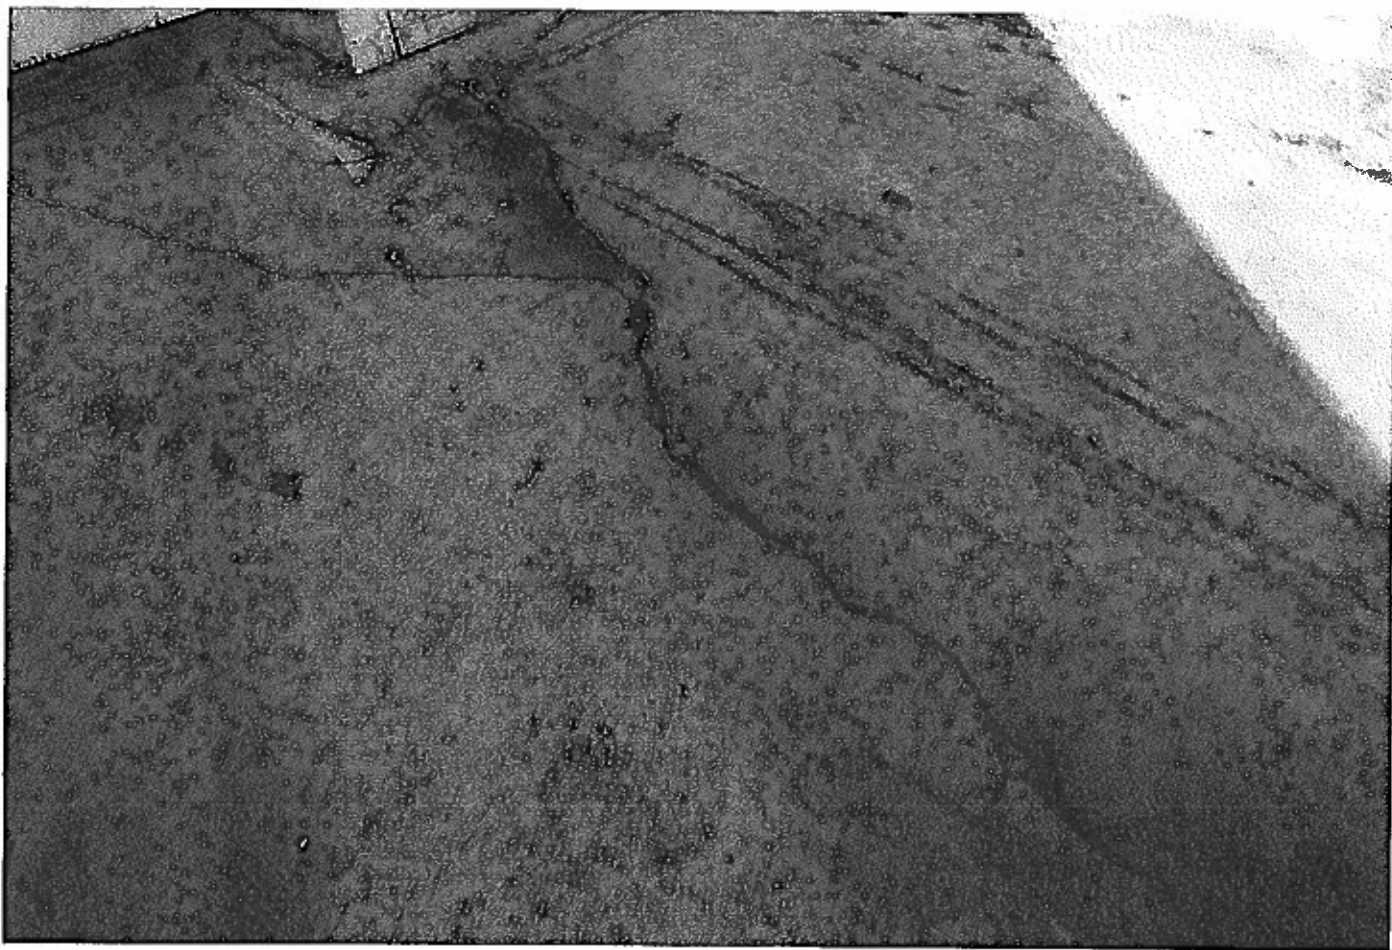
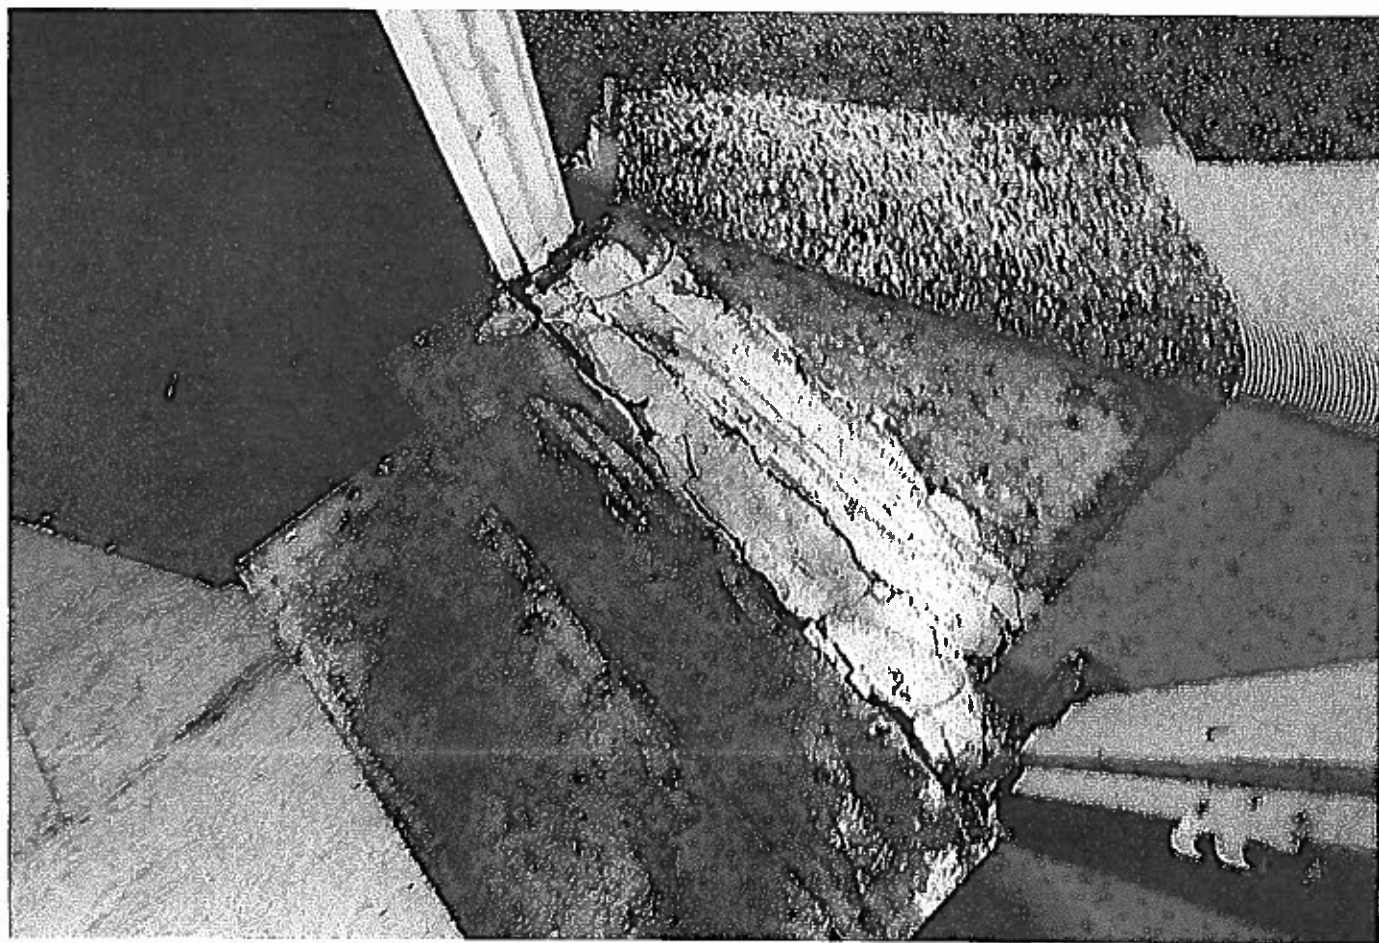
Inside the house, there are wall cracks on finished surfaces and are in deteriorated condition. There are signs of termite or carpenter ant trails through slab cracks and into interior walls. There are vertical offsets and fractures in the slab

Interior structural floor areas have a noticeable deflection across the floor area. There is a maximum deflection differential of almost 3-inches measured across the slab.
