MEMORANDUM

SITE PLAN: Block 36 (SP-2018-0015C)

REQUEST: The applicant is requesting to remove two heritage trees, each with a single-stem greater than 30 inches as allowed under LDC 25-8-643

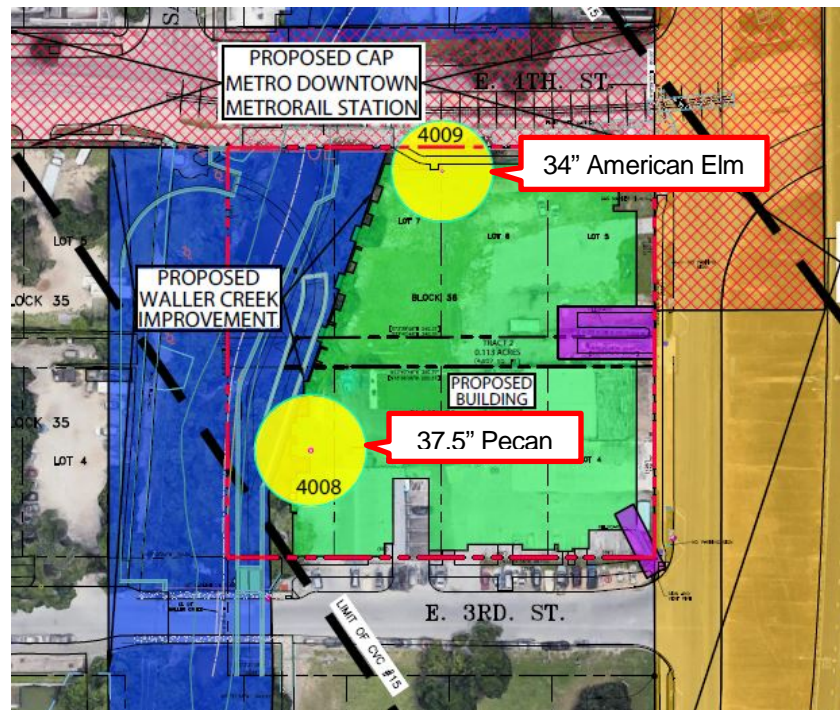
EXHIBIT A: Site Constraints Exhibit with 37.5" Pecan and 34" American Elm Tree Locations

REQUEST: There are two heritage trees on the site that are being requested for removal: a 37.5" Pecan located at the southwestern corner of the property, and a 34" American Elm located along the northern edge of the property along East 4th Street. See Exhibit A for tree locations.

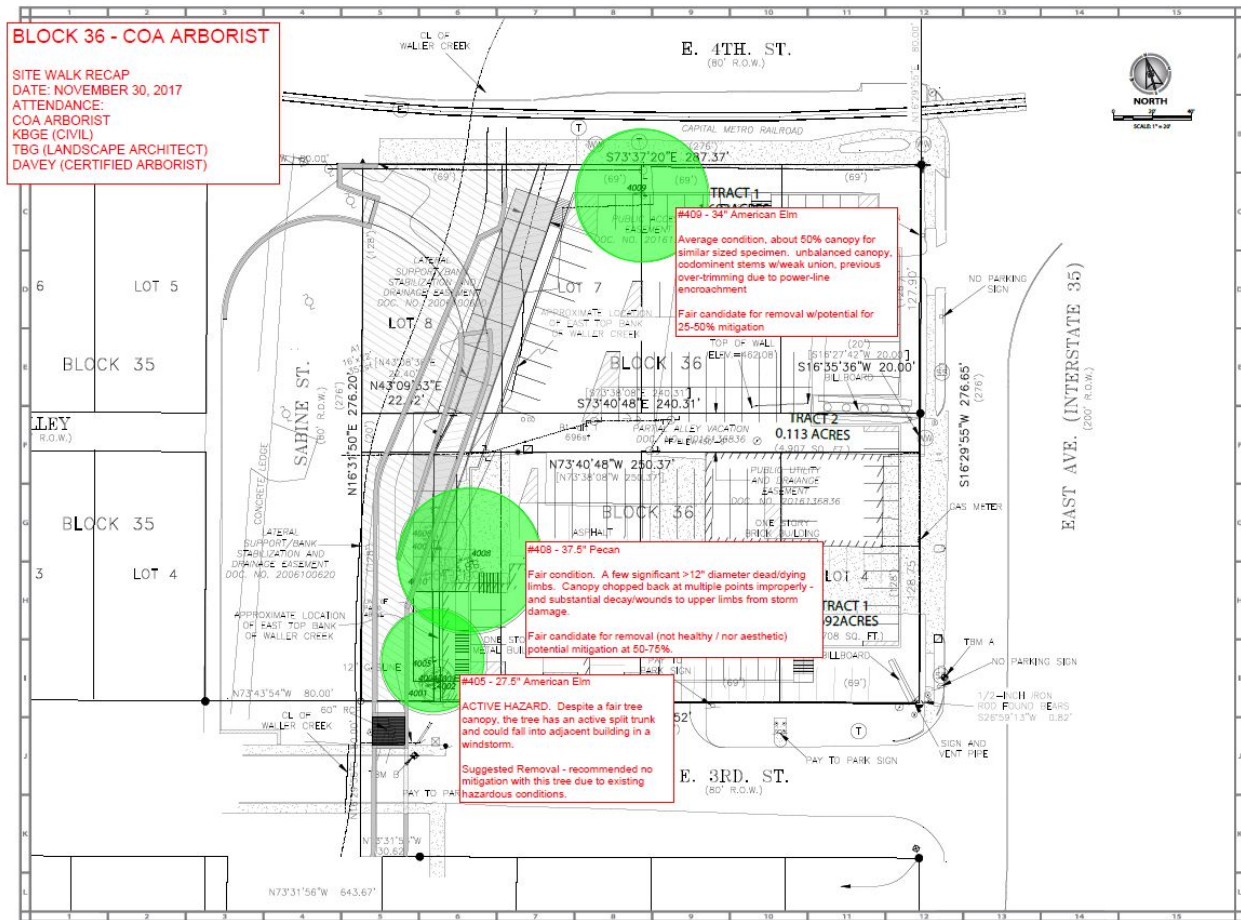
SITE SURVEY

Site survey showing 34" American Elm and 37.5" Pecan trees proposed for Land Use Commission Approved removal. The 27.5" American Elm also shown is proposed for administratively-approved removal.

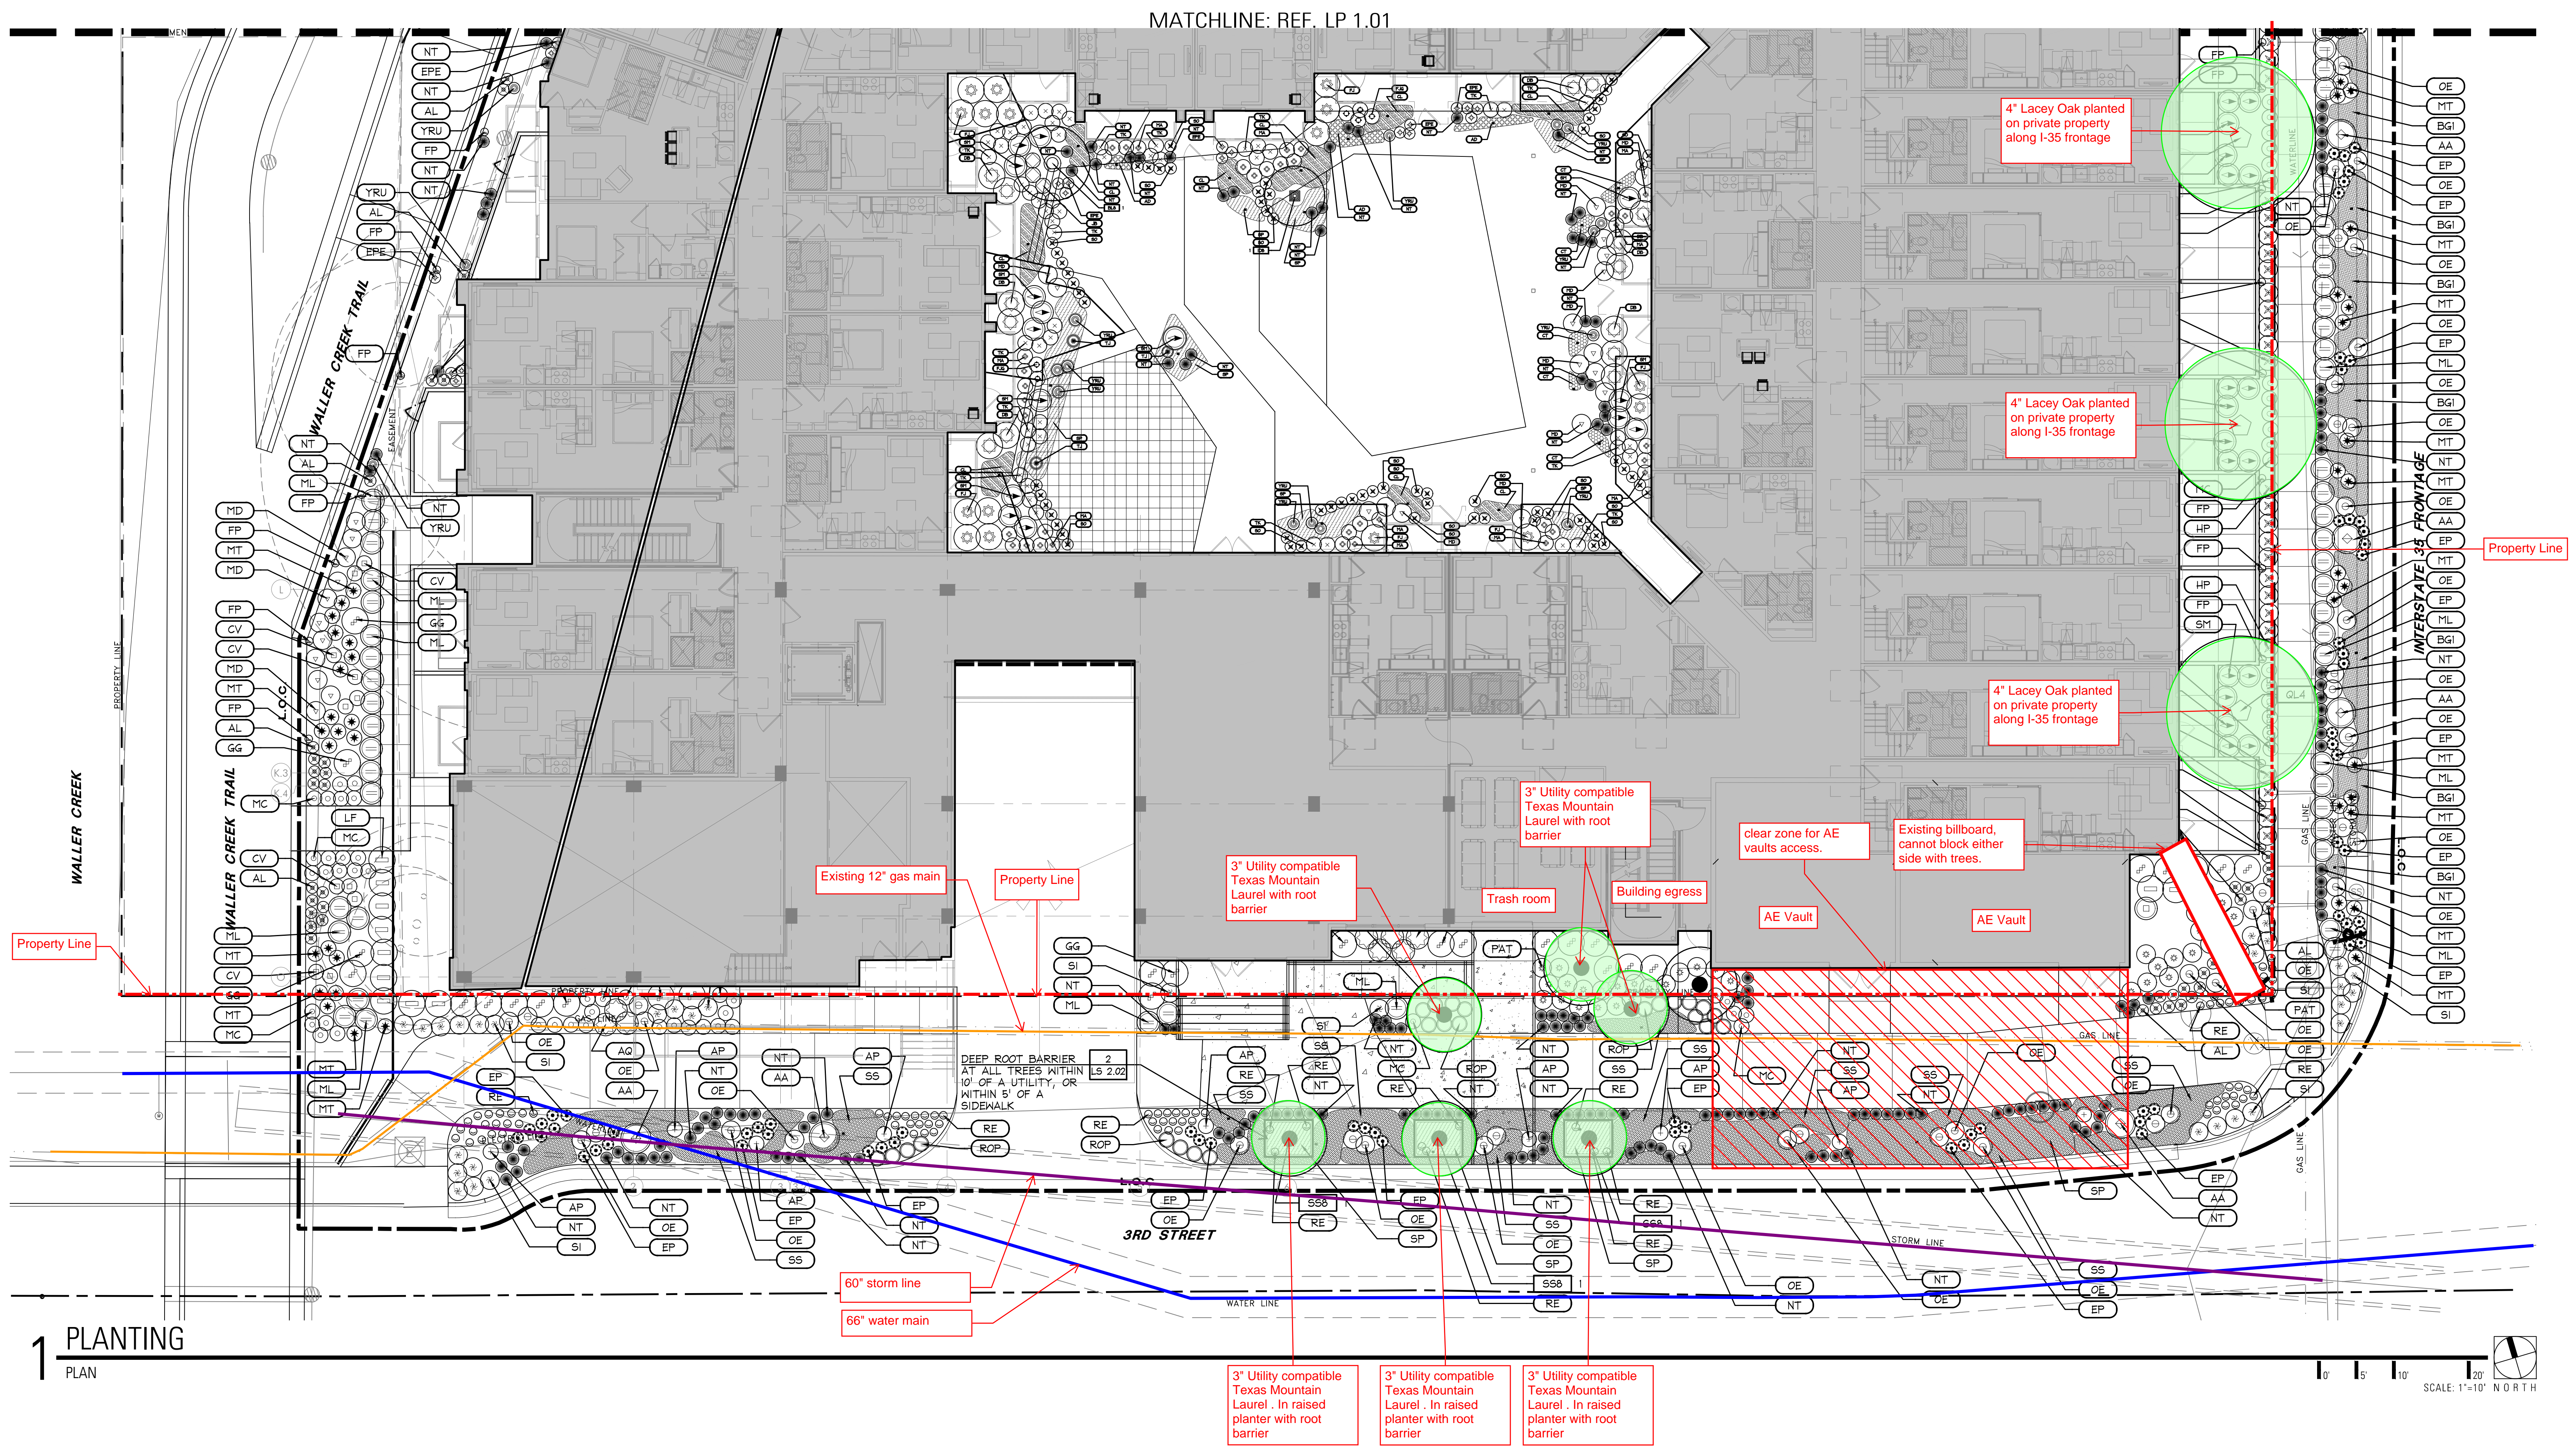
409 34" American elm – Average condition. Only retains ~50% of canopy of similar-sized specimen. Tree ~40' tall x 50' wide. Has heavily unbalanced canopy to east/southeast and multiple codominant stems with weak unions which could present future structural issues. Heavy poison oak infestation (~60%) present and evidence of previous over-trimming near power lines.

- This tree is a fair candidate for removal. It's not an active hazard, but it's not in a great condition and is also in a poor location. I'd *estimate* that this could be dropped down to a 25-50% mitigation rate.

408 37.5" Pecan – Fair/Average condition. ~40' tall x 55' wide. Has a few significant (12" diameter) dead/dying scaffold limbs. Canopy has been topped back at multiple points in past improperly. Some old decay/wounds higher up on major limbs and a few places of past storm damage.

- This tree is a fair candidate for removal. It's not an active hazard, but it's not a healthy/pretty tree that would be viable to preserve thru construction due to ~80% of its roots having been covered by pavement for many years. I'd *estimate* that this could be dropped to a 50-75% mitigation rate.

405 27.5" American elm – Fair condition (was mistakenly labeled a pecan). ACTIVE HAZARD. This tree has a fair canopy but an actively split trunk that could rip over onto the building in the next good windstorm. There would be no mitigation with this tree being hazardous.
