**HISTORIC LANDMARK COMMISSION  
MARCH 25, 2019  
DEMOLITION AND RELOCATION PERMITS  
HDP-2019-0090  
1603 WILLOW STREET**

Demolish a ca. 1902 house.

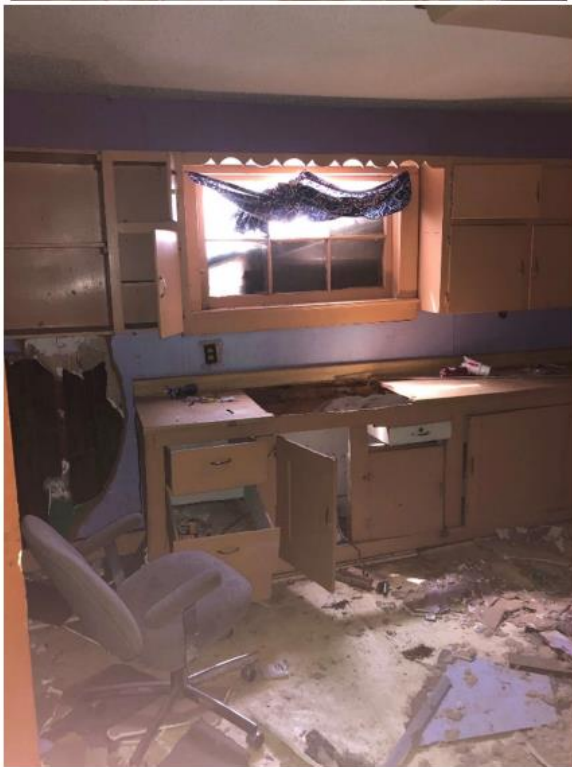
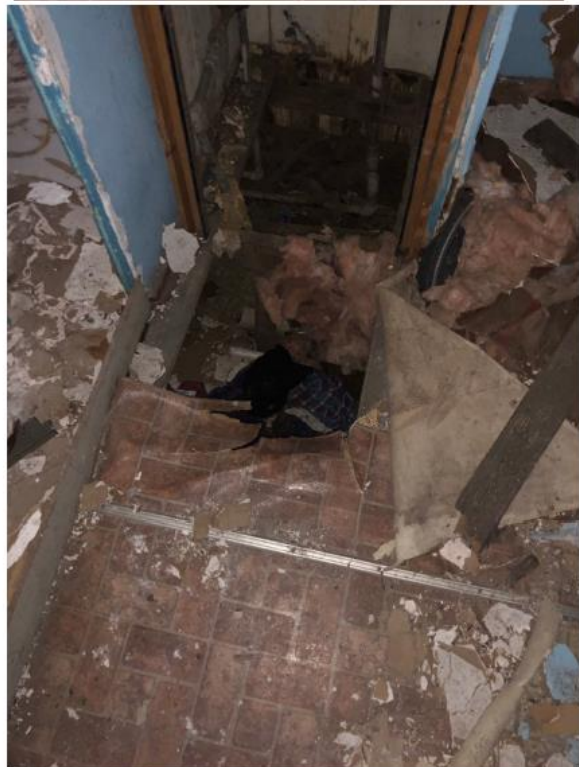
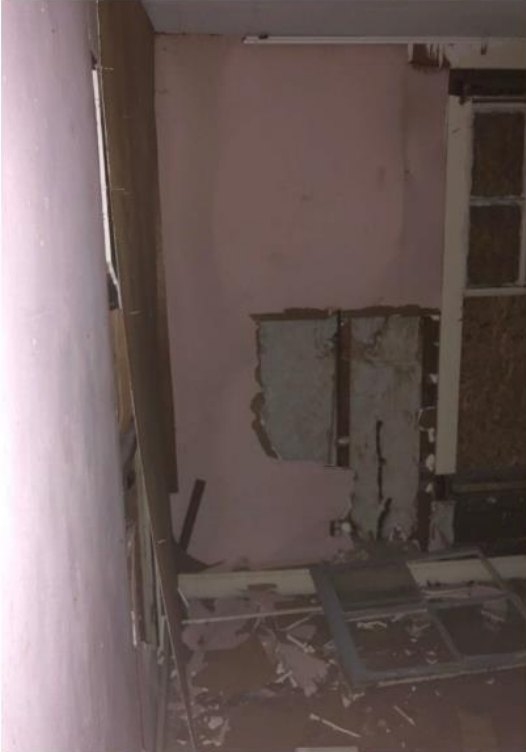
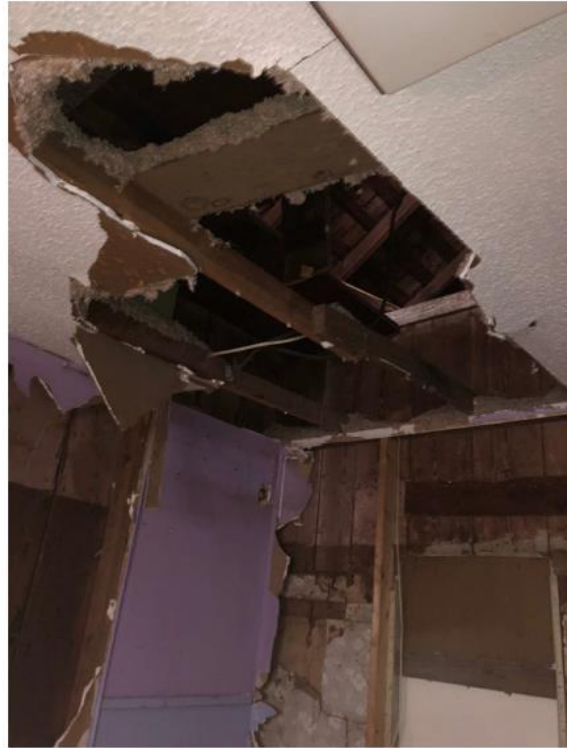
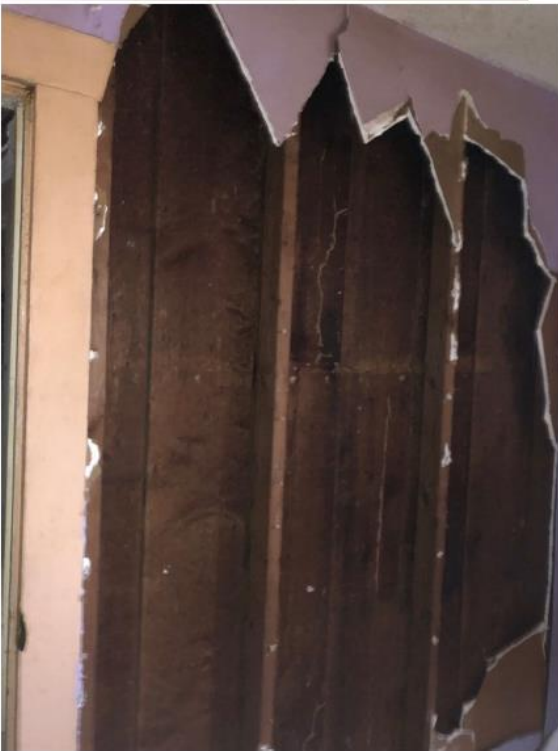
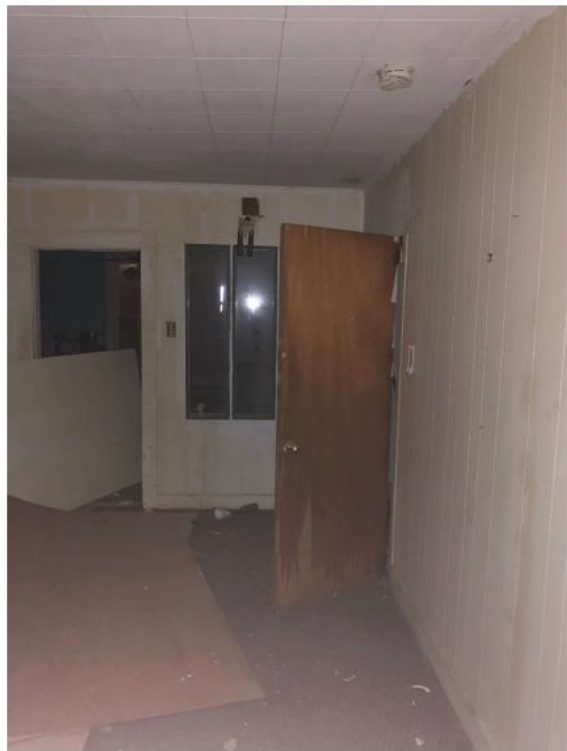
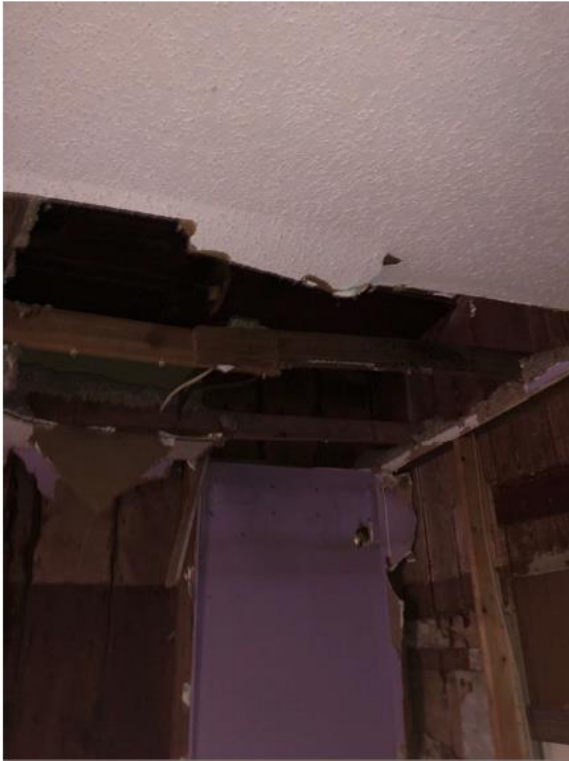
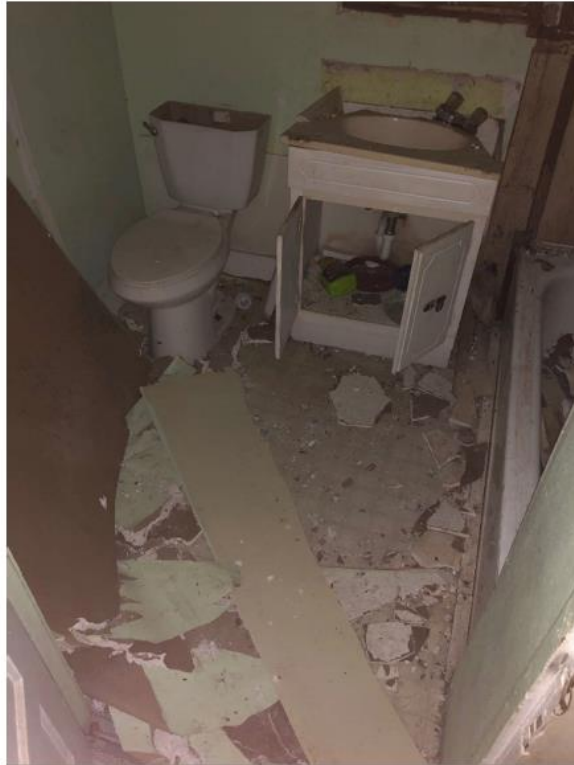
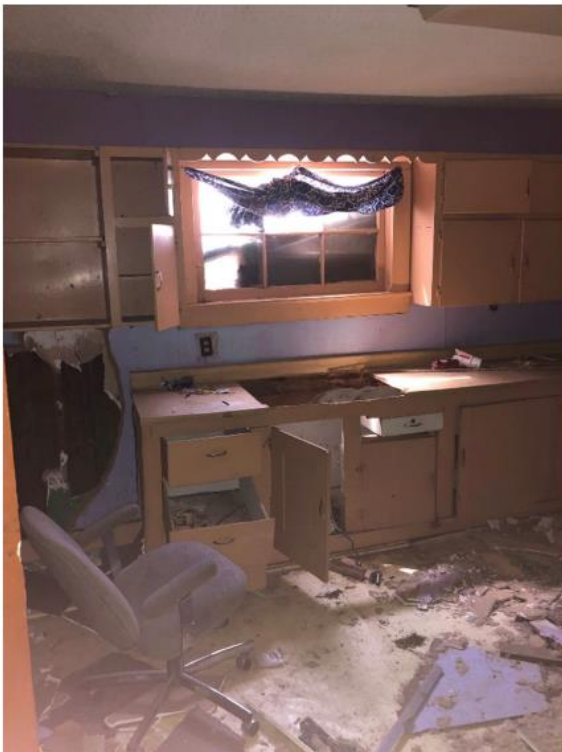
Based on the condition observed during the site visit, the subject property appears to be in very poor condition. The roofing system appears to be metal, in poor condition, the current roof is not salvageable and will need to be completely replaced. There appears to be multiple leaks that have caused damaged to the framing structure.

The current state of the interior of the home is in poor condition. There is exposed electrical wiring where sheetrock or wall paneling has been removed. This entire electrical system will need to be replaced due to the wiring being out of compliance. All ceilings and walls will need to be repaired. The flooring throughout the house is in poor condition and will all need to be replaced. There are multiple rotten areas in the floor framing and extensive repair and replacement work will need to take place to bring the structure up to a livable condition.

The foundation appears to be wood piers with no concrete foundation or base. All wood piers will need to be replaced with concrete piers, engineered to support the structure of the house. The foundation work needed would be extensive.

Overall, the property would require significant repairs to bring the home up to code. It is the opinion of Oakman Building Company that the home should be demolished. The cost to remodel the home would far exceed the cost of demolishing the home and re-building.
