Inspection Report

704 W 22nd St
Austin TX 78705

PROPERTY INSPECTION REPORT

By: Chad Garrett 6785 / Austinspect 4/3/19

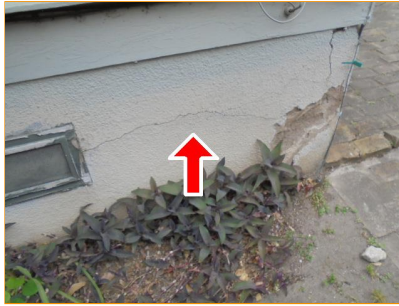
A. Item 3(Picture)

(2) Cracks were observed in one or more areas. The advancement rate of hairline cracks cannot be determined from a one time visual inspection and we cannot determine when the cracks occurred or if they will progress. If the cracks advance a structural engineer or foundation specialist should be contacted. If you are concerned about the cracks, you should hire a structural engineer to evaluate.

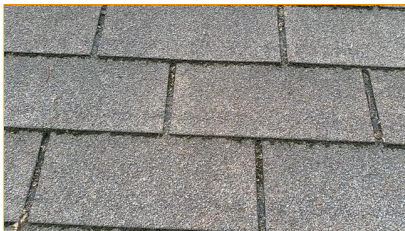
C. Item 1(Picture)

- (1) The tree limbs that are in contact with roof or hanging near roof should be trimmed.
- (2) The roof is missing granular material in one or more areas and should be further evaluated by a roofing contractor. Replacement of the roof or the damaged areas (if feasible) may be needed for insurability purposes. Inspector does not confirm insurability of the roof covering.

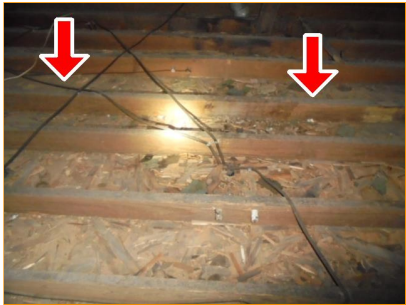
D. Item 2(Picture)

(2) Rodent droppings were observed in attic area, pest control and sealing of access points recommended
(3) Roof structure is sagging in many areas due to poor support structure. Have a framing contractor repair.

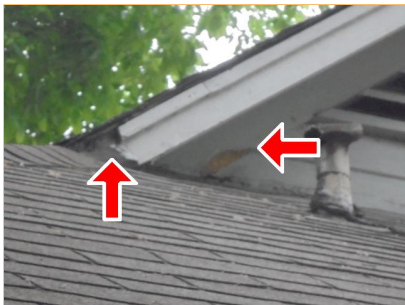
D. Item 4(Picture)

(4) Chewed wood trim in one or more eave/soffit ends, repair and seal all exposed wood. Trimming trees away from roof can limit rodent access and future rodent damage/infestation.

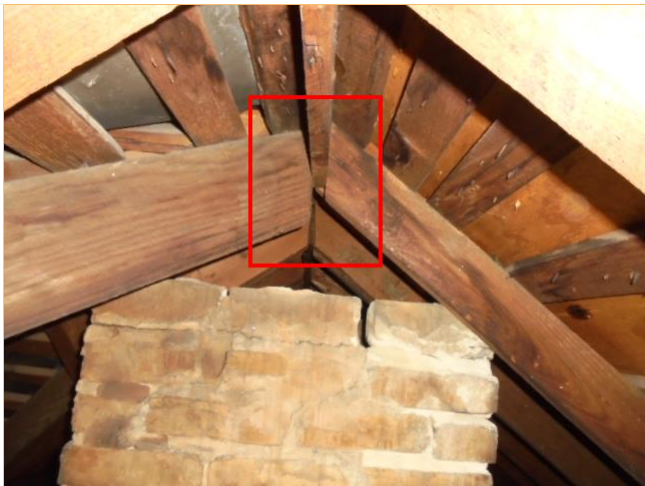
D. Item 5(Picture)

- (5) No fire wall present in attic between units per current code requirements, fire wall should be no less than 1/2 gypsum with at least a 45 minute burn rating
- (6) Additional attic ventilation recommended
- (7) Attic access openings are undersized by todays code standards,

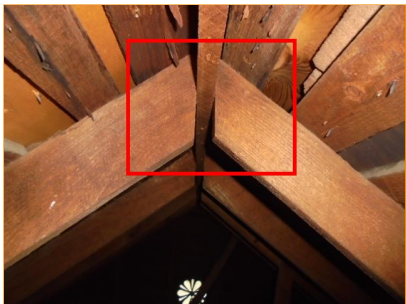
D. Item 6(Picture)

(8) Ridge beam should be the same size/thickness as the roof rafters. This is a current code standard. The roof and structure were performing as intended at the time of inspection

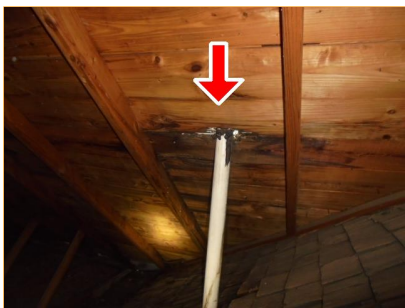
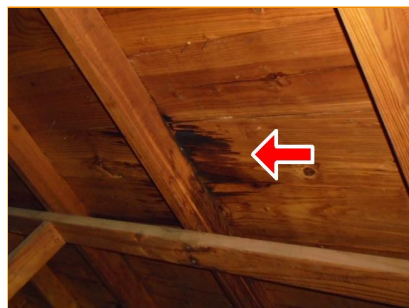
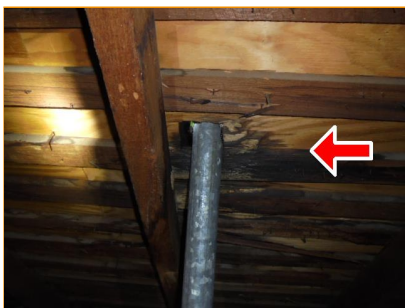
(12) Water staining at various areas of roof decking

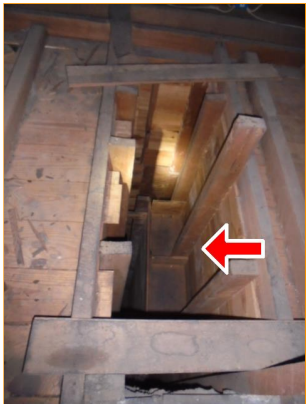
D. Item 16(Picture)

(16) Inadequate support and framing in attic

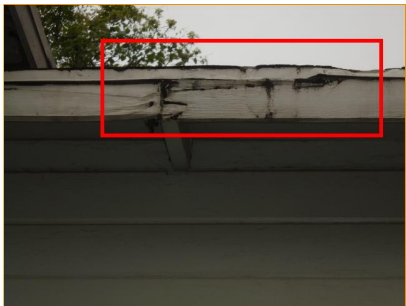
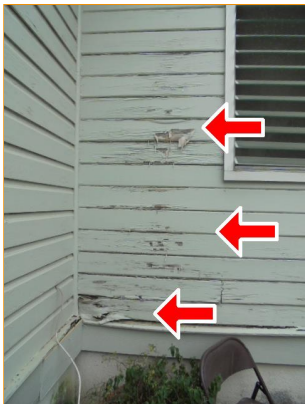
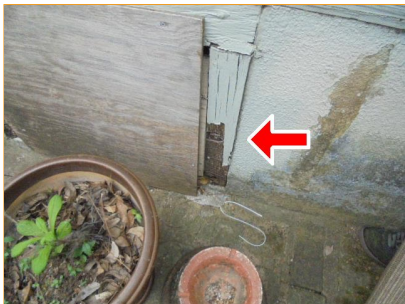
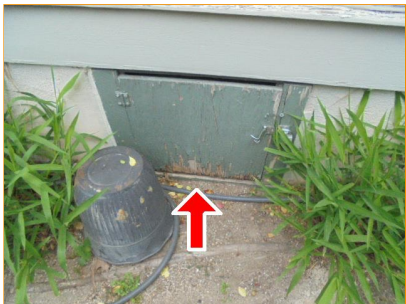
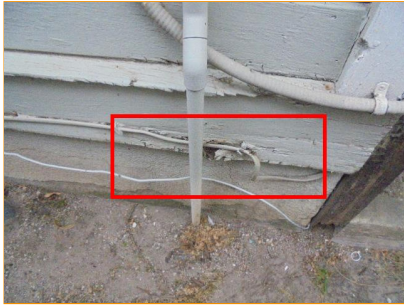
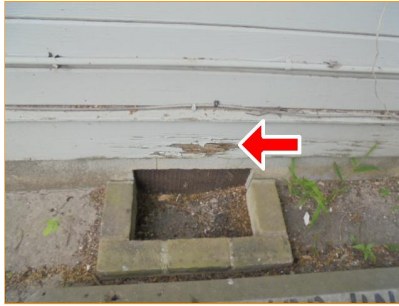
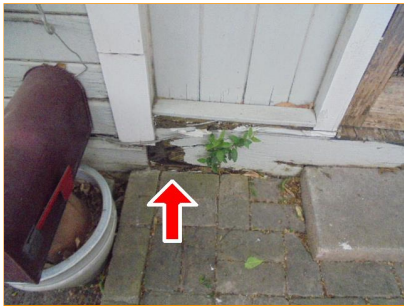
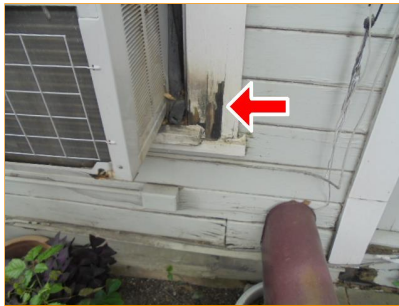
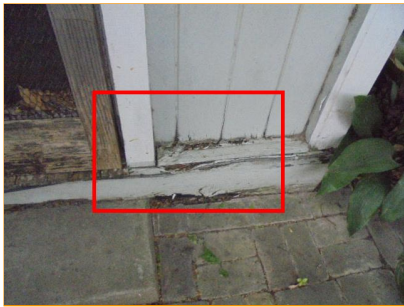
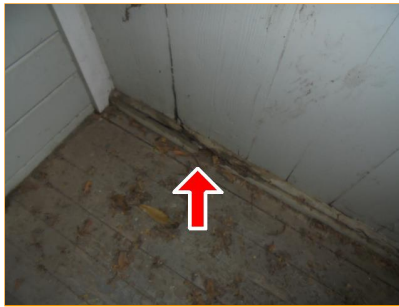
(1) Rot at wood trim and siding in various areas. Included pictures are examples and do not represent all areas needing repair

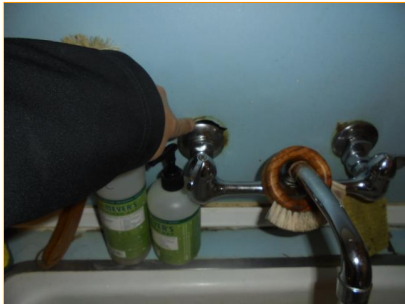
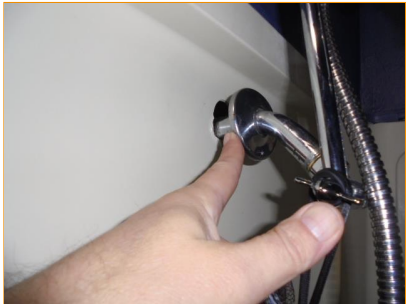
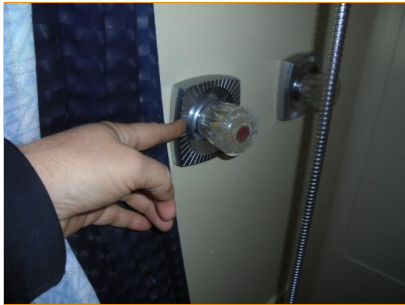
(9) Caulk around all Sink/shower/tub fixtures. It is important to keep all around wet area fixtures well sealed to prevent water damage. Damage can be present behind these areas that is not visible to inspector. The inspector does not perform destructive testing or investigation. Repair as needed.

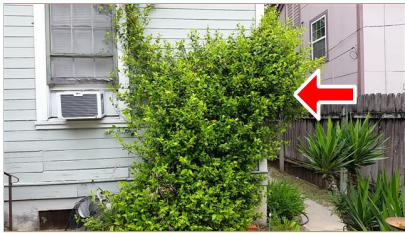
E. Item 18(Picture)

(10) Seal countertop to back splash/wall connections behind and next to various sinks
(11) Remove all foliage growing on exterior walls. Vines/Shrubs can hold moisture on exterior building materials and also promote insect/rodent infestation. Damage may be present behind foliage that is not visible to inspector

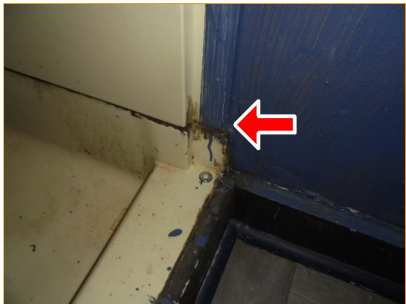
E. Item 24(Picture)

(15) Evidence of leaking around B sink

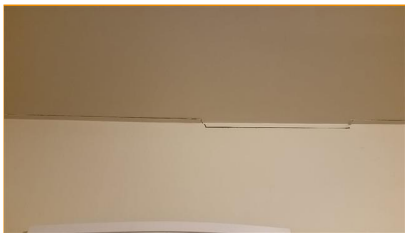
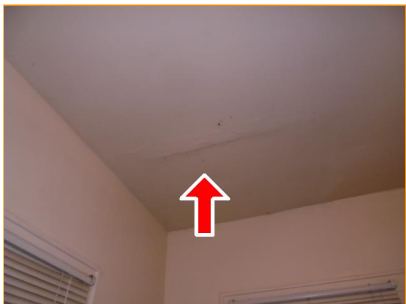
(1) Cracks observed at various ceiling areas. We do not know when the cracks occurred, if they will grown larger or if new cracks will appear in the future.

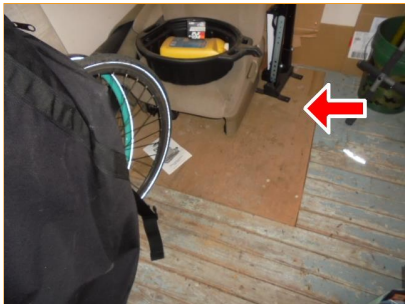
F. Item 3(Picture)

(3) Interior floor are uneven and sloping sue to settlement

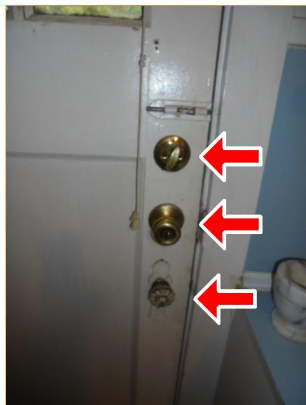
G. Item 1(Picture)

- (1) Missing door stops behind one or more doors, install door stops to prevent wall damage
- (2) Daylight is present around one or more doors to exterior, weather stripping and or adjustment needed. Moisture may enter these areas during wet weather.
- (3) Weather stripping is needed at various doors
- (4) Multiple door knobs at fire egress doors is a fire safety hazard

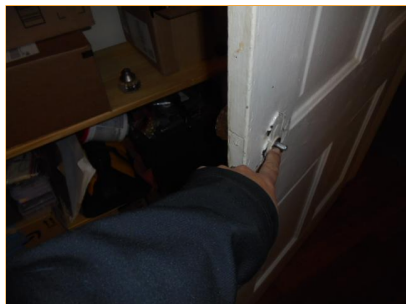
G. Item 2(Picture)

- (5) Door knobs are loose at various doors.
- (6) Doorknobs are missing in various areas

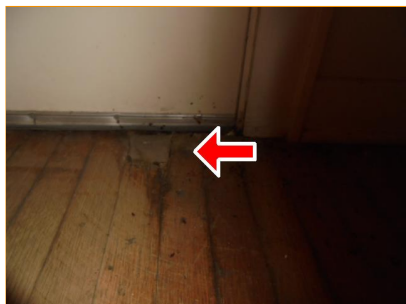
G. Item 3(Picture)

- (7) Some doors were obstructed and could not be opened
- (8) Signs of previous water penetration at rear door. A roof or porch covering is recommended over all doors. Monitor this door in wet weather.

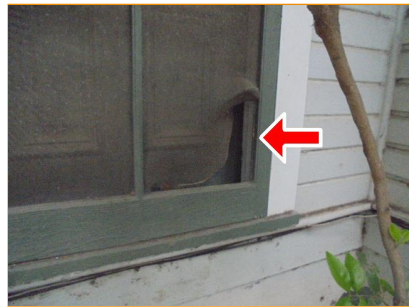
H. Item 1(Picture)

- (1) Some windows are painted shut
- (2) Many windows will not stay in the open position
- (3) Windows in various areas of the home meet the requirements for tempered/safety glass. Some of the code requirements are: In all bathtub/shower areas. In all stairways where windows are not protected from damage. Exposed area of an individual pane is greater than 9 square feet. Bottom edge is less than 18" above the floor. Top edge greater than 36" above the floor. One or more walking surfaces within 36" horizontally of the glazing. Glazing in any part of a building wall enclosing these compartments where the bottom exposed edge of the glazing is less than 60" measured vertically above any standing or walking surface. Recommend installing tempered glass in all required areas
- (4) Missing various window screens
- (5) Some window screens are damaged and need repair or replacement.

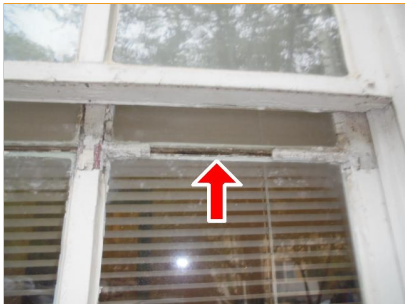
H. Item 2(Picture)

- (6) Missing and/or damaged locks were observed at one or more windows. Repair as needed
- (7) There are cracked glass in some windows throughout home.
- (8) The wood trim is peeling paint at most windows. Further deterioration may occur if not repaired. I recommend a qualified contractor inspect and repair as needed.
- (9) Unable to verify proper flashing over windows installed in siding
- (10) Evidence of previous moisture at various windowsills. Likely due to condensation. Ensure that windows are caulked at exterior perimeters.
- (11) Window glazing is damaged in various areas

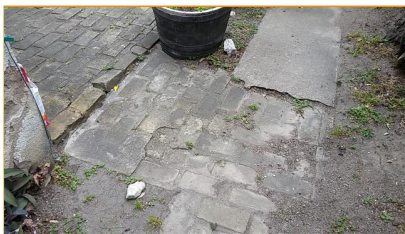
K. Item 1(Picture)

(1) Walk ways around the home or uneven and a tripping hazard

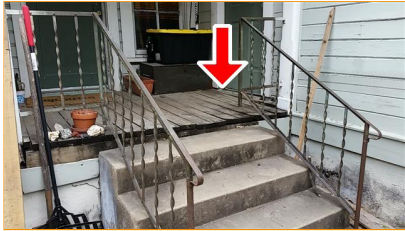
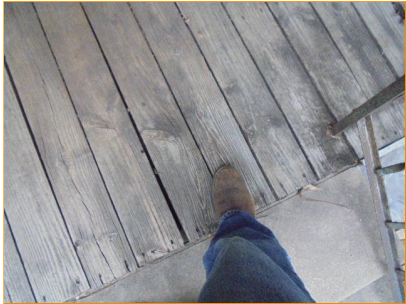
(2) Decking outside unit B is sagging and is loose

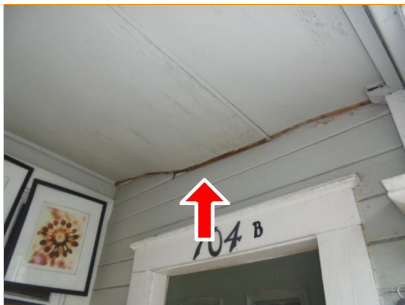
K. Item 4(Picture)

(3) Ceiling material is sagging over unit B entry door

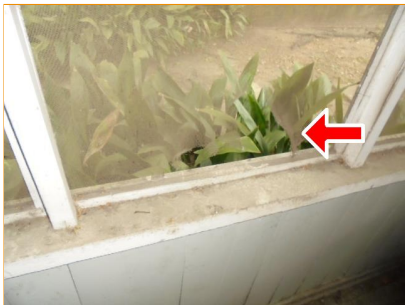
K. Item 5(Picture)

(4) Holes in screen porch screening

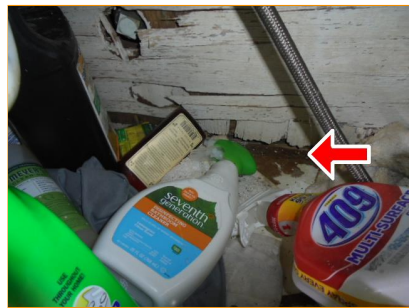
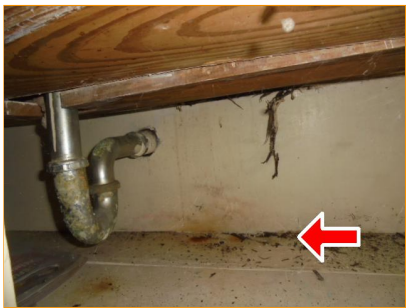
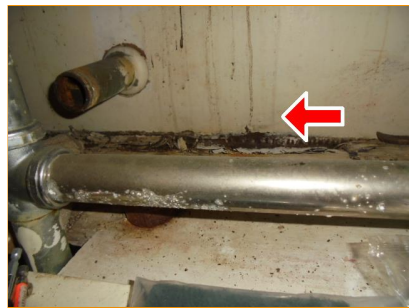
- (1) As contractors complete work requested by the home inspector, there is a possibility that additional work will be found by said professional.
- (2) There is the possibility that conditions may exist which were hidden from view, which could affect some of the conclusions and recommendations in this report. This investigation did not include a detailed analytical study of the structural elements of the superstructure. No guarantee, expressed or implied, is intended by this report and no examination was made to determine compliance with any governmental code or regulation.
- (3) Cabinets and countertops are not inspected. Damage will be reported on at the inspectors discretion. Per the TREC standards cabinets and countertops are not required to be inspected.
- (4) Water staining at cabinet/cabinet decking under one or more sinks. No active leaks at the time of

inspection. Replace all damaged building materials as needed. Damage can be hidden from view. Some damage may be present that is not visible to inspector.

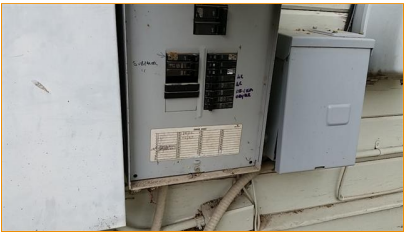
A. Item 1(Picture)

- (1) Unable to locate gas line bond wire per todays code standards. Current code requires all exterior meters and interior unions to be bonded. This may have not been code when this home was built
- (2) Label all breakers
- (3) Ancillary wiring items not inspected include but are not limited to: telephone, cable, speaker, computer, photocells, low voltage, hard wiring on smoke detectors, electric gates and doors, yard and tree lighting. Intercom systems are not inspected.
- (4) No ARC fault protection present. Current safety standards require arc fault protection (AFCI) devices for electrical receptacles in family rooms, dining rooms, living rooms, parlors, libraries, dens, bedrooms, sun rooms, recreations rooms, closets, hallways, or similar rooms or areas. This was not code when this home was built
- (5) Missing one or more knock out plates at sub and/or main electrical panel(s)

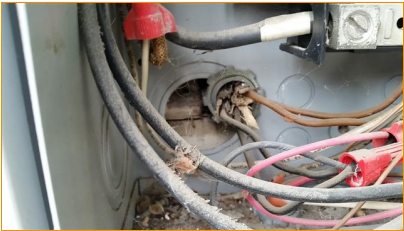
A. Item 2(Picture)

(6) Wire retention is the wrong size for panel opening

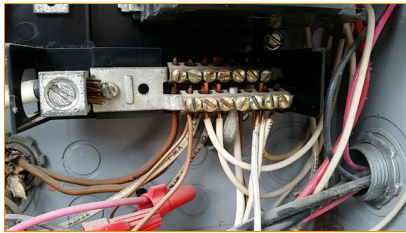
A. Item 3(Picture)

(7) One or more of the ground and neutral conductors are attached together (double lugged) under the same lug improperly. This is an outdated industry practice and all neutral conductors within the panel should be properly isolated from the ground conductor according to present industry practices. We recommend repair with remedy as necessary by a qualified electrician.

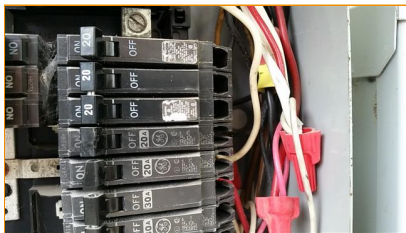
A. Item 4(Picture)

(8) Wiring is bundled in electrical panel. While this is common practice it is not allowed by todays electrical code.

(9) I did not see a bond/ground wire on metal plumbing. If there is not one then I recommend a ground wire and clamp be installed on metal plumbing line within five feet from where plumbing line enters home.

(10) Neutral wiring being used in the hot position should be wrapped in red or black tape

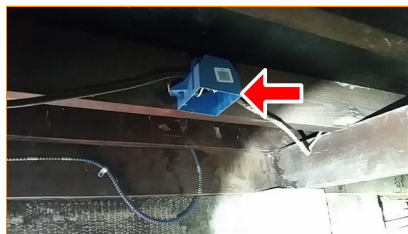
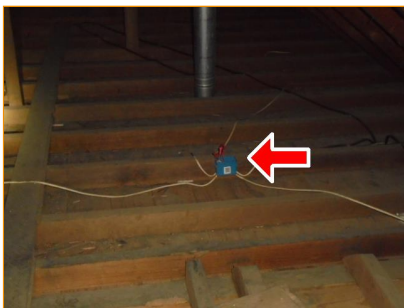
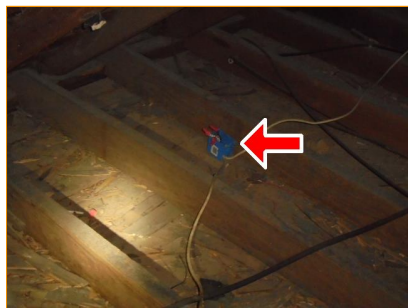
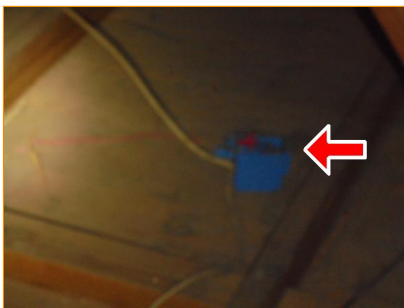
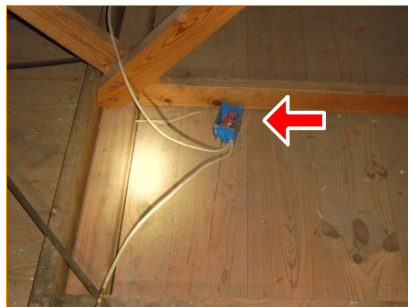
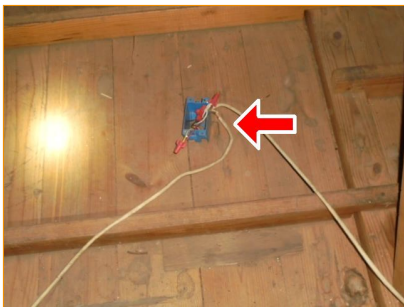
- (a) Replace the 2-wire receptacle with another 2-wire receptacle.
- (b) Replace the 2-wire receptacle with a GFCI-type receptacle and marked the receptacle with the words "No Equipment Ground."
- (c) Replace the 2-wire receptacle with a grounding-type receptacle where protected by a GFCI protection device (circuit breaker or receptacle). Since the grounding terminals for the receptacles are not grounded, the receptacles must be marked with the words "GFCI Protected" and "No Equipment Ground."
- (4) Missing covers at junction boxes in attic and crawl space

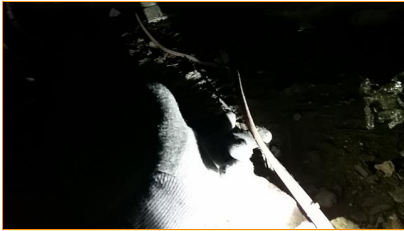
B. Item 7(Picture)

- (5) Secure all wiring away from grade in crawl space

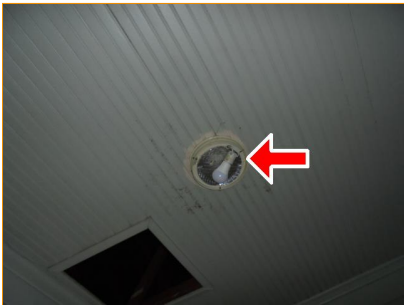
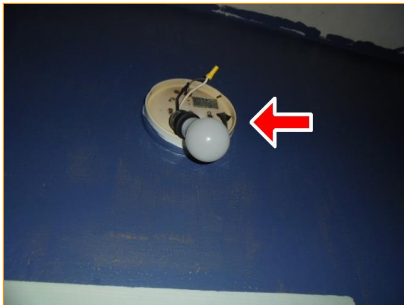
- (11) Missing bulb shields at various lights. Bulb shields recommended at all exposed bulbs

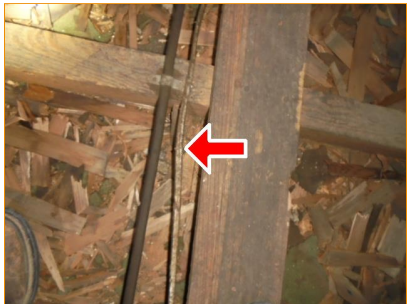
B. Item 11(Picture)

- (13) Cloth covered wiring is still in place and possibly in use in some areas of the home. Recommend having a licensed electrician evaluate and update all wiring to meet todays code and safety standards

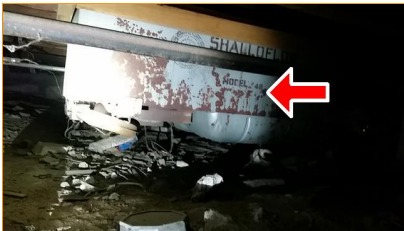
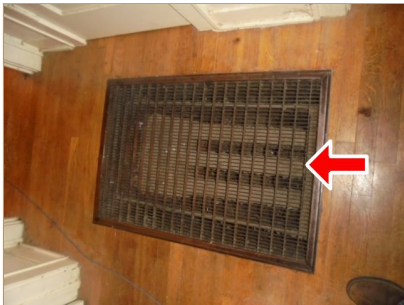
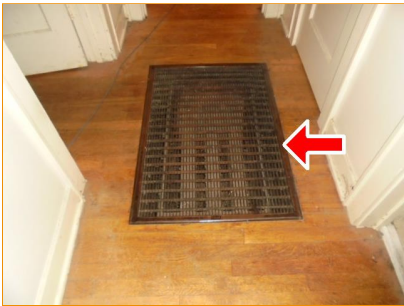
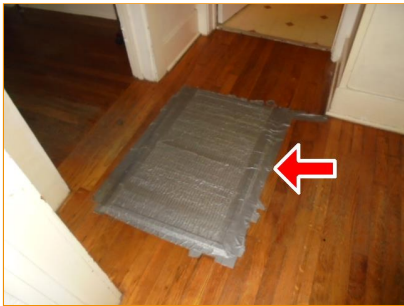
(1) Remove abandoned floor furnaces from crawl space and units

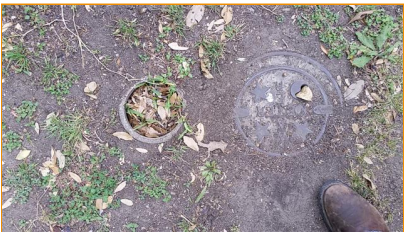
A. Item 1(Picture)

- Comments:**
- (1) Water leaks at one or more toilet fill valves, replace flushing assemblies where needed
 - (2) Insulate all water lines in crawlspace to prevent freezing
 - (3) Owners water shut off valve was not visible due to debris

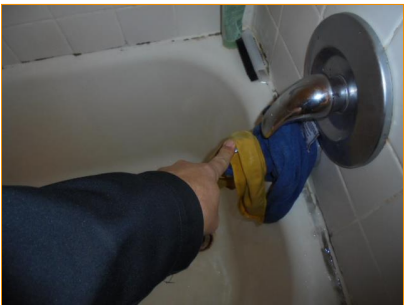
A. Item 2(Picture)

- (4) I could not locate the owners shut-off for water. Please ask the current owners for the location. Otherwise, you will need to use a water key at the street meter or have a plumber install an owners shut off valve.
- (5) Missing backflow prevention devices at one or more exterior water hose bibbs
- (6) Water leaks at various sink faucet, shower head and shower and sink fixture handles. Repairs are needed to stop leaking water from damaging the cabinet bottom or to eliminate moisture that may contribute to fungi growth. I recommend repair as necessary by a qualified person.
- (7) One or more toilets do not appear to have proper clearance from walls or other hard surfaces, Plumbing code calls for 15" from the center of the toilet to the nearest wall or hard surface
- (8) Unit A shower diverter is stuck in the on position

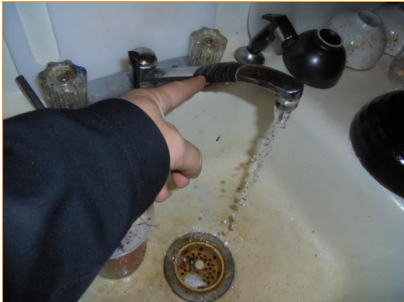
A. Item 3(Picture)

- (9) Clean aerator screening at various sink faucets
- (10) Unit C kitchen faucet is damaged and leaks

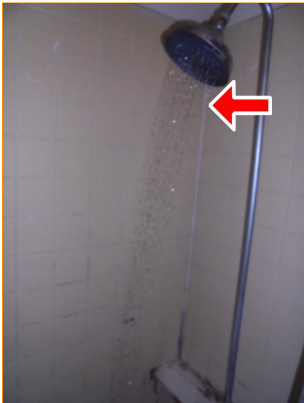
A. Item 4(Picture)

- (11) Handles are loose at various sinks and tub/showers
- (12) Low water flow observed at various fixtures

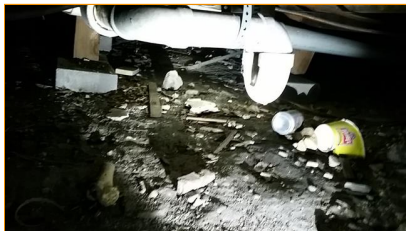
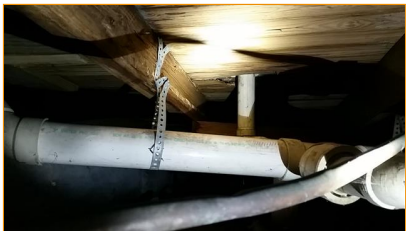
(1) Evidence of leaking under all bathroom areas

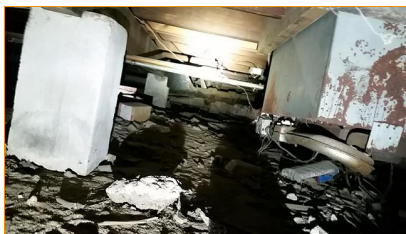
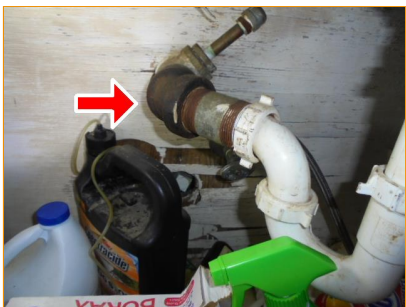
(2) Cast iron and galvanized drain lines are still in use some areas of the crawlspace and under various sinks. These lines can rust from the inside out and should be replaced.

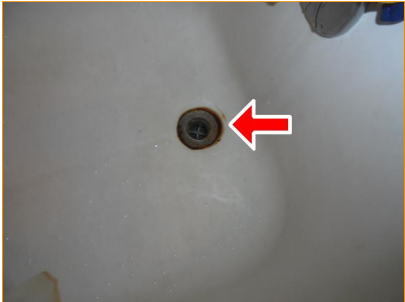
B. Item 5(Picture)

(5) B bathroom sink was slow to drain

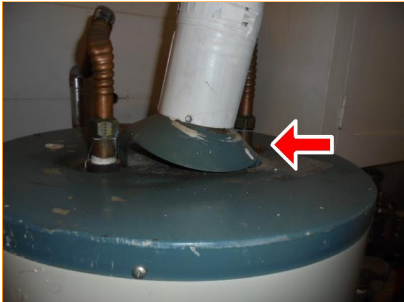
C. Item 2(Picture)

- (5) Water heaters should be elevated 18" above closet floor
- (6) Churning sound present at water heaters. This sound typically indicates excess sediment in tank. Recommend plumbers evaluation
- (7) The water heaters are older and may have reached the end of their life expectancy. Have a licensed plumber evaluate
- (8) Rear unit water heater vent is disconnected in attic
- (9) Front water heater vent is not properly positioned

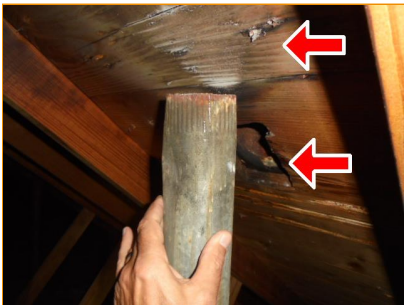
C. Item 3(Picture)

- (10) Water heaters should be isolated from the living space. Combustion and draft air should not be drawn from the the living space. Having the gas appliances in the living space is a carbon monoxide hazard
- (11) Unit B water heater vent is not connected to roof vent and is exhausting on to roof decking. Fire hazard

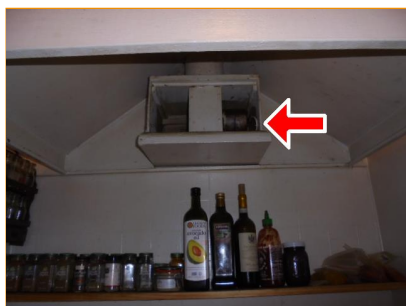
C. Item 1(Picture)

Unit A stove top vent does not work and is disconnected in the attic area
