PHASE IA PRELIMINARY HISTORIC STRUCTURES REPORT  
FOR THE OLLIE AND CALIE NORWOOD HOUSE

Ruth Parshall, AIA  
Parshall + Associates Architects

submitted for review May 3, 1995

PRELIMINARY HISTORIC STRUCTURE REPORT  
for the NORWOOD ESTATE

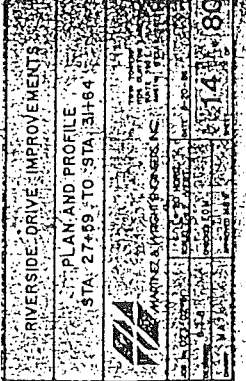
SHOWS ORIGINAL ROADWAY AND STREET ALIGNMENTS. SHOWS THE LOCATION OF THE CAPPED ARTISIAN WELL THAT THE NORWOODS HAD DRILLED FOR FILLING THEIR SWIMMING POOL. SHOWS PECAN TREE LOCATIONS.

Provided courtesy of Martinez and Wright Engineers, Inc. Drawn in 1986.

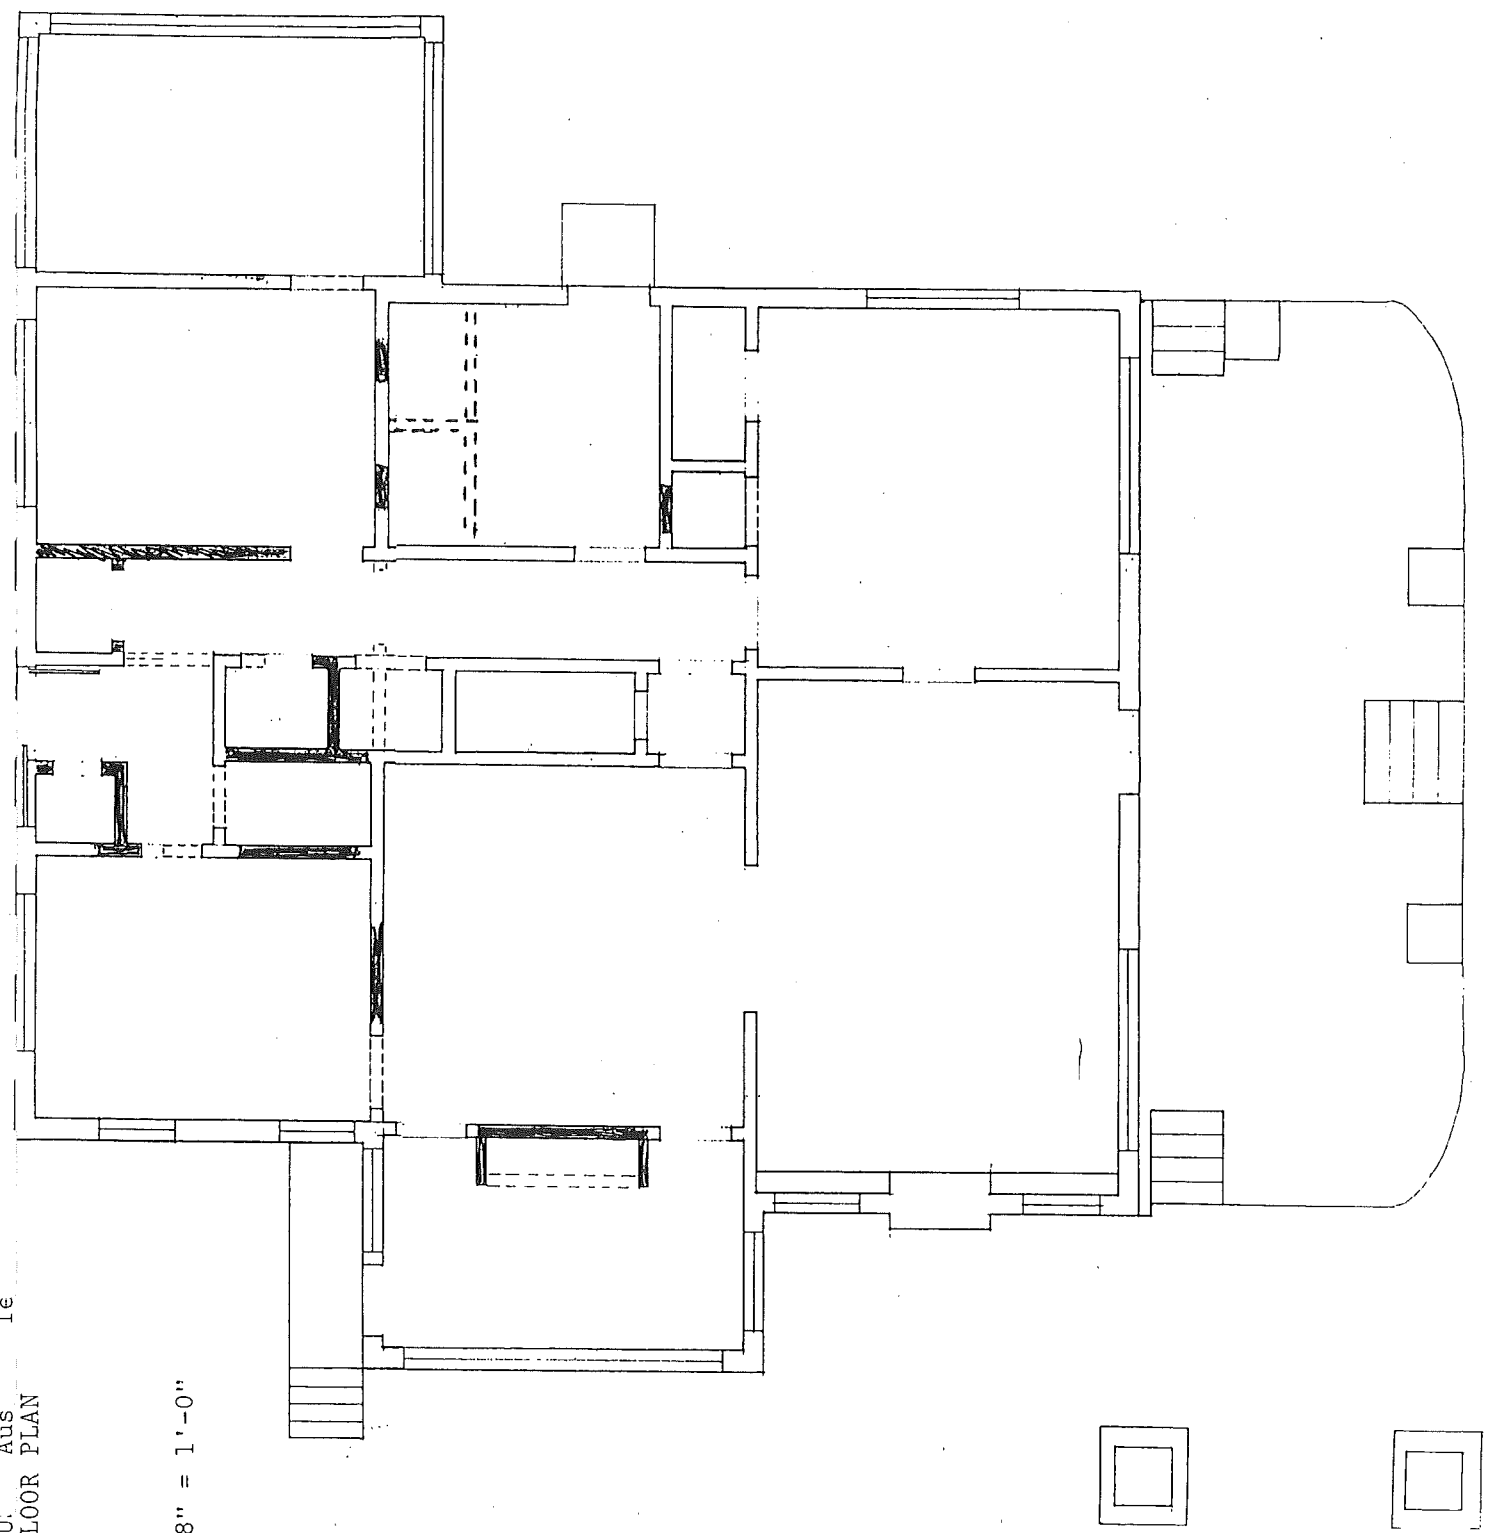
1 00D SE, titir  
 "original" floor plan  
 as described by Mrs.  
 Jean Porter

The original bathroom, now delineated only by the plywood flooring has no remaining features. What was once a window is now an exterior door. Mrs. Porter described the floor as 1" white hexagonal ceramic tile and the walls as 1" white square ceramic tile. She also described a bathroom closet and the plumbing fixture locations shown on the sketch of her recollections.

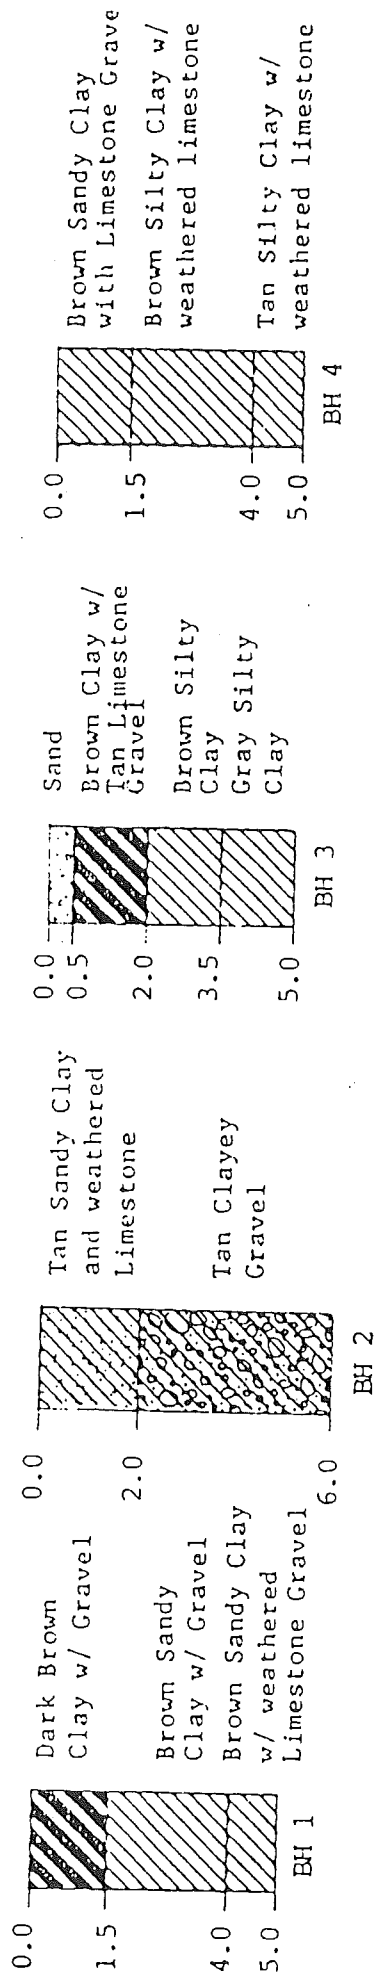
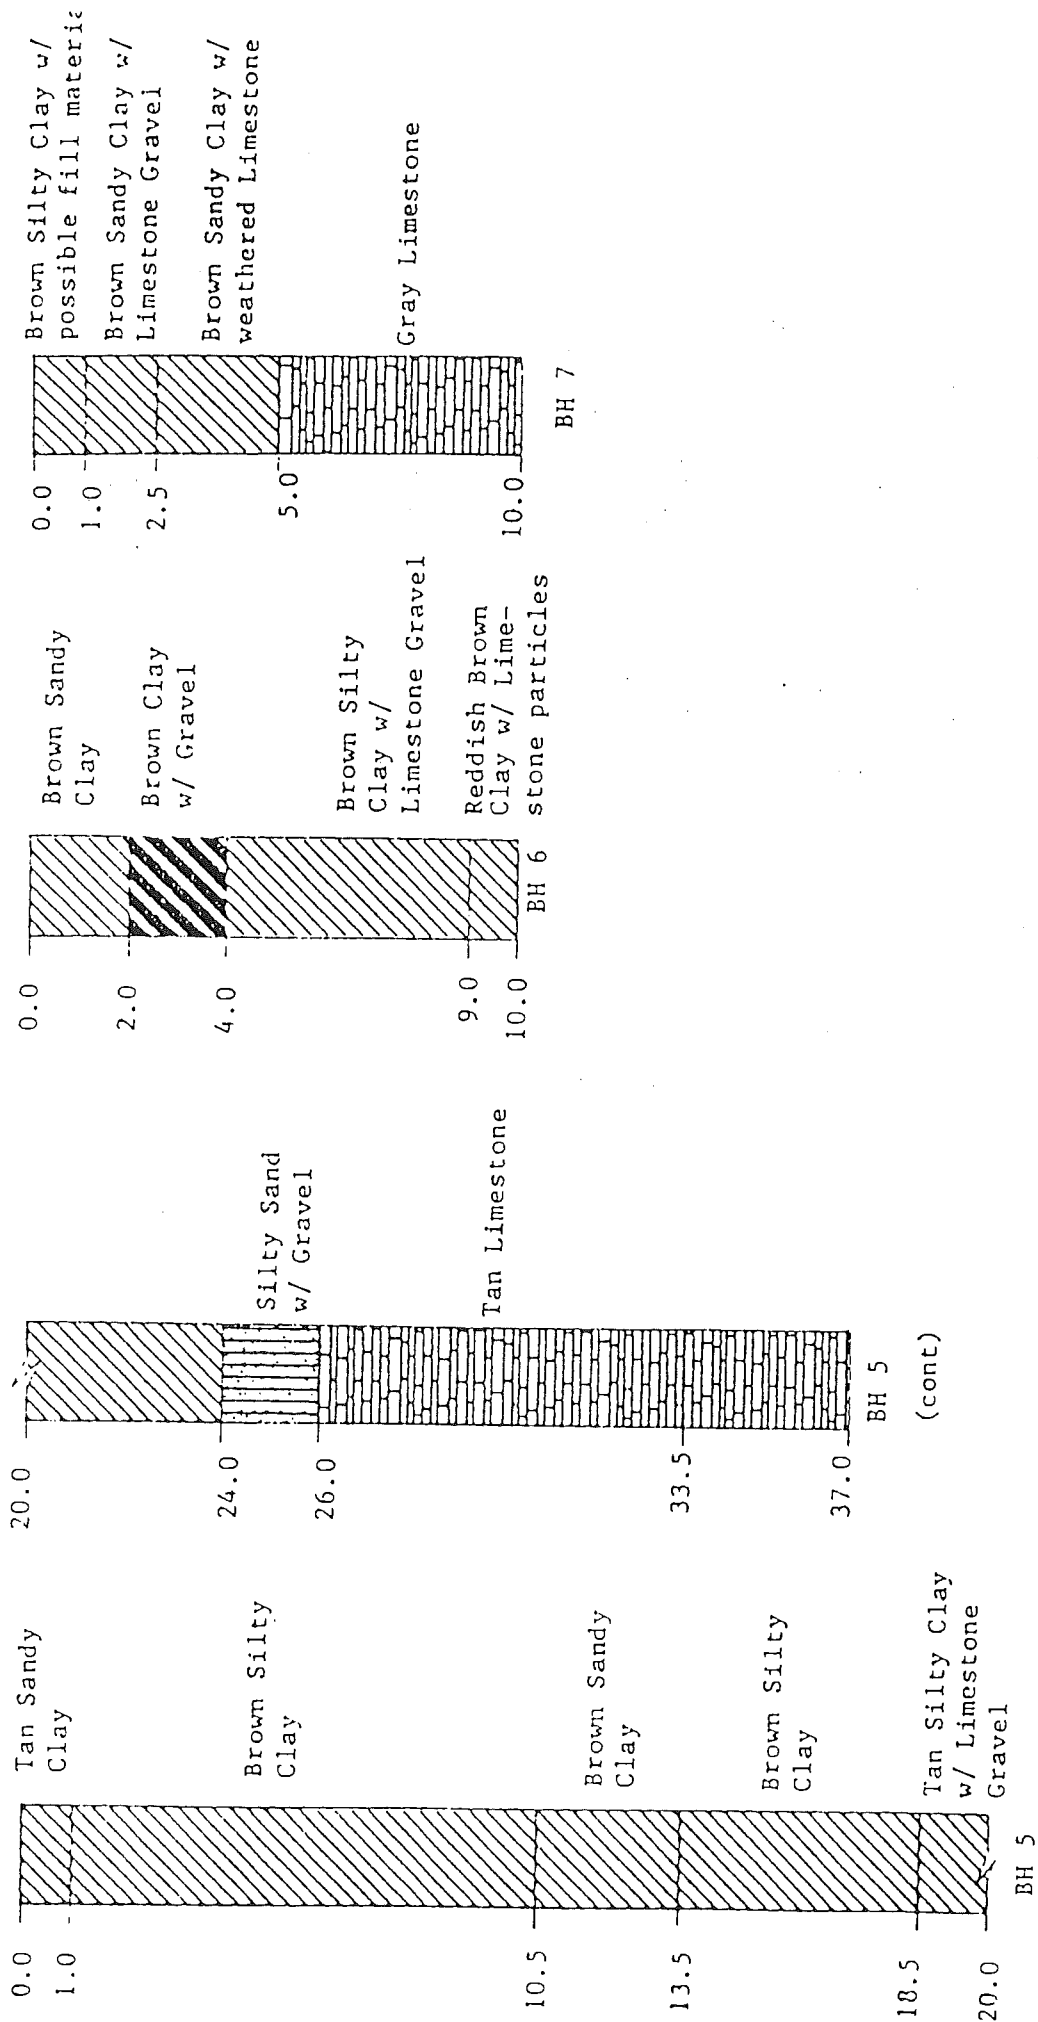
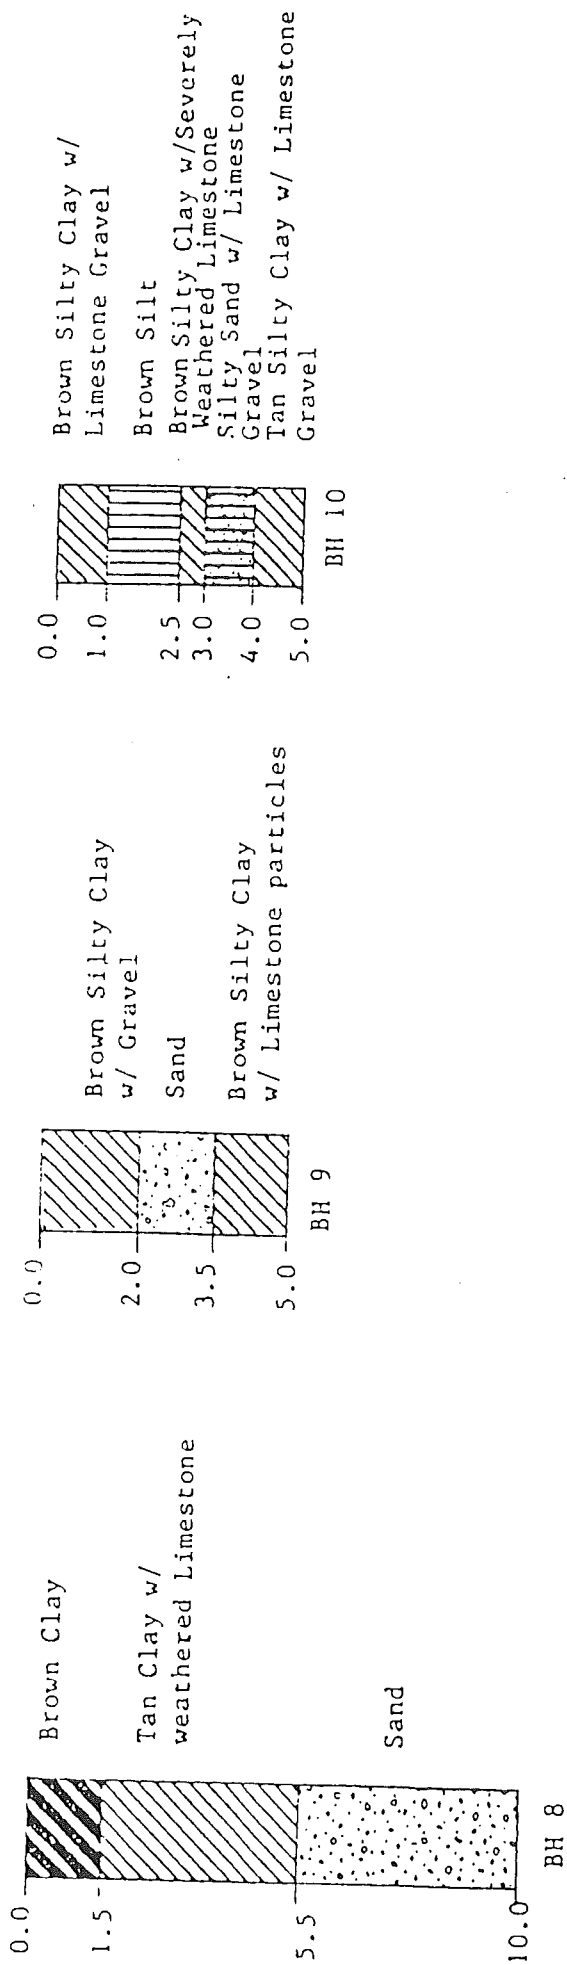
Figure 2. Log of borings  
Riverside Drive Improvements

The primary boring strategy was to advance the holes by pushing thin-wall tubes, taking undisturbed samples of the soils. The undisturbed soil samples were identified according to boring number and depth, and encased in polyethylene plastic to prevent moisture changes. Where limestone was encountered, the depth was logged and the hole advanced with a rock bit to the depth planned. Where gravel precluded undisturbed sampling, disturbed samples were taken and placed in plastic bags. All samples were then placed in core boxes and transported to the laboratory for testing and further study. Interpretations of the subsurface conditions are shown on Figure 2, Log of Borings. (The symbols used on the log are described in Appendix C.)

The surficial soils at this site generally consist of brown sandy or silty clays. These surficial brown clays usually ranged from 1 to 2 feet in depth and were underlain mostly by a variety of tan and gray silty clays. Virtually all of the clays contained limestone particles and/or limestone gravel.

Groundwater was not encountered in any of the bore holes at the time drilling was completed.

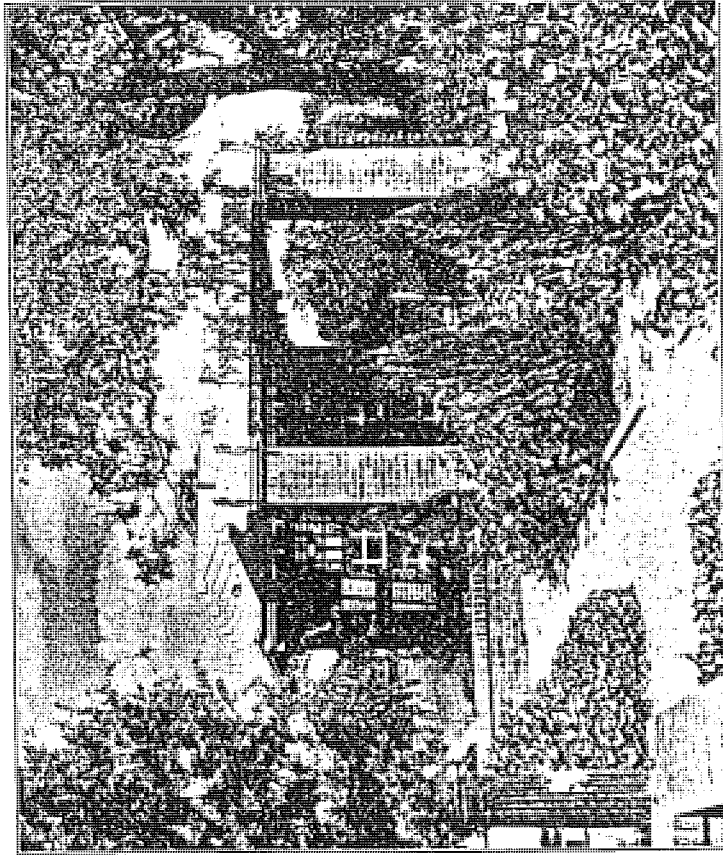
The formal flower garden with a glimpse of the river below.  
This flower garden is one of the most beautiful in town, with its Japanese tea house, beds of gorgeous flowers, conservatory, sun dial, gazing globe, and fountain. The Norwood home is one of Austin's show places.
