Austin 10/26/2020

Re: Existing Residential Foundation and Superstructure Assessment

808 Avondale Rd, Austin, TX 78704

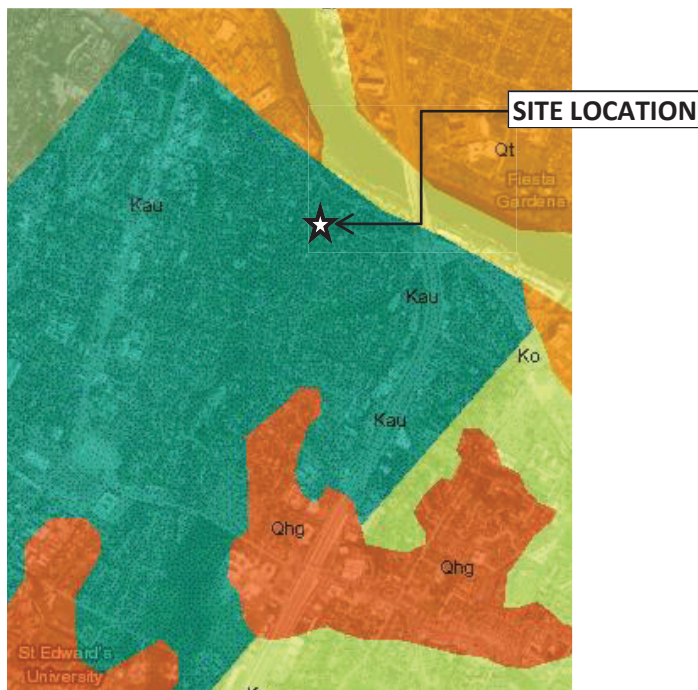
The site is located in Austin, Travis County, Texas. The geologic map (Geologic Atlas of Texas, Austin Sheet, Texas, Bureau of Economic Geology, The University of Texas at Austin, 1981) shows the proposed site located in the *Austin Chalk (Kau) Formation*. The Austin Chalk consists of beds of impure chalky limestone, containing 85 percent or more of calcium carbonate, interstratified with beds of softer marl. It is usually of an earthy texture, free from grit, and on fresh exposure softer, so that it can be cut with a handsaw, but on exposure more indurated. A partial geologic map of the location is shown on Figure 1. According

Figure 1. Site Geology. Source: Geologic Map of Texas, Austin Sheet, Bureau of Economic Geology, The University of Texas at Austin (Reprinted 1981).

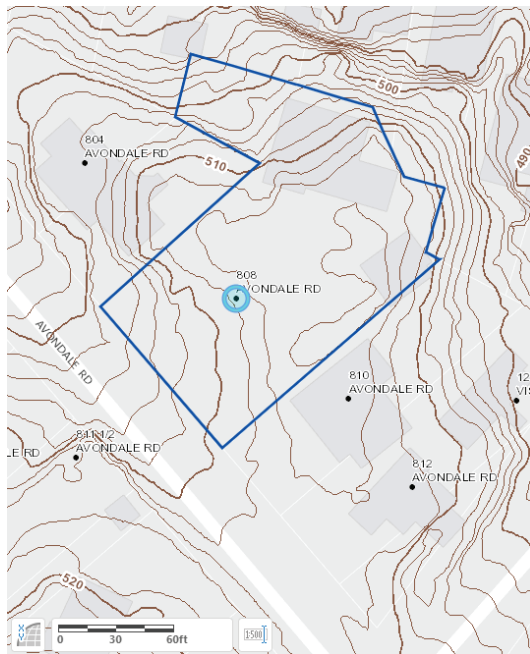
Preliminary geotechnical investigation by SEC Solutions confirms the information above. Two geotechnical borings show 2ft to 4ft of Lean Clay (CL) overlaying limestone bedrock, Kau (Austin Formation). The site also presents high topography, Figure 2.

Figure 2. Site Topographic Map (Source: COA Property Profile). Contour lines: 2ft (light) 10ft (heavy).

The high topography of the building site indicates that the original foundation and subsequent additions were likely constructed over non-engineered fill at the time. Foundations constructed over non-engineered fill will experience excessive settlement due to fill consolidation over time. Interior and exterior walls are made of conventional wood framing elements. Numerous signs of foundation movement were identified during visual inspection.

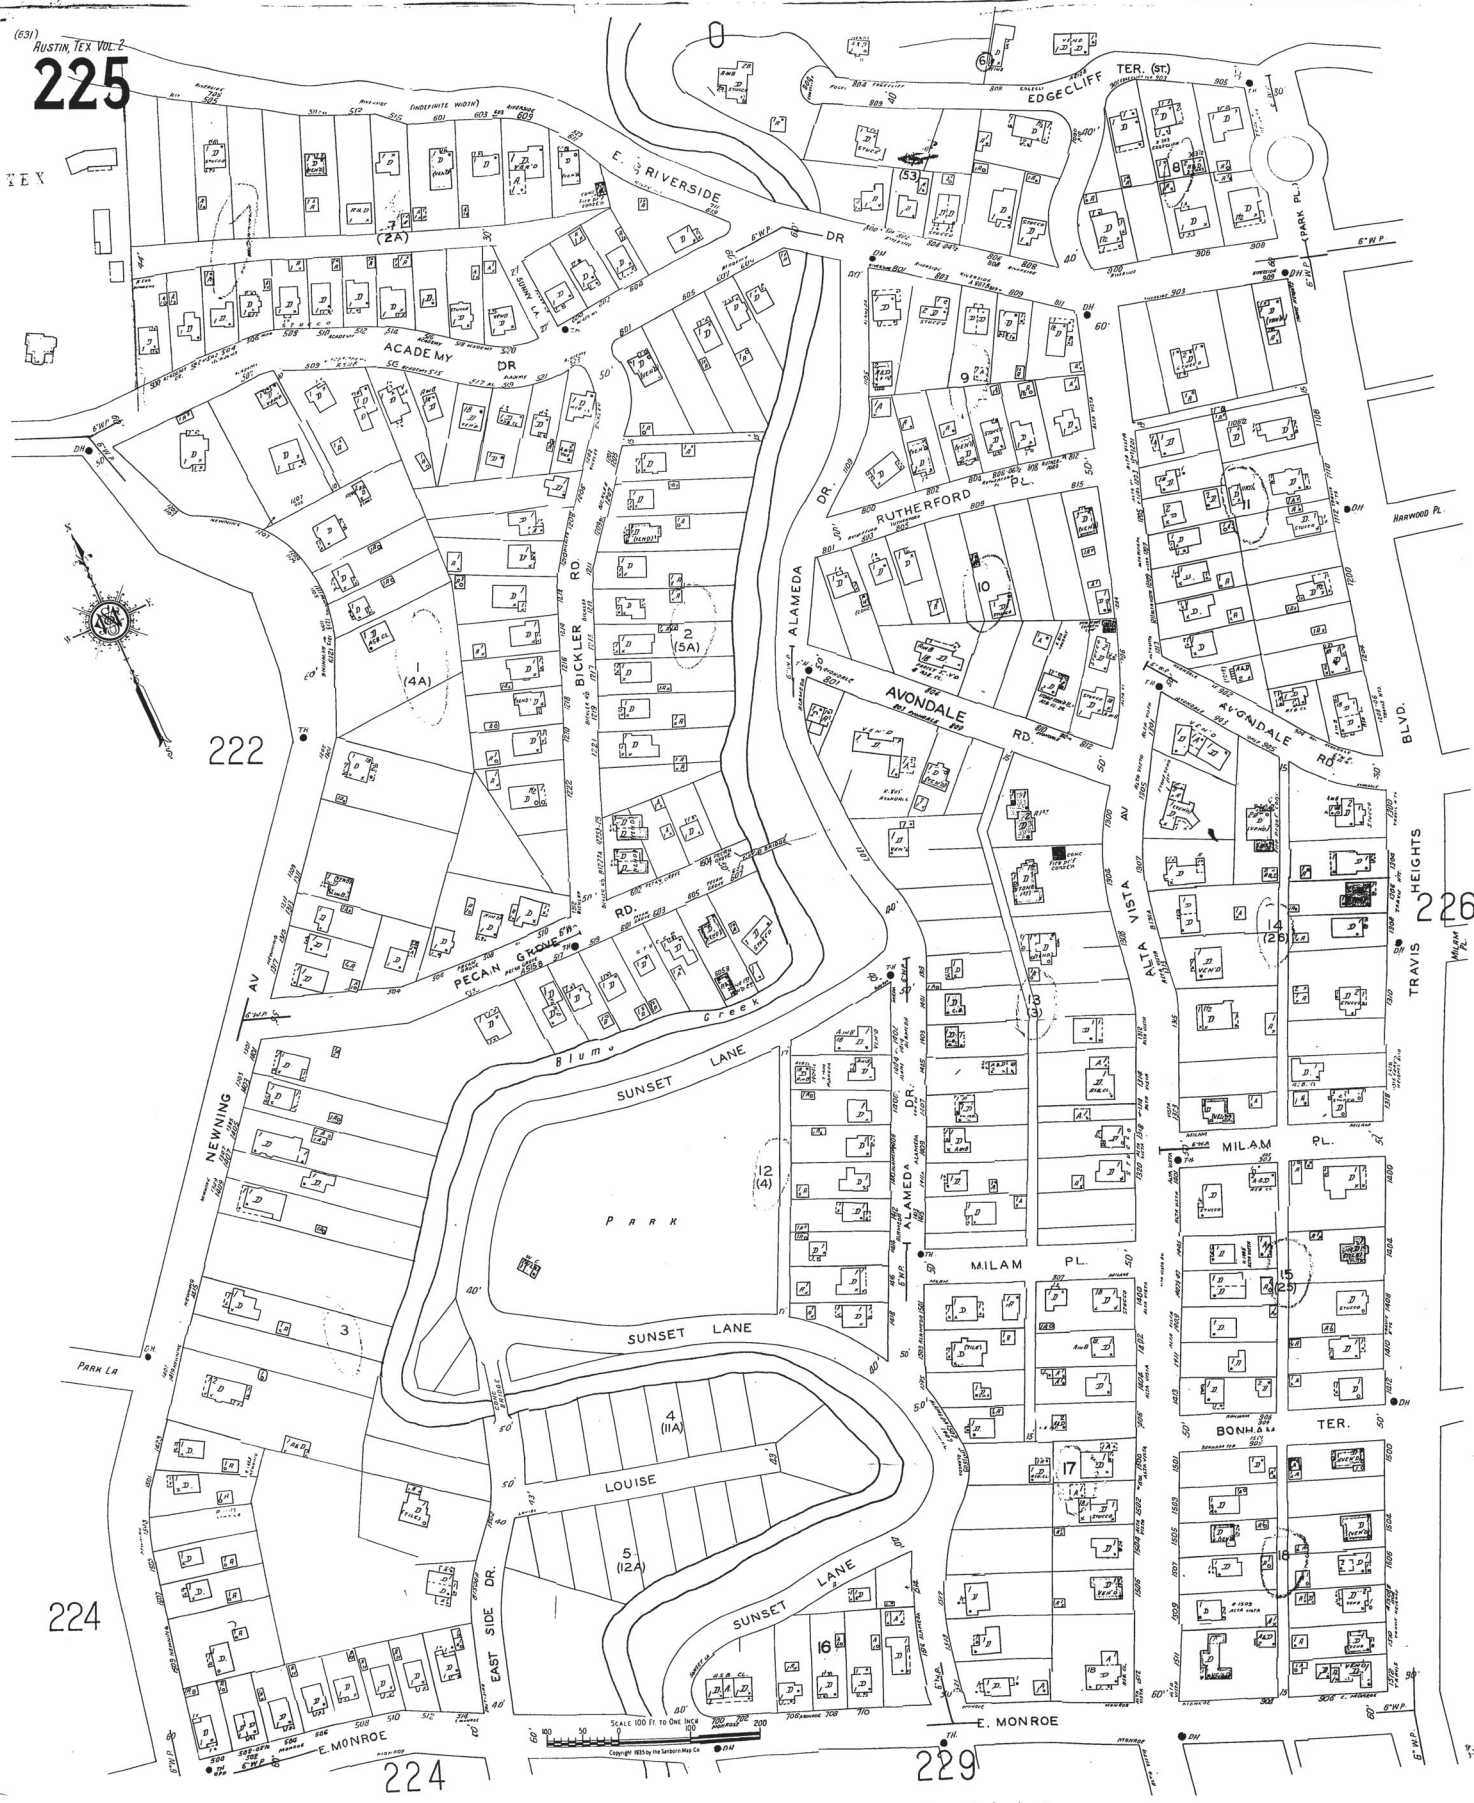
SURVEY MAP OF

The east lot lines of Lot 12, Amended Plat of Lots 3, 4, 5, 12, and 13, Block 2, Travis Heights do not appear to be in accordance with the best evidence as to the location of the record east lot lines of Lots 3 and 13, Block 2, Travis Heights. There also appear to be discrepancies of these east lines with the occupied and monumented west lines of Lots 2 and 14 of said Block 2, Travis Heights. Perhaps there are areas of excess or deficiency in the original lots in the east portion of this block which might explain these discrepancies. Without found, reliable original monumentation for the lots in this portion of the block, this issue cannot be solved definitively. This survey shows the property lines of Lot 12 as established by the plat recorded in Volume 86, Page 68B. For the reasons cited above, the location of the east property line of the subject lot may be open to other, possibly adverse interpretation. It may be desirable to seek legal remedy, such as boundary line agreements, to settle these various areas of possible conflicting claims of ownership.
