BPG Inspection, LLC

**2816 San Pedro Street
Austin TX 78705**

Client(s): Joseph
Inspection Date: 9/15/2020
Inspector: Randal Pitts , 9911

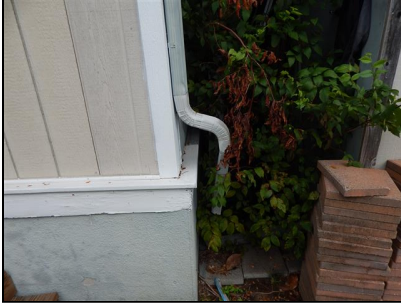
☒ The gutters are damaged, rusted and deteriorated in various areas. Several downspouts are detached. The gutter system will require replacing. Consult with a qualified contractor for repairs.

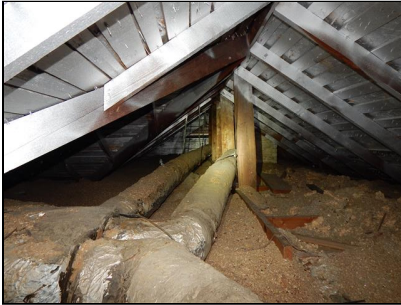
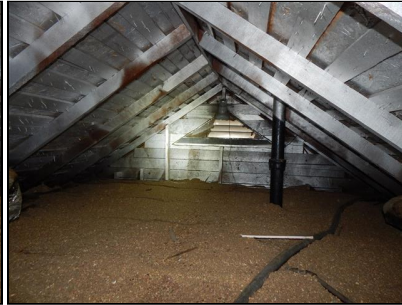
☒ There was evidence of leaks in areas of the attic (flue pipe penetrations, chimney, valleys etc.). Some areas of the deck may require repair. Replacement of flashings, jackboots or possibly parts of the covering at these areas may be necessary to ensure it is leak free. A roofer should further evaluate roof covering, deck and exterior flashing systems for need of repair or replacement.

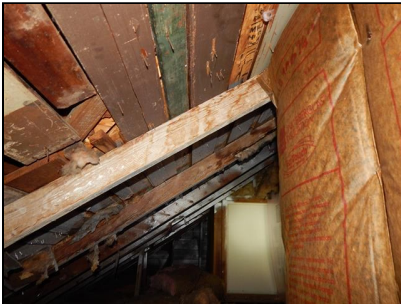
☒ Gable vent pest prevention screens are damaged and need to be replaced. Note: There are indications of past pest activity in the attic (compacted insulation, mouse droppings, birds nest).

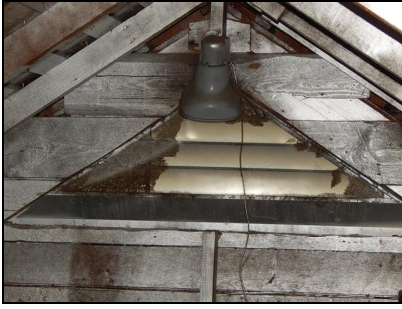
☒ Older structures typically do not have modern standard lateral, vertical or required dimensional lumber as would be found in newer houses. This can include undersized ridge beams, lack of purlin and/or king post supports (vertical). This structure does exhibit some of these older style construction. This structure had undersized and improperly off-set rafters attached the an undersized ridge beam. There was visible deflection of the beams most notably at the valley. Contract a structural contractor or engineer to evaluate for additional support and/or bracing recommendations.

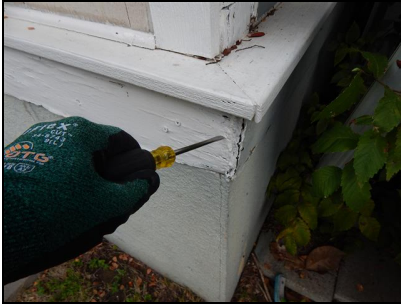
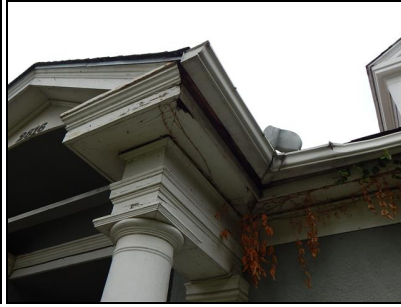
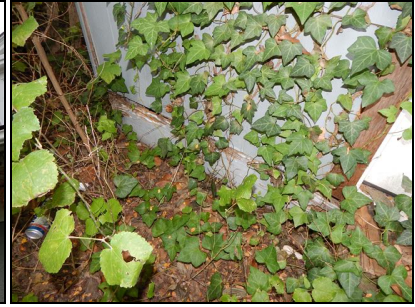
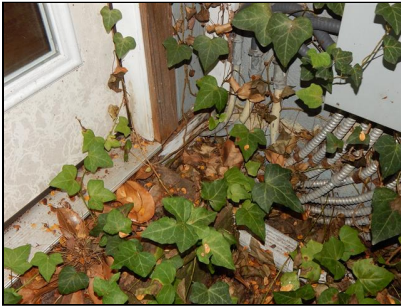
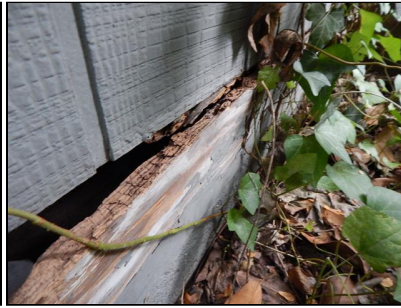
☒ Stucco finish does not have proper visible expansion joints around dissimilar materials. (i.e. - window frames, eaves, and door frames.) Cracks and water penetration may occur in these locations. Have these areas serviced and sealed with high quality exterior sealant as cracks present themselves.

☒ Areas of the stucco walls were found where the installations did not meet the installation criteria of the Portland Cement/Plaster/Stucco Resource Guide, as used by members of The Texas Lathe and Plastering Contractors Association. These guidelines generally require stucco wall terminations to have approximately two inches minimum when terminating adjacent to concrete, brick, or other "hard" materials, and at least four inches when terminating adjacent to soil.

☒ Stucco cracks were observed. These will allow water to penetrate into the interior walls. A qualified stucco contractor should further review the siding installation for repairs or replacement.

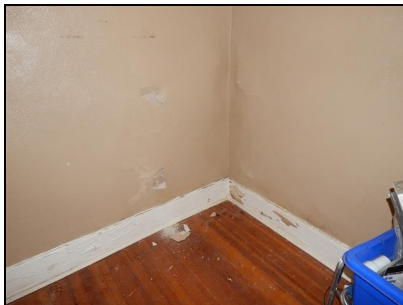
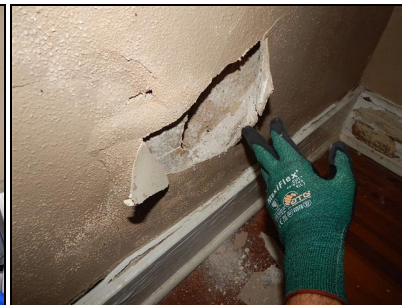
The interior plaster walls are failing in the front right living room. This appears to be from water penetration at the front right exterior corner.

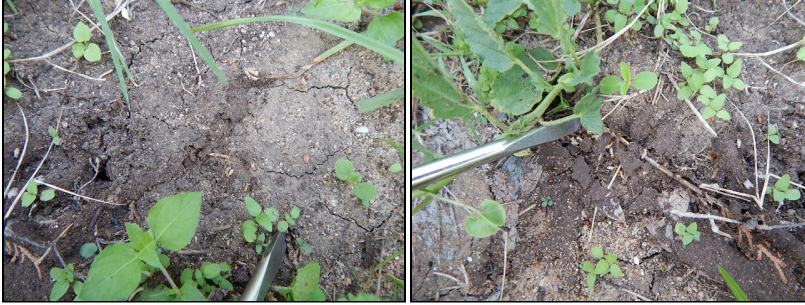
There is an active wood destroying insect infestation throughout the front yard. Pest control is needed.

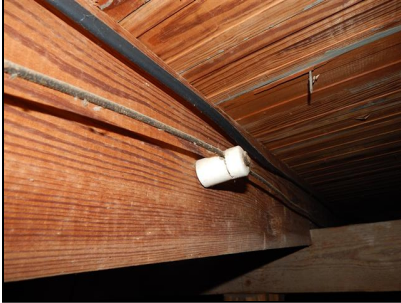
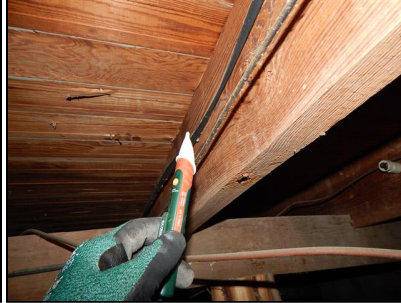
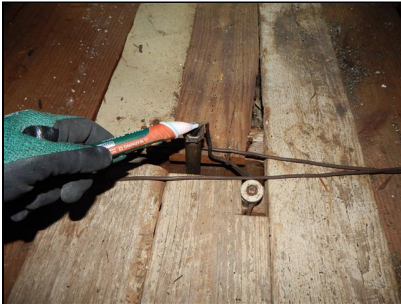
☒ There was original knob and tube electrical system employed throughout the house. This type distribution system has not been employed for several decades as it was a known source for igniting insulation and sometimes structural components. The conductors were also in traffic areas where personnel could come into contact with it, resulting in injury. For that reason we recommend you contract a licensed electrician to remove or disable the system and install modern day non-metallic sheathed conductor distribution system before taking occupancy. Obtain a proposal for this service as it will be expensive.

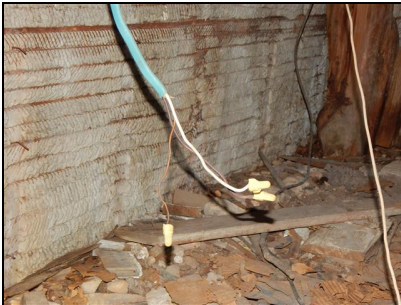
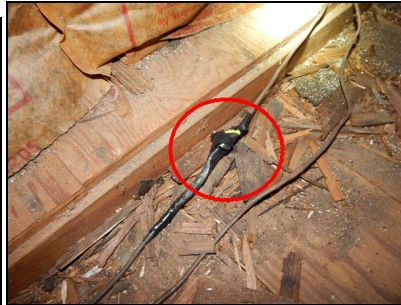
☒ There were exposed connections, open boxes observed in the attic, downstairs closets and in the crawlspace. Secure, enclose in rated enclosures to prevent hazards.

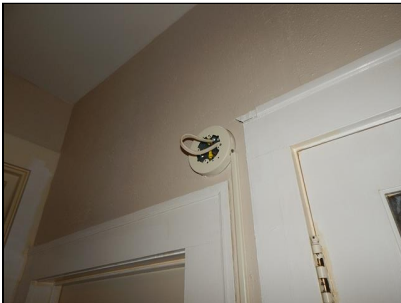
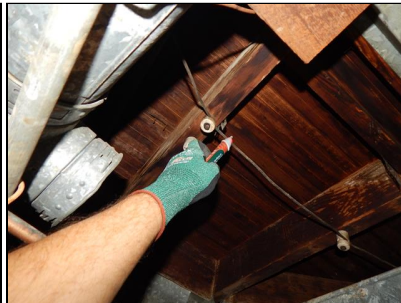
Spliced knob and tube wiring.

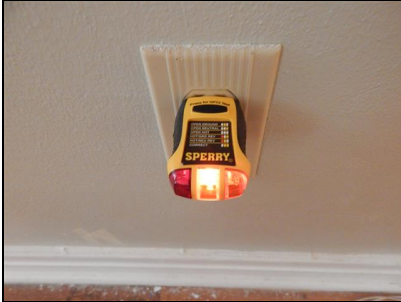
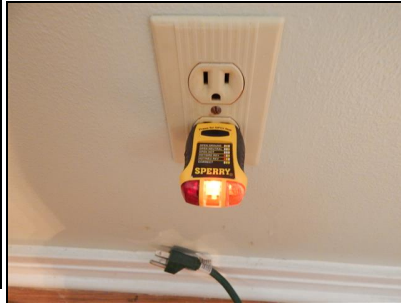
☒ The house is wired with original 2-wire non-grounded branch circuits. Three prong outlets identified, as having an "open ground" are modern three slotted receptacles attached to an older two-wire system. This creates the appearance of a grounded outlet without providing the safety of a ground wire. Correction is to

Upstairs ungrounded throughout.

eliminate the deception by installing two slotted type receptacles, providing a ground wire or providing properly installed GFCI protection in the circuit. Grounding is most important at locations near water or where appliances with ground pin plugs are likely to be used. All construction after 1965 required three slotted grounded outlets. The two slotted outlets noted at this property are, therefore, functional but not technically correct. The best solution is to update the electrical system with two-wire ground conductors, with grounded three prong outlets. I recommend you contract a licensed electrician for estimates on upgrading the system.

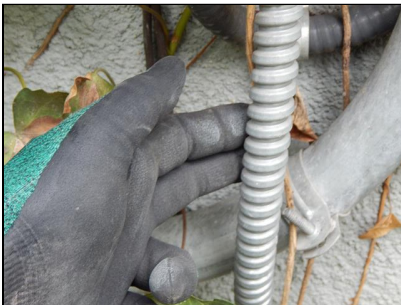
- ✘ There are no GFCI (Ground Fault Circuit Interrupt) protected outlets in locations called for by today's standards: all kitchen, baths, non dedicated garage below 6', laundry, exterior outlets, under kitchen sink/appliance, attic/crawlspace,. I recommend updating to current standards.
- ✘ Smoke alarms are not in all required locations (sleeping and adjoining common areas, interconnected, hard wired, battery back up). Recommend updating to current standards.
- ✘ There was no carbon monoxide detector observed. It is recommended that one be installed according to the manufacturer's instructions.
- ✘ There is conduit that is not weather rated being used at the exterior. Replace as needed.

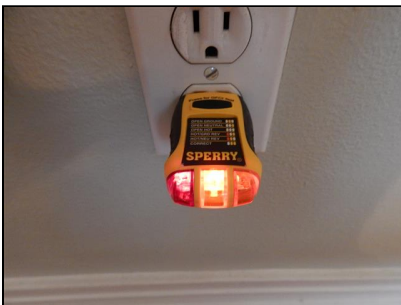
- ✘ There was a circuit with reversed polarity (hot neutral reversed) observed in the upstairs living room. The cause should be diagnosed and repaired by a licensed electrician.

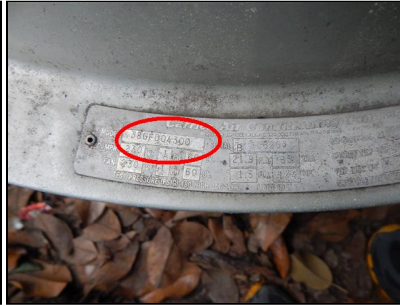
30K Btu, 2.5 ton system.

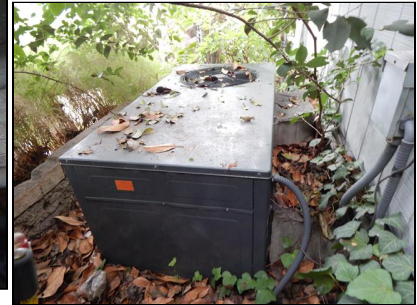
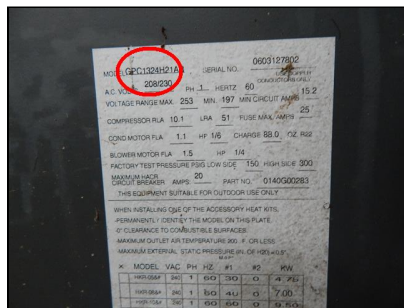
43K Btu, 3.5 ton system.

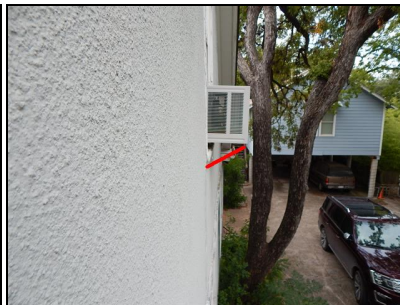
☒ There are no exterior supports for the window A/C units to prevent them from falling from the windows.

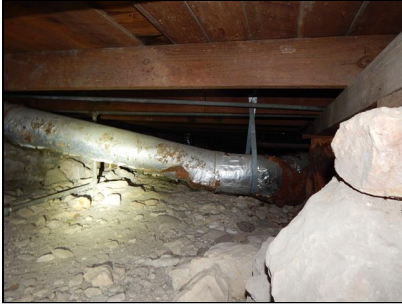
☒ Ducts are in contact with the ground in the crawlspace. These require support to prevent ground contact.

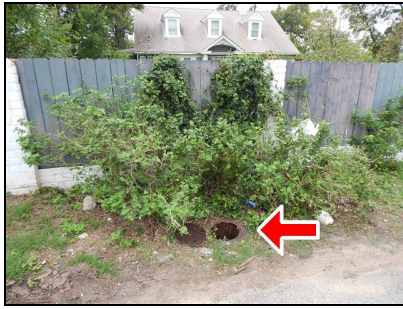
Meter location.

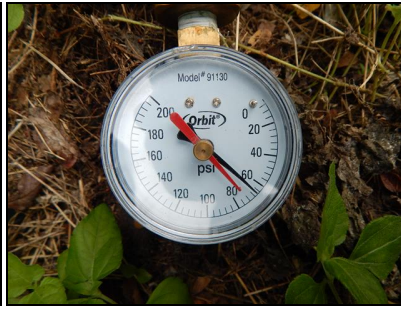
65 psi

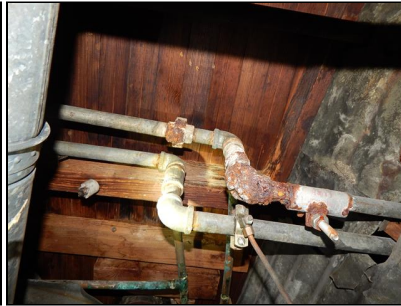
☒ This house has original galvanized supply lines. Lines of this age are known to develop leaks and clogs overtime as they deteriorate i the interior. Supply problems may not be detectable until they actually fail. There was visible rust and corrosion on the pipe system throughout the structure. It also could not be determined if any of these lines had lead content which was common at the time of construction. Active leaks were observed in the basement area. Consult with licensed plumber for replacement options and pricing.

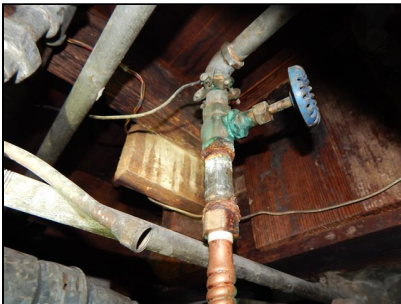
☒ The water heater supply fittings have electrolysis/corrosion build-up. These connections should be repaired and corrected with di-electric unions.

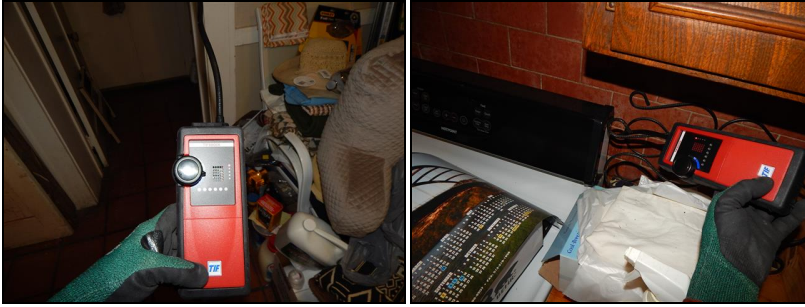
☒ There was an active gas leak in the kitchen. The gas supply to the house should be shut off and the system repaired.

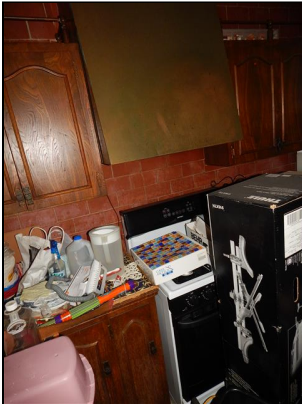
The unit was not functional.

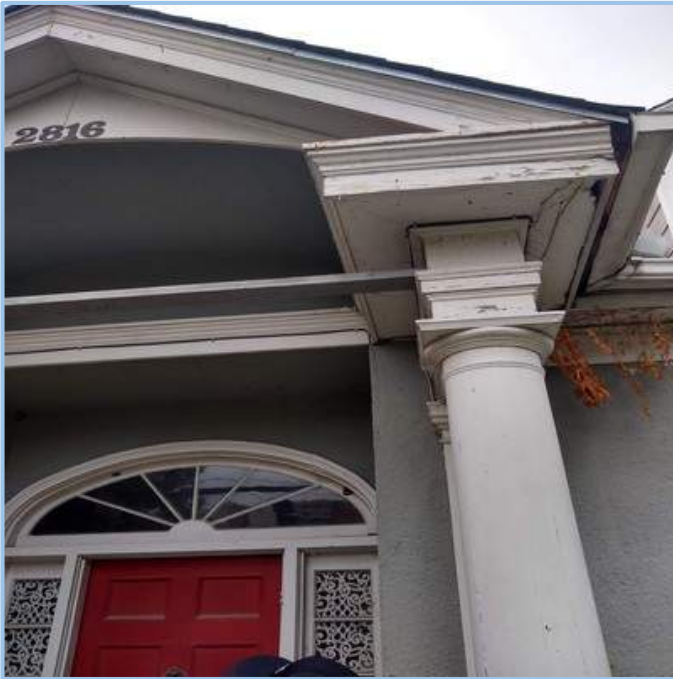
Rotted Wood at Building Facade

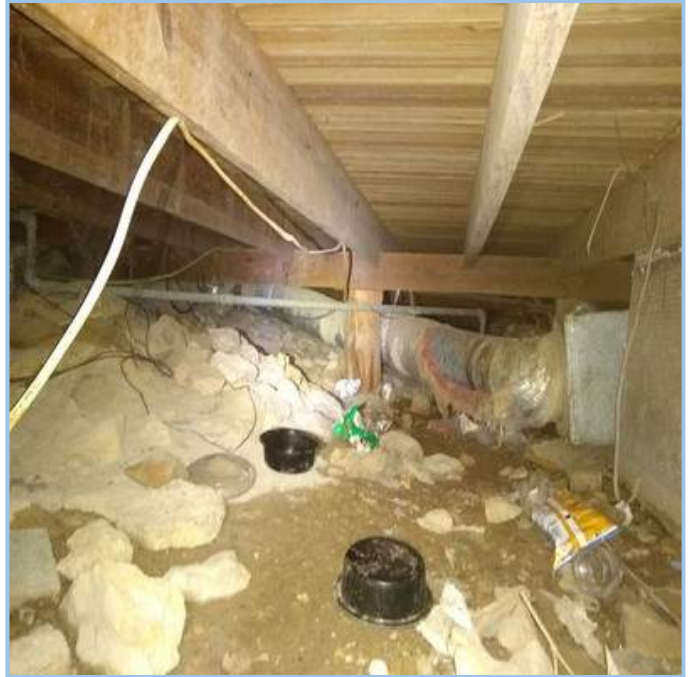
Cedar Piers & Foundation Framing
