The Herrera House
1805 East 3rd Street, Austin, Texas

Historic Condition Assessment Report
December 18, 2019

SOUND HISTORICAL RESOURCES, LLC
Seattle, Washington • 206-582-9989 • adam@soundhistorical.com

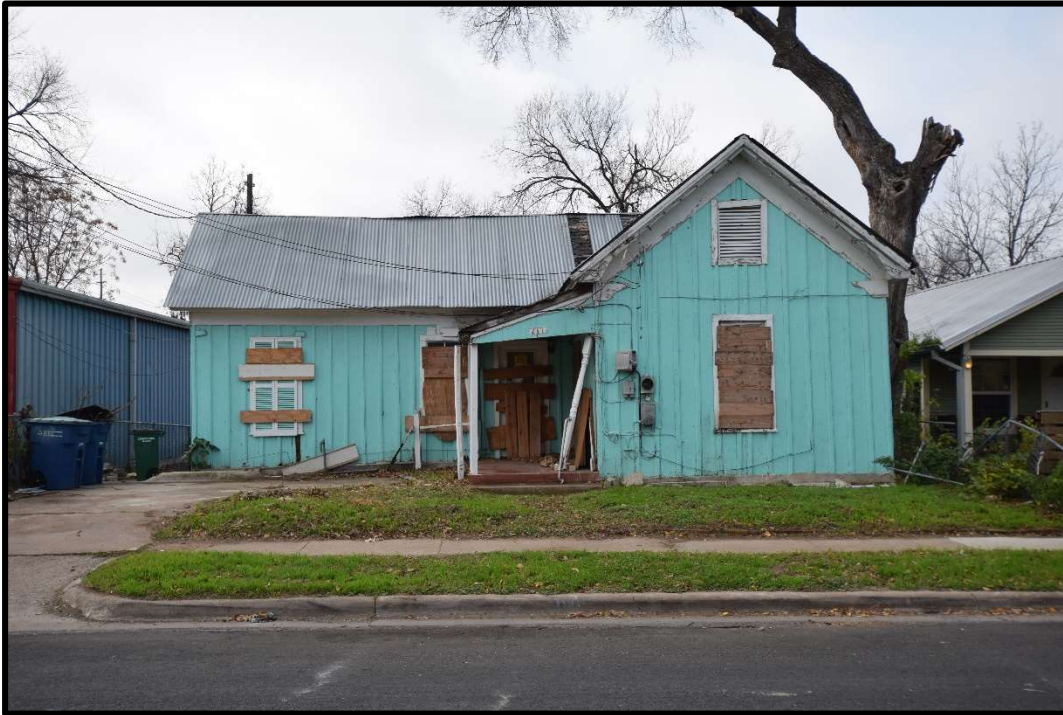
Figure 4.1: General view of the north façade.

The exterior of the historic main house is clad in painted wood siding. This siding is comprised of a single layer of painted 1x12 wood planks laid vertically, with painted 1x2 battens covering the vertical joints. The vertical edges of the battens feature a molded double-ovolo edge detail, which is also Classically known as a *cyma reversa* profile. The boards and battens are laid up directly on the wall framing and is not installed over any additional wood sheathing. The bottom edges of the boards and battens are not trimmed, and the tops of the boards and battens butt up underneath the painted wood frieze band discussed further in Section 3.5). This painted wood board and batten siding is a character defining feature of the house and should be preserved or restored. [Figures 4.1 – 4.7, 4.13 – 4.17, and 4.23 – 4.25]

The siding on the north-facing gable end of the north wing and the east-facing gable end of the main wing of the house was installed starting at the corners and working inward, so that a narrow board remained roughly on center with the window and gable vent at each wall. The painted wood board and batten siding on the north and south walls of the main wing of the house and the east and west walls of the front wing also feature spacing particular to each of these facades. These character defining features of the house should be preserved or restored. [Figures 4.1, 4.2, 4.14, and 4.23 – 4.25]

The roof of the main house is clad in three layers of roofing materials. The first layer is the original layer of wood shingles, very likely installed circa 1911 when the house was originally constructed. The wood shingles are installed over 1x4 wood skip sheathing (also known as purlins) mentioned earlier in Section 3.3 of this report. Composition shingle roofing comprises the second layer of roofing material, which was installed circa 1935-1962 according to the Sanborn fire insurance maps. This layer of composition shingles appears to have been laid directly over the wood shingles without asphalt-impregnated building paper (also known as tarpaper). The third most recent layer is a corrugated galvanized metal roof that has been installed over the two layers of wood and composition shingle roofing. [Figures 4.1 – 4.4, and 4.18 – 4.20]

There is a concrete paved sidewalk along the north end of the parcel along East 3rd Street, and a concrete paved parking area located between the street and the northeast corner of the building. A concrete paved curb cut connects the street and this concrete paved parking area. The gutter and curbs along East 3rd Street are concrete. The rest of the front yard is covered in grass lawn. The side yards are narrow and are covered in bare soil and some patchy grass. The rear yard of the property is covered in overgrown grass and other vegetation. The vegetation is particularly thick and overgrown around the perimeter of the rear additions. **[Figures 4.1, 4.2, 4.3, 4.13, and 4.18 – 4.21]**

Two tall trees are located along the east property line of the adjacent property immediately to the west of the subject property. One of these trees is close to the southwest corner of the house, and the other tree is about twenty to thirty feet south of the tree closest to the house. The tree closest to the house appears to hang over the house on the subject property. Both of these trees appear to be old and may not have much life left, so the owner may consider hiring an arborist to evaluate the condition and estimated life of these two trees, with the permission of the adjacent property owner. [Figures 4.1, 4.2, 4.3, 4.18, 4.19, and 4.21]

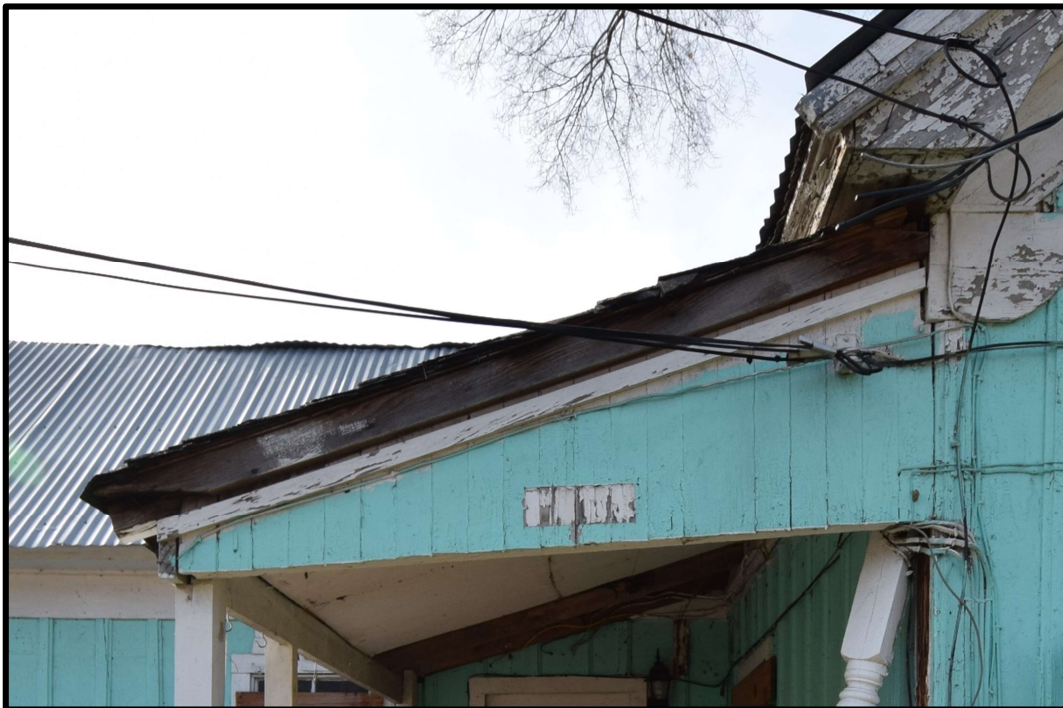
Figure 4.8: Close up view of siding at the north end of the front porch.

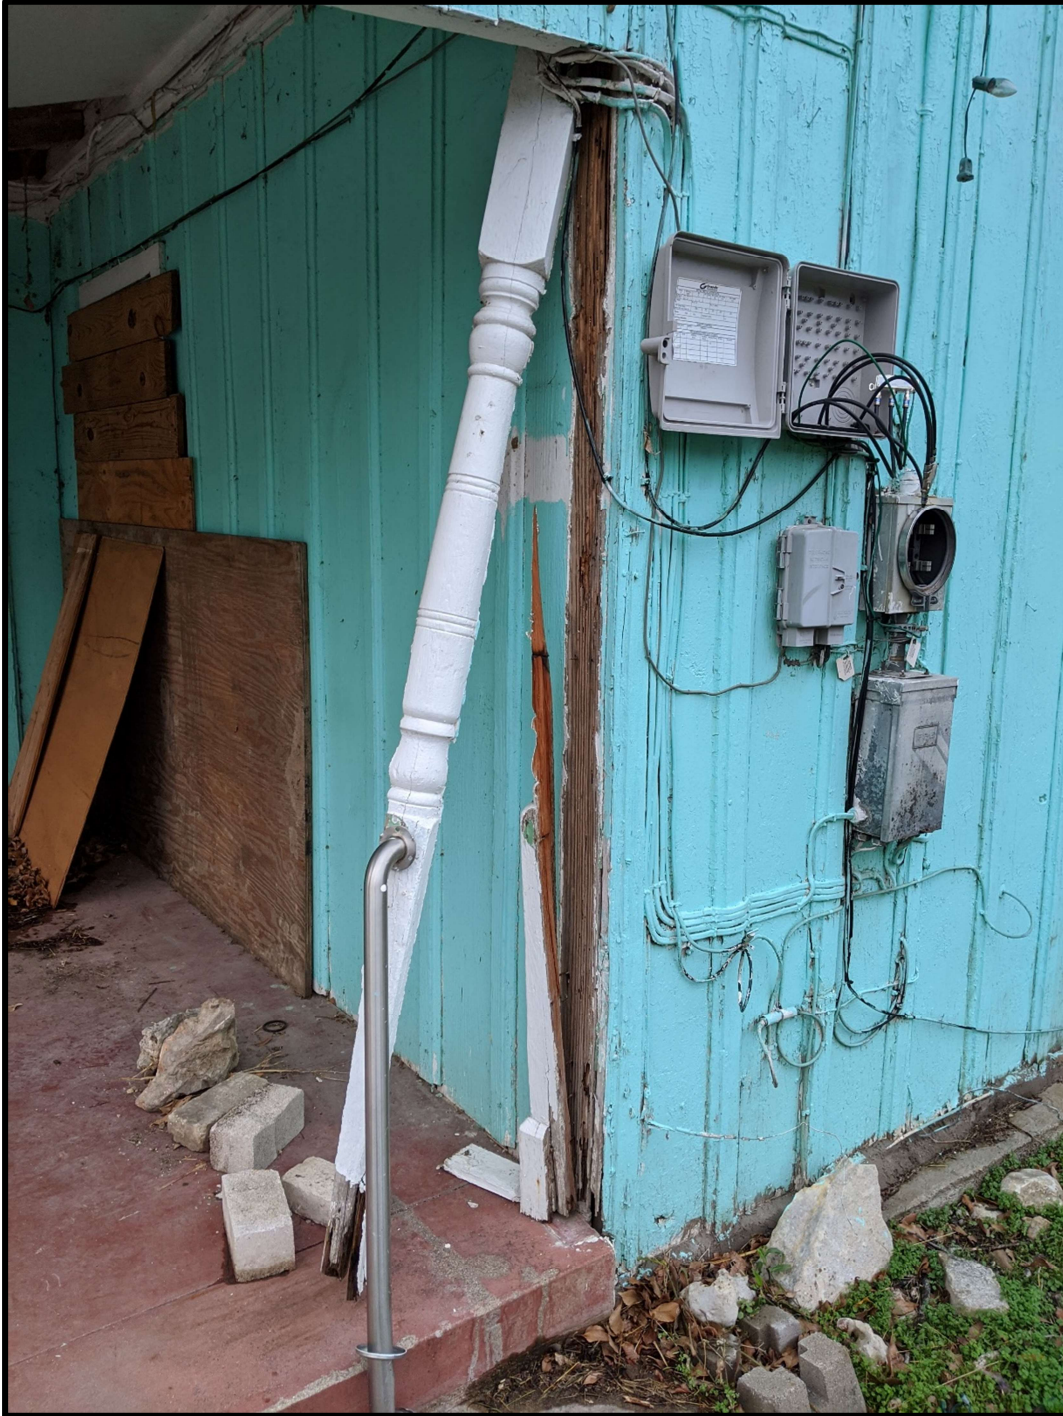
Traditional land-line telephone service in this area is furnished by a wide variety of service providers, ranging from legacy telecommunications carriers to recently established companies. The telephone lines are strung along the same utility poles that Austin Energy uses to deliver electrical power. Telephone service is provided to the house via an overhead service drop from a utility pole located to the northeast of the property on the south side of East 3rd Street. This overhead service drop terminates at the north side of the house closest to the street, approximately three feet to the east of the front porch. This service drop appears to be intact. The telephone service demarcation box is located immediately to the east of the electrical meter base on the north side of the house nearest to the street. [Figure 4.12]

Cable television service to customers in the neighborhood is also offered by a range of service providers. Coaxial cable telecommunications lines are strung along the same utility poles that deliver electrical power and telephone service. Cable service to this house is provided by means of an overhead service drop from a utility pole located to the northeast of the property on the south side of East 3rd Street. This overhead service drop terminates at the north side of the house closest to the street and appears to be intact. The cable service demarcation box is located immediately above the telephone service demarcation box described above. [Figure 4.12]

Austin Energy overhead power lines provide electrical service to the customers in the neighborhood. These lines run along the north side of East 3rd Street. Electrical service is provided to the house via an overhead service drop from a utility pole located to the northeast of the property on the south side of East 3rd Street. This overhead service drop has been disconnected, and the electrical meter has been removed. The meter base and main disconnect switch are still in place on the north side of the house about 3 feet from the front porch, however, Austin Energy would likely require complete replacement of the meter, disconnect, and all wiring prior to the reestablishment of electrical service in the future. **[Figure 4.12]**

Figure 4.12: Close up view of engaged column at north end of porch and existing electrical, telephone, and cable television utility services.

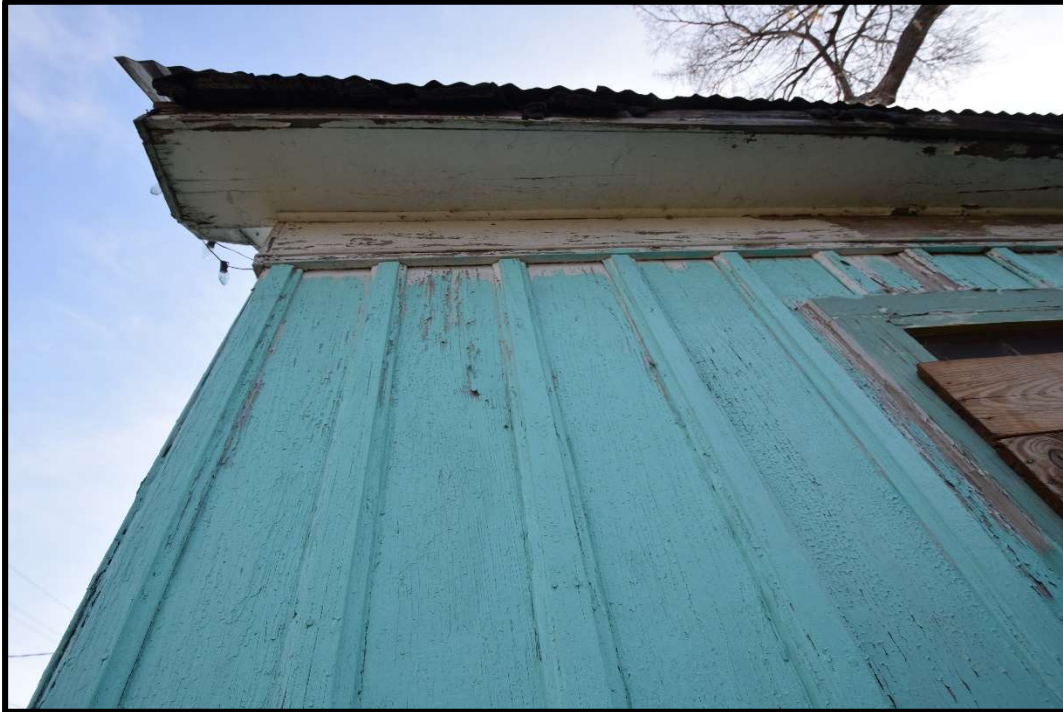
Figure 4.16: Detail view of cornice and eave at northwest corner of the front wing.

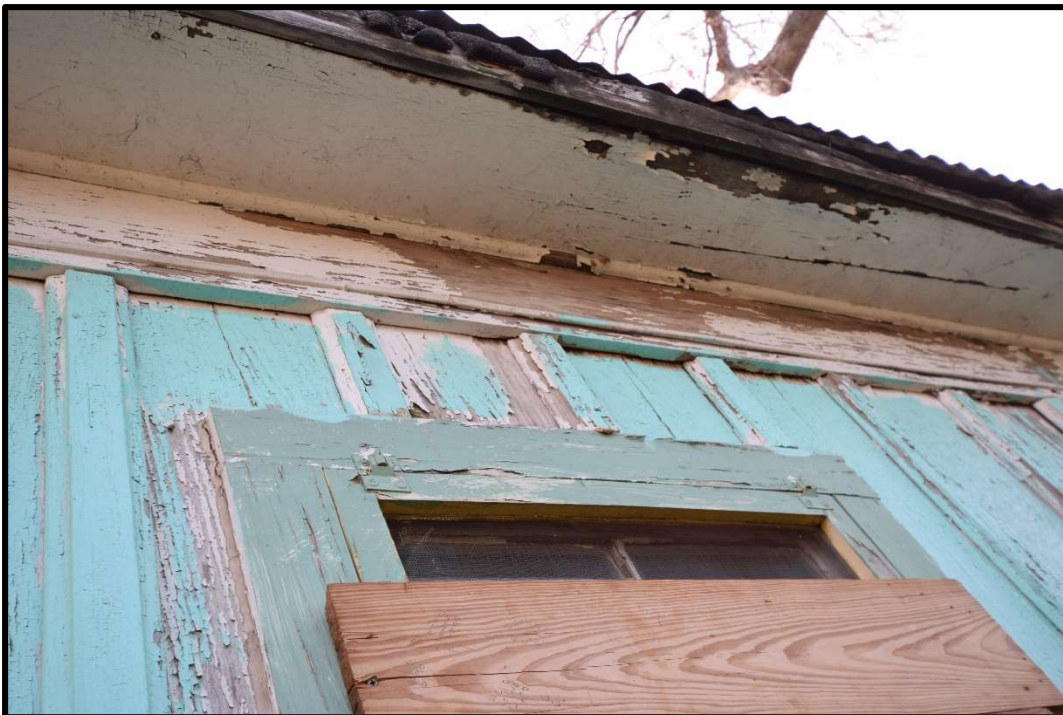
Figure 4.17: Detail view of cornice and eave at east façade of the front wing.

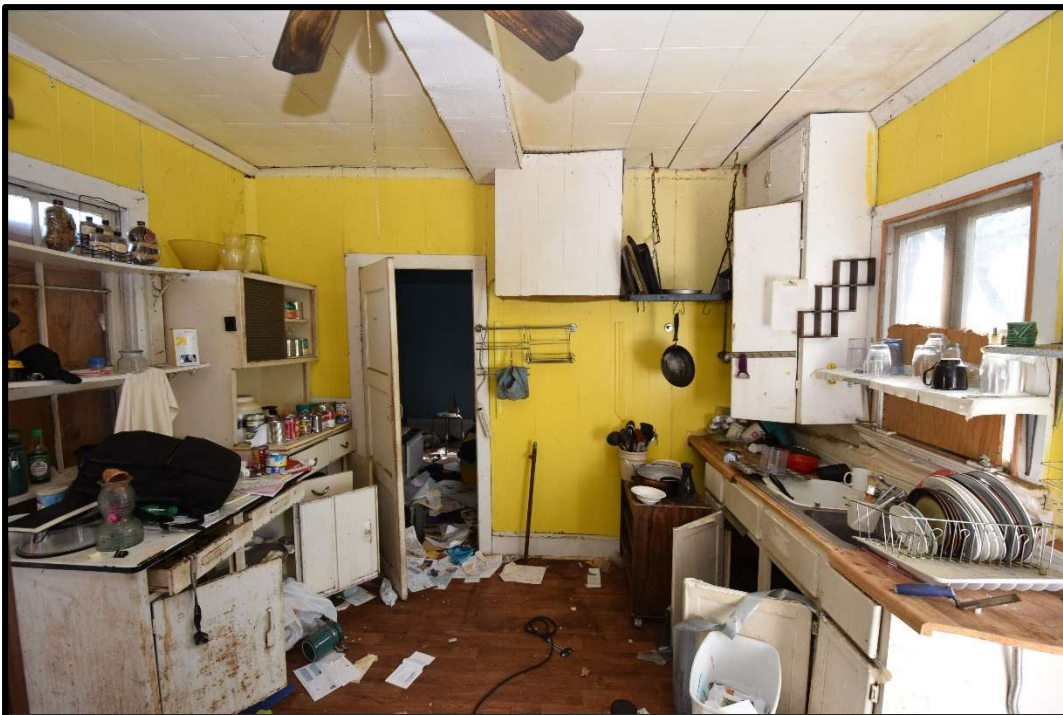
The original cooking appliance for this house would have been a wood or coal-fired cooking stove. There is a gas line located at the east wall of the kitchen (Room 1), which likely served a gas-fired cooking range. This appliance has been removed, so there is no facility for cooking at this house. [Figure 4.31]

Figure 4.31: View of east wall of Room 1.
