Proposed Demolition Permit 2501 Inwood Austin Texas

## McMath Residence 2501 Inwood Place Austin, Texas 78703

## Condition Observations

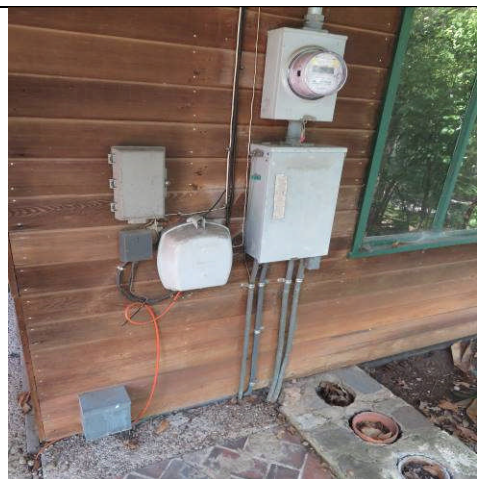
43. Electrical service entrance

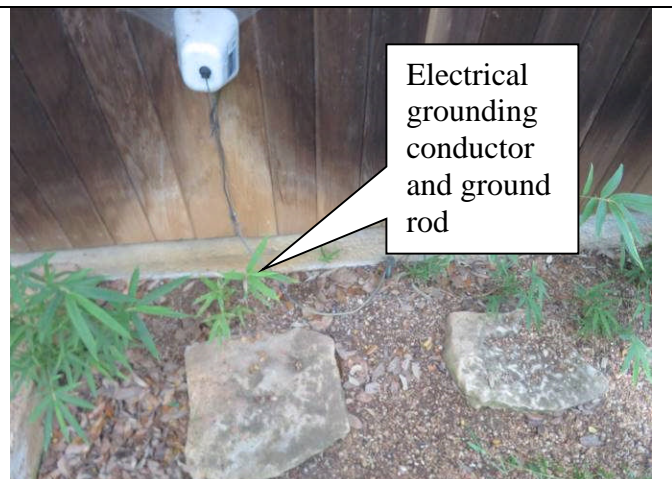
Much of the exterior electrical work appears to be DIY installations that do not conform to code and present safety/fire hazards. The ground rod assembly at the rear hose bibb does not conform to code and represents a possible shock hazard to the domestic water piping system.

44. Ground rod at rear hose bibb
