RYAN STREET
ARCHITECTS

2002 SCENIC DRIVE RESIDENCE, EXISTING CONDITIONS | JUNE 28, 2022

2002 SCENIC DRIVE
EXISTING CONDITIONS

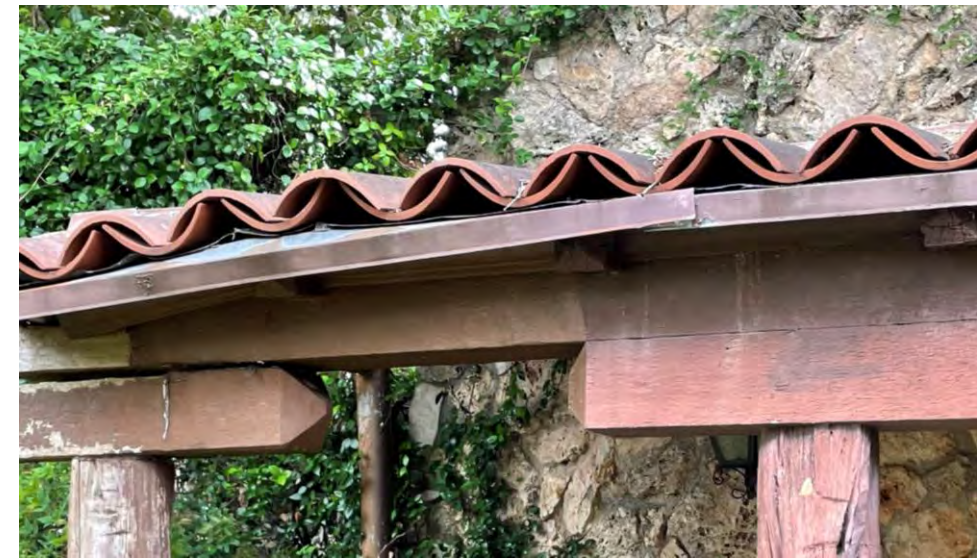
1. THE ROOF IS FALLING APART AND IS SHOWING SIGNS OF WATER DAMAGE.
2. THE ROOF IS SLANTING, WHICH IS A SIGN OF STRUCTURAL FAILURE AND MATERIAL DETERIORATION.

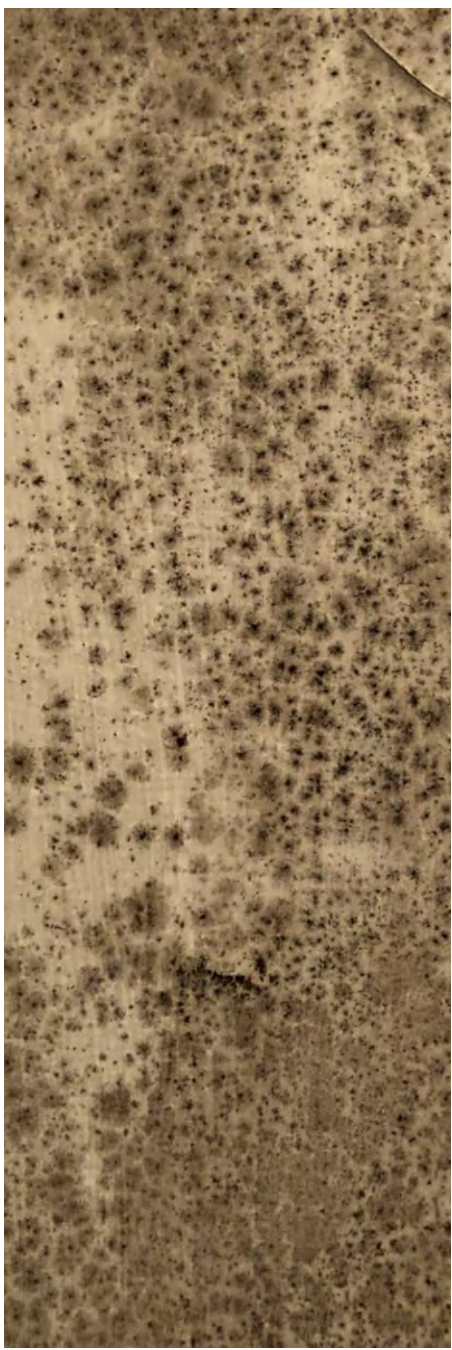
1. DEBRIS HAS COLLECTED INSIDE THE BATHTUB, SHOWING WATER DAMAGE AND CEILING FAILURE.
2. THE CEILING HAS MOLD GROWING ON THE SURFACE OF THE WOOD, WHICH IS CAUSING FAILURE AND COMPROMISING THE MATERIAL.

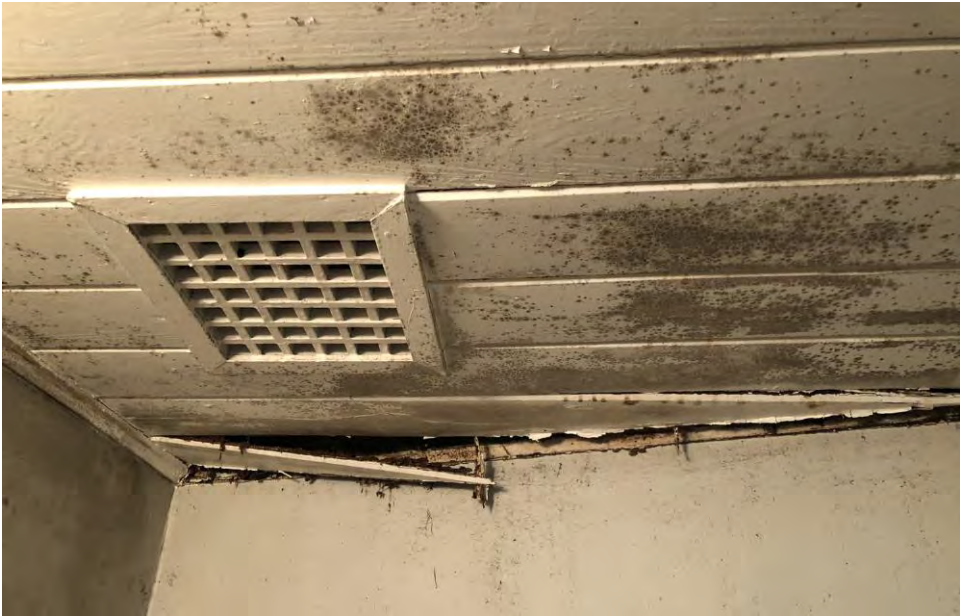
3. THE CEILING IN THE BATHROOM IS DETERIORATING AND MOLDING.
4. THE CEILING OVER THE BATHTUB IS DETERIORATING AND ALLOWING DEBRIS TO COLLECT IN THE TUB.

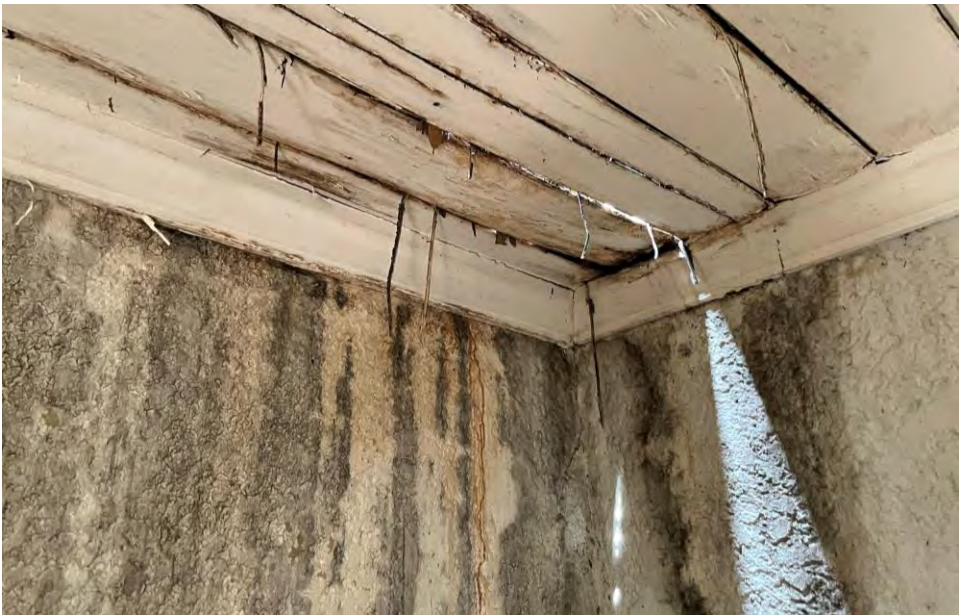
1. WOOD CEILING IS ROTTED, FALLING APART, AND SEPERATING.
2. CEILING FAILURE HAS OPENDED THE INTERIOR UP TO EXTERIOR LIGHT, WATER, AND AIR. WATER DAMAGE CAN BE SEEN ON THE WALL AND CEILING.
3. THE KITCHEN CEILING AND STRUCTURE HAS DETERIORATED AND IS FALLING APART.

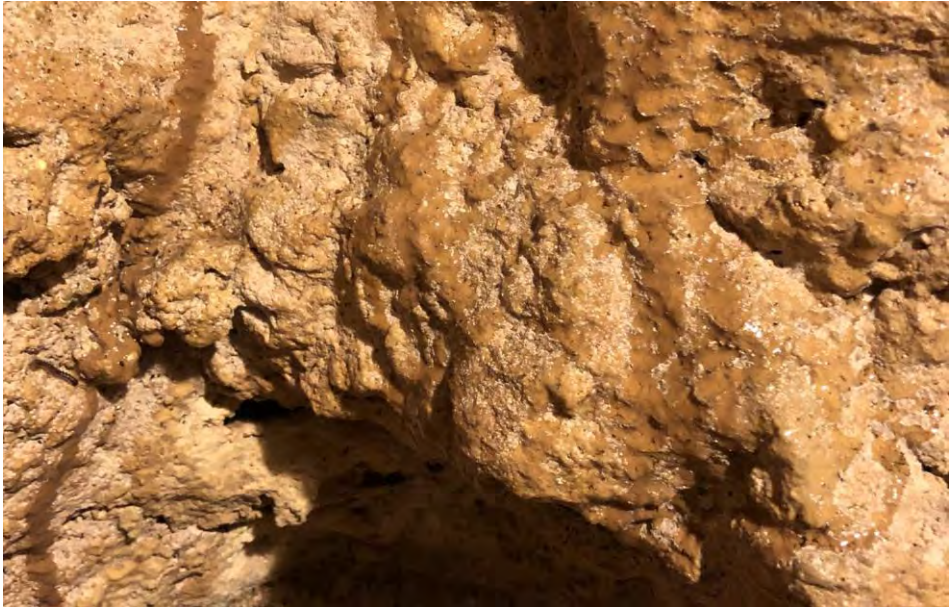
1. WATER IS LEAKING THROUGH THE RETAINING WALL AND INTO THE APARTMENT. WATER CAN ACTIVELY BE SEEN DRIPPING DOWN THE ROCK WALL.
2. IN ORDER TO HOLD UP THE SECOND FLOOR, RAILWAY TIES ARE USED AS STEEL BEAMS.
3. WATER IS DRIPPING DOWN THE ROCK AND FINDS ITS WAY TO THE STRUCTURE'S CONCRETE BASE.

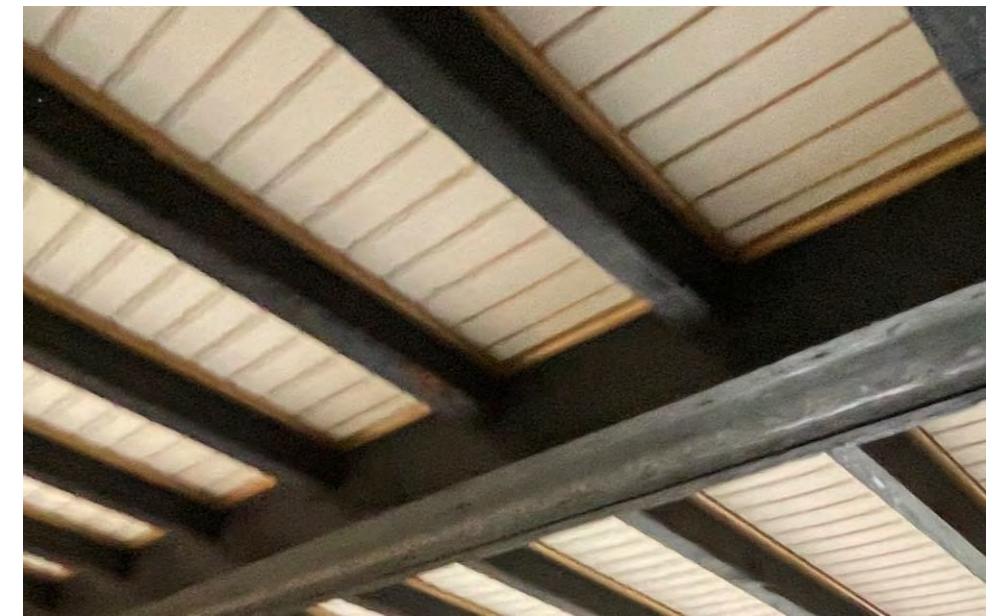
1. A STRUCTURAL ENGINEER HAS INDICATED THAT THESE BEAMS ARE INADEQUATE OF BEING STRUCTURALLY CAPABLE TO HOLD THE LOAD OF THE SECOND FLOOR.

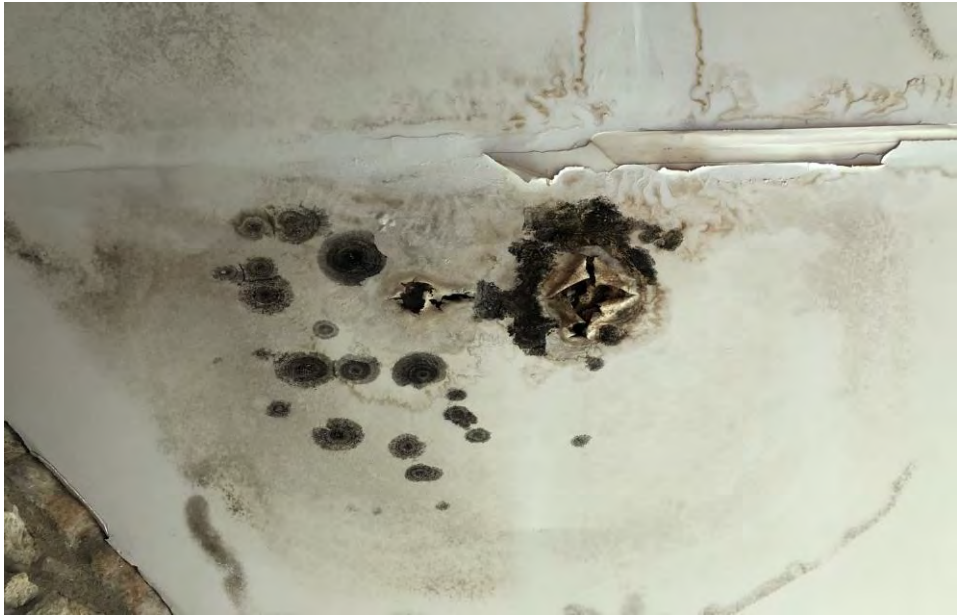
1. THE FLOOR IS DAMAGED AND FLAKING. ON THE EXTERIOR, THE HEIGHT OF THE GROUND IS HIGHER THAN THE HEIGHT OF THE WINDOW SILL, ALLOWING WATER TO FLOW INTO THE HOUSE.
2. WATER IS DAMAGING THE CEILING IN LARGE AREAS. BLACK MOLD IS EVIDENT IN MULTIPLE LOCATIONS.
3. IN THIS LOCATION THE WATER DAMAGE IS ESPECIALLY EVIDENT AND DESTRUCTIVE. MOLD IS A POTENTIAL HEALTH HAZARD AND WOULD REQUIRE AN EXTENSIVE MITIGATION EFFORT.

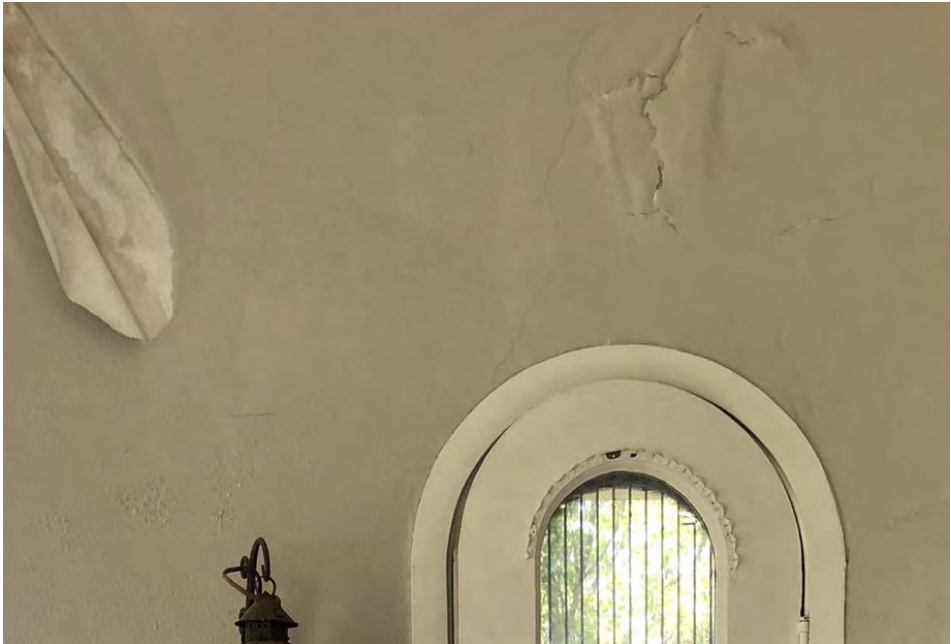
1. THE PLASTER DRYWALL IS FALLING APART AND CRACKING. THE DOOR IS TOO SMALL AND IS UP AGAINST STONE STAIRS.
2. THE PLASTER IS CRACKED AND FALLING APART.

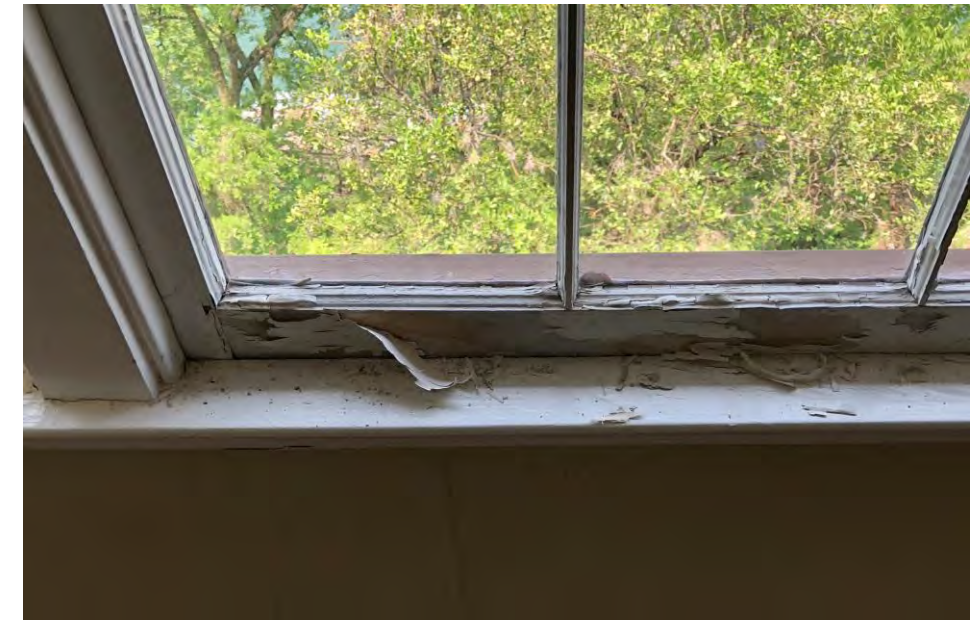
1. THE WINDOWSILL IS FALLING APART AND IS DROPPING DEBRIS ONTO THE WINDOW SILL AND FLOOR.
2. THE FLOOR IS BOWING DUE TO THE LACK OF STRUCTURAL SUPPORT BELOW.
