Project: 407 E. Monroe Austin, TX 78704

**HR-2022-070860/2022-065132 PR**

**Cost Prohibitive Rehabilitation**

# Current State of Property

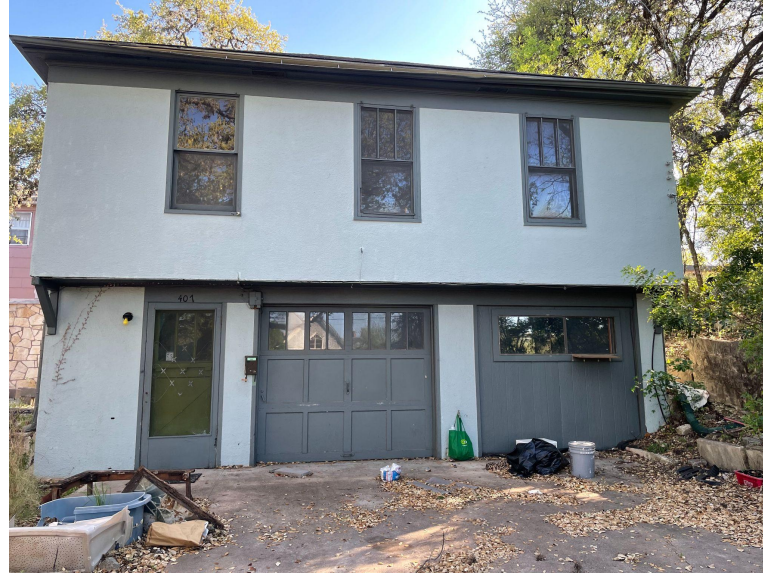
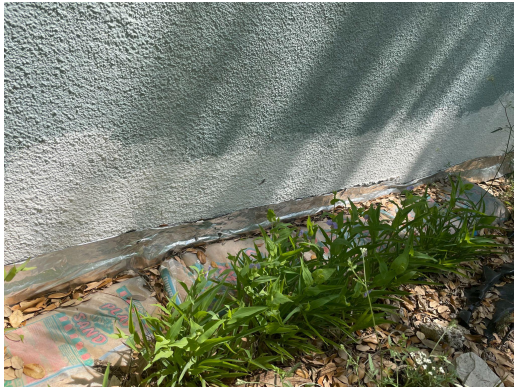
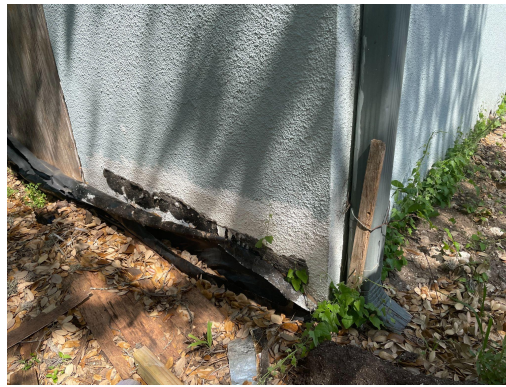
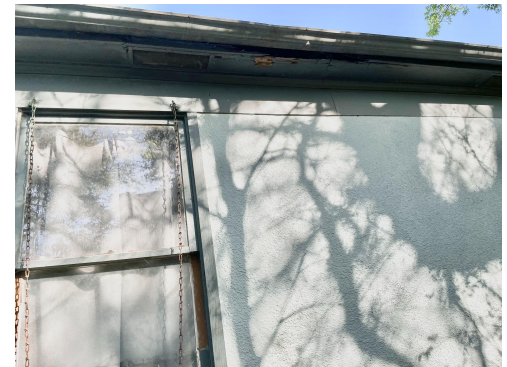
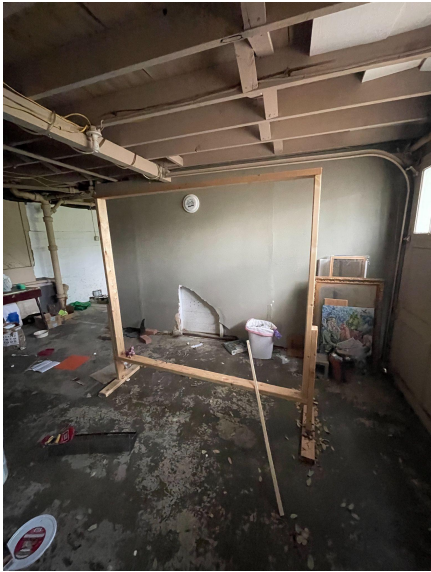
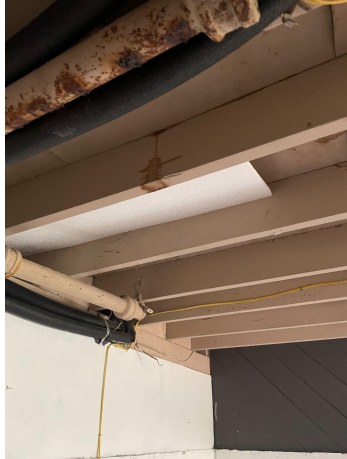
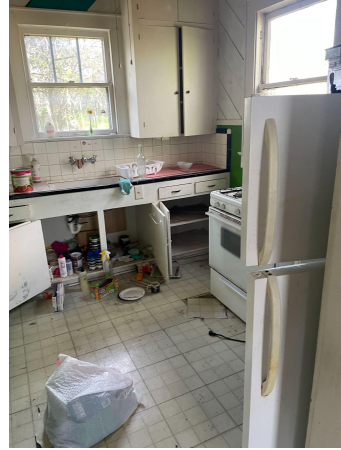
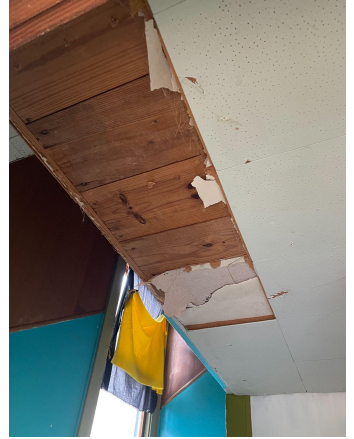
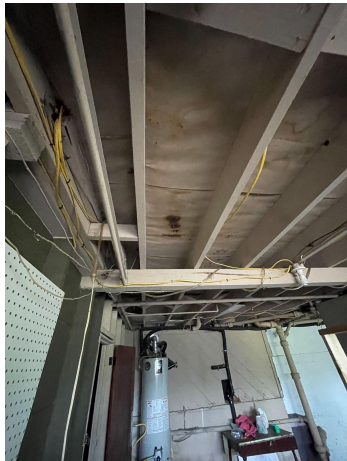
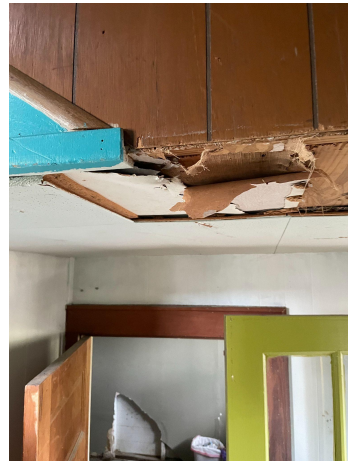
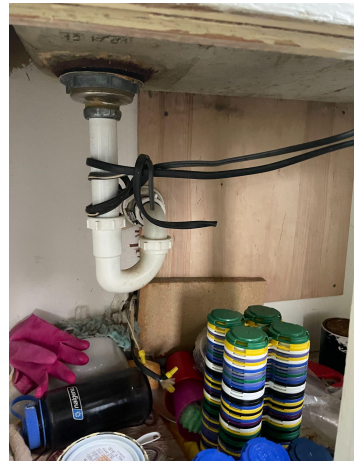
- Garage Apartment Built in 1937 and Located in Historic Fairview Park Austin, TX
- Exhibit 1 Has been used as a rental unit with the bare minimum updates as can be seen in exhibit photos

- Framing and Roofing is considered to be deficient and needs to all be replaced
  - Termite damage confirmed within the walls
  - Rotting Soffit and cracked veneer
