MONROE RESIDENCE

407 E MONROE AUSTIN, TX 78704

On 05 April 2022, R. Derek Hammond of RDH C&E performed a site observation to 407 E. Monroe Street in Austin, Texas to view the condition of the existing ADU. Based on the site observations, and calculations it appears the roof, attic, and portions floor framing are over spanned and insufficient for code required loading. Sagging in framing, cracking within the veneer, and rotting within the soffit and around the bottom plate were also observed. Roof & upper attic framing would all need to be removed and replaced or reinforced with additional framing and bracing. The 4x6 2nd floor framing support was also found to be deficient and would need to be reinforced or removed and replaced. Rotting was noted around the perimeter of the building due to the proximity of grade to the bottom plate of the wall. Termite damage was confirmed, and all wall framing at was damaged would need to be replaced.

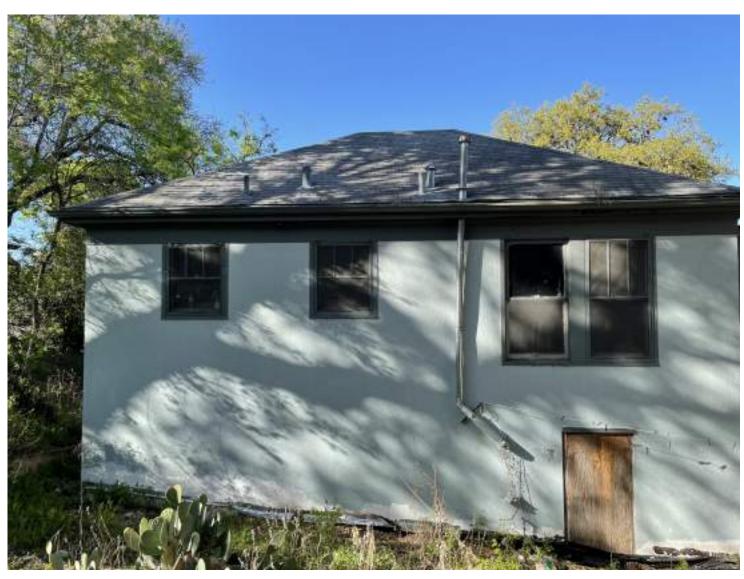
5/17/22, 3:24 PM Back Side.jpg

Soils around the South and West sides were observed to be above the bottom plate of the wooden portions of the exterior wall framing. Cracking was observed in the skirting around the base of the home and sand bags were present to mitigate water infiltration. Wall framing was obscured from view, but is likely rotted due to the evidence of water infiltration over a long period of time. Rotting soffits were also noted around the perimeter of the ADU as well as evidence of settling, namely cracking around openings.

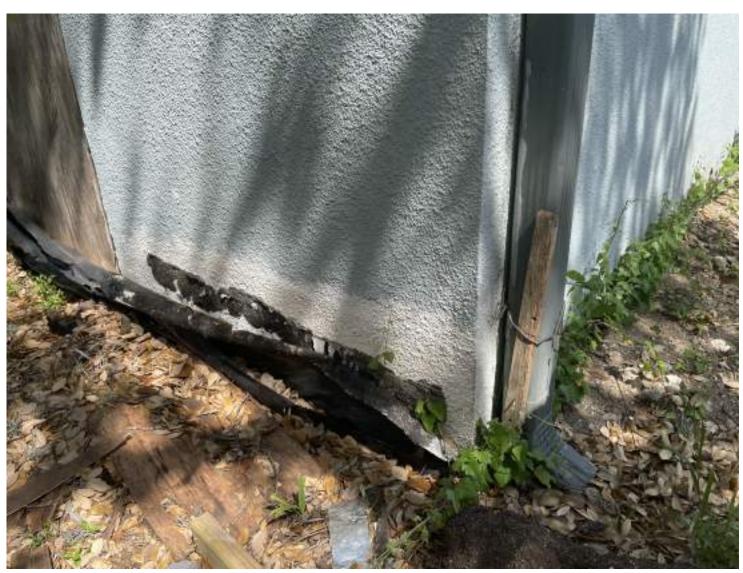
5/17/22, 3:25 PM Detail 1.jpg

Termite damage had been confirmed within the walls, further investigation would be necessary to determine wall framing adequacy. Where damage or insufficient framing and/or sheathing attachments are discovered, removal and replacement would be recommended.
