**SITE PLAN REVIEW SHEET
ENVIRONMENTAL VARIANCE REQUEST ONLY**

CASE: SP-2021-0350C

PROJECT NAME: Shoal Cycle

Tree Risk Assessment Report

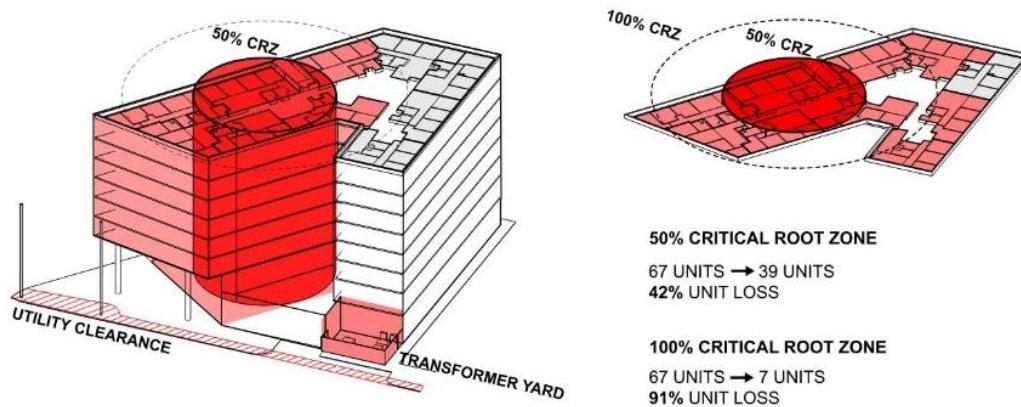
EXHIBIT B: Critical Root Zone Exhibit

The location of the 32-inch Live Oak tree provides a significant impact on the developable area of the site and would not allow for reasonable use of the site to construct a workforce housing project in the Northwest District of Downtown Austin where increased affordable housing is preferred and encouraged within close proximity to transit.

By keeping the existing tree, the developable area of the site and resulting building footprint are severely impacted and reduced to 37.3% of the lot area. Not only will the max FAR of 5:1 be unachievable, an efficient residential unit layout with appropriate separations, egress distances and corridor space will decrease the unit count from 10 units per typical floor, to an estimated 4 units per floor. Furthermore, the southwestern portion of the remaining footprint – approximately 25% of the “developable area” – is rendered unusable and structurally implausible to build. Exhibit C below shows the 25% unusable space, equating to 2,072 square feet of the remaining 8,654 square feet.

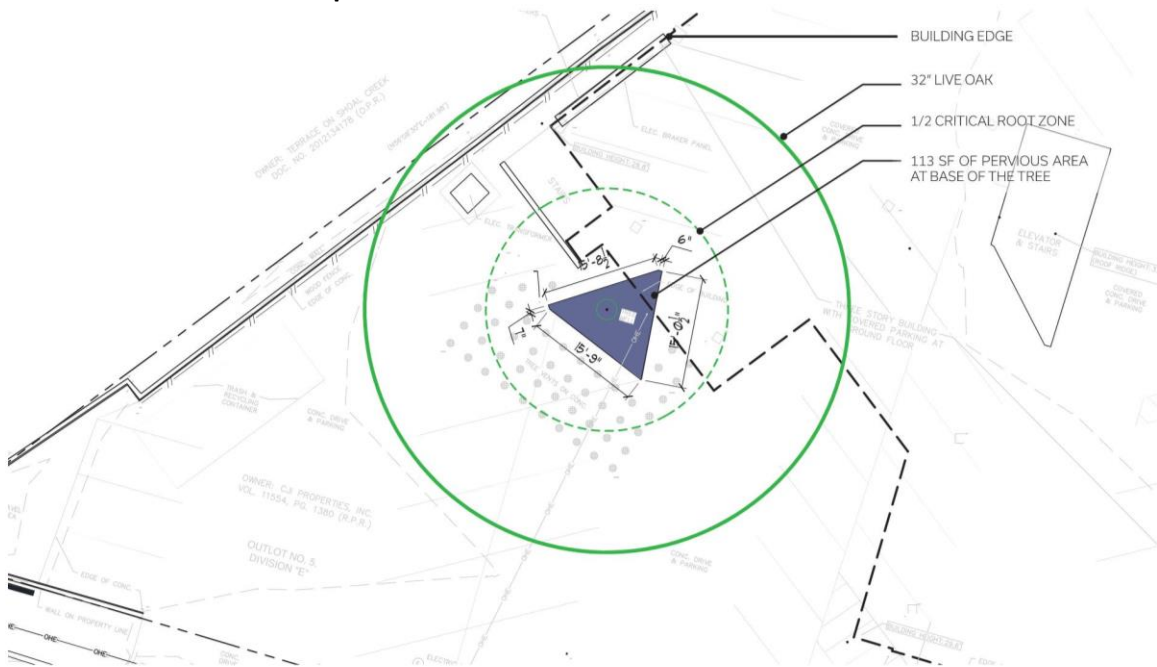
Exhibit E: Critical Root Zone Impact

The issues affecting the 32-inch Live Oak include (1) approximately 35% existing canopy, (2) greater than 90% impervious surfaces over the Critical Root Zone, (3) significant decay areas in primary branching and (4) below average vigor. As a result of these impacts, the 32-inch Live Oak was assessed as not a good candidate for transplant.

The 32-inch Live Oak tree is described by experts as in poor condition with visible decay and significant pruning wounds on the east and west stems and on its limbs. Existing conditions consisting of 95% impervious cover over the roots and its location abutting the existing office structure created treacherous and unhealthy conditions that did not provide an ideal environment for the continued survival of the tree.

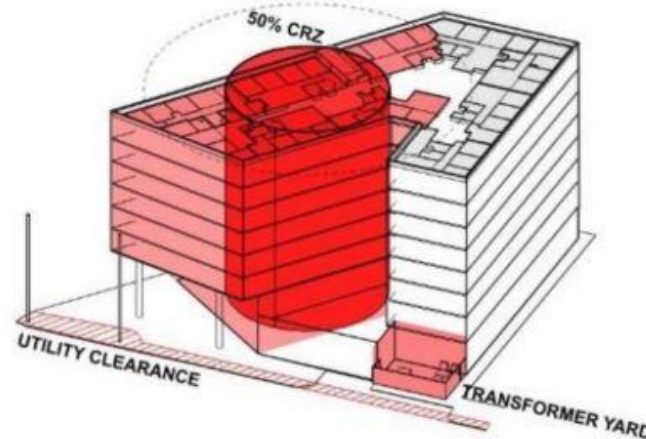
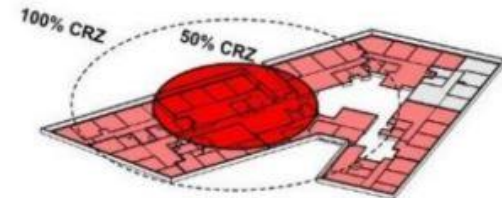
50% CRITICAL ROOT ZONE

The root zone of the 32" Heritage Live Oak occupies 28.9% of site

- Current location results in a reduction of over 50% of the gross square feet of buildable area
- Preservation of the Half critical root zone would result in a loss of 28 units (or 42%) of the proposed 67 units
- Preservation of the Full critical root zone would result in a loss of 60 units (or 91%) of the proposed 67 units

67 UNITS → 39 UNITS
42% UNIT LOSS

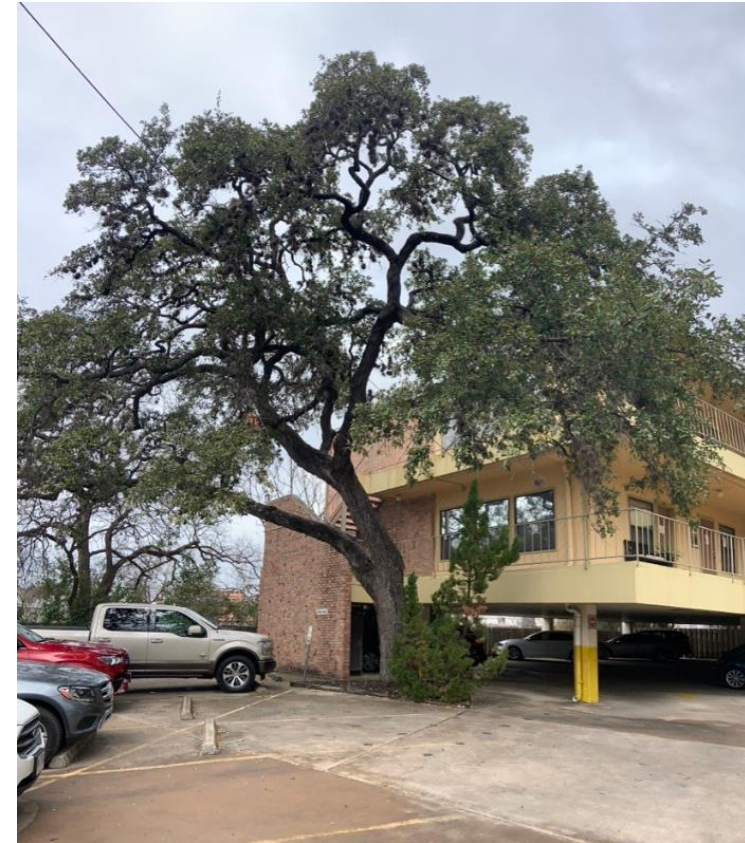
Tree structure

Additional significant decay is on the west stem limb shown in Exhibit G below. This limb is characterized by a large pruning wound of approximately 10 inches in diameter, and sapwood and heartwood decay, measuring 30 inches by 12 inches. This wound and decay area are noted to make up 1/3 of the circumference of the west stem with little response wood.

Large scaffold leader decay – west stem
