Questions and Answers Report

**FACILITY HVAC ASSESSMENT REPORT - DRAFT
VOLUME 1 OF 1**

Stanley Consultants (Stanley) was retained by the City of Austin (COA) – Austin Public Health (APH) to perform an assessment of the heating, ventilating, and air-conditioning (HVAC) systems in the following buildings:

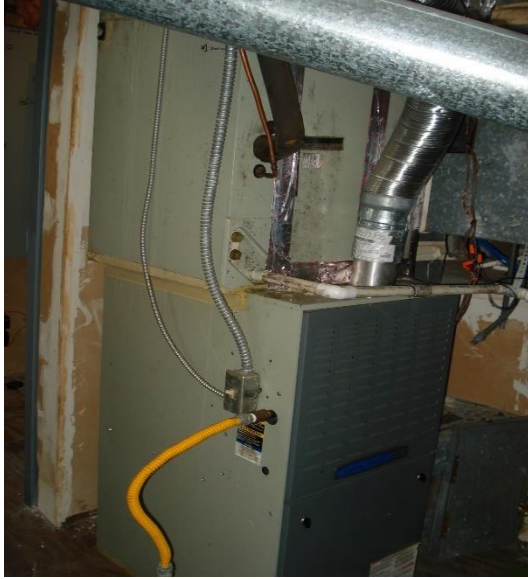
1. Building Heating, Ventilation, and Cooling (HVAC) is provided by three residential-type Direct Expansion (DX) split system Air Handling Units (AHU) manufactured in 2004. AHU's are in an attic mezzanine accessed via a drop-down ladder in Corridor 113. Associated condensing units are in an enclosed mechanical yard exterior to the building. Industry expected equipment service life for residential DX split system AHUs is 15 years. The AHUs have been in service for 16 years and are beyond their life expectancy. There appears to be areas of rust developing on the AHU casings as well as biological growth at the unit seams. The AHUs are controlled by wall-mounted Honeywell programmable thermostats.

Figure 1 – AHU-1 (typical of all 3 AHUs)

1. Replace AHU-1, AHU-2, AHU-3, and their associated condensing units. Replace all duct systems and air devices (grilles, registers, & diffusers) and replace other appurtenances.
2. Provide an Energy Recovery Ventilator (ERV) to pre-condition the outdoor air before it enters the AHU mixing box.
3. Provide a building pressure monitoring and control system to maintain a positive building pressure of at least 0.05 in wg.
4. Provide an air sterilization device such as UV-C lamps or bipolar ionization systems.
5. Provide a minimum MERV 13 air filter at each AHU.
6. Replace the HVAC control system.

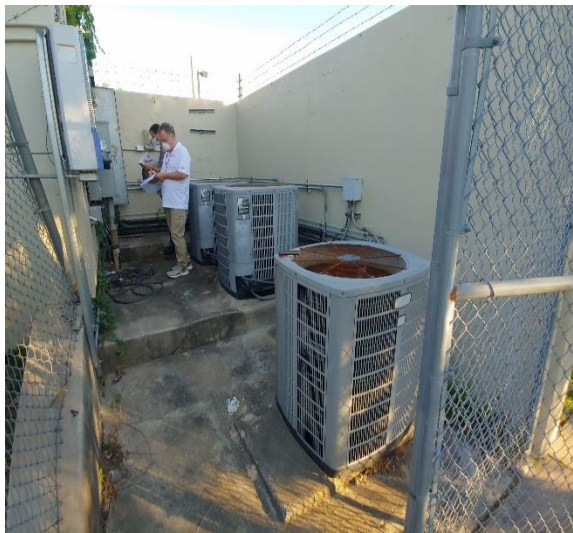
2. The AHU's provide heat to the building by natural gas fired furnaces. Raw (unconditioned, ambient temperature) outdoor air is provided to the building by air direct ducted to the return side of the AHU's. Residential AHUs are not designed to condition raw outdoor air and should not be used for that application.
3. The condensing units were manufactured in 2004. Industry expected equipment service life for residential DX split system AHUs and their associated condensing units is 15 – 20 years. The condensing units are 16 years old and are beyond their life expectancy. Areas of rust have developed on the condensing unit casings and the refrigerant pipe insulation has begun to deteriorate. Some of the insulation has fallen off the refrigerant piping.

Figure 2 – Condensing Units in Mechanical Yard

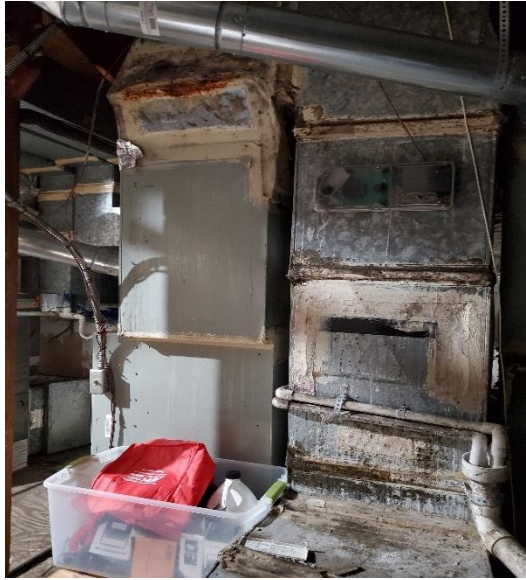
4. Building ductwork was observed to be uninsulated. Ductwork exterior and interior was observed to be developing biological growth due to condensation, which adversely affects indoor environmental quality and occupant health.

Figure 3 – Typical Ductwork with biological growth.

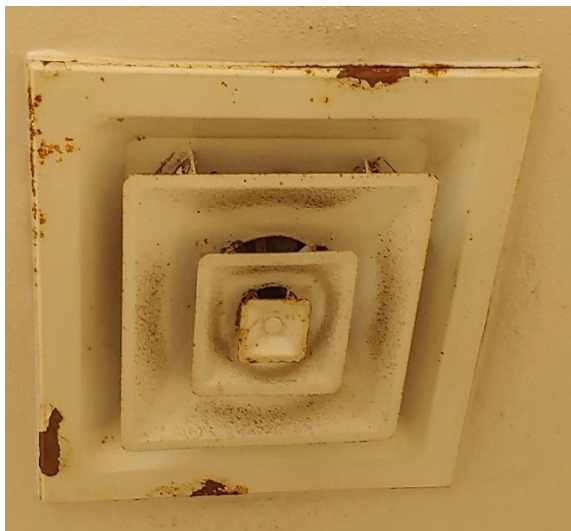
5. Air devices in the occupied spaces were observed to be stained with dirt and corroded. In addition, it appears some of the diffusers have some biological growth indicating humidity issues within the building.

Figure 4: Typical Rusty Air Device with Suspected Microbial Growth

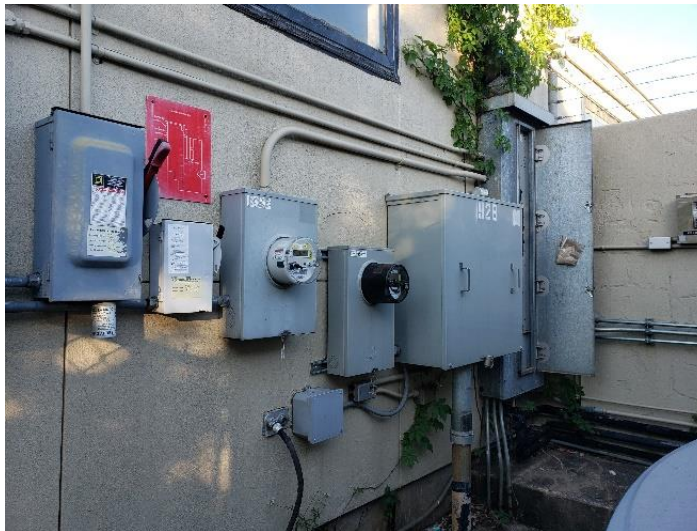
1. The main electrical service is fed from Austin Energy 12.47kV distribution to a pole mounted single phase 100kVA transformer and then transitions underground to a 400A, 120/240V single phase electrical service. The main service is a 400A panelboard “MS-1” with associated metering (Figure 5). The existing exterior condensing units are served from three 40A/2P breakers in the existing General Electric type NLAB panelboard “MS-1”. The panelboard and most of the existing circuit breakers are roughly 34 years old and are beyond their life expectancy. Some of the existing branch breakers have been replaced however the main and sub-feed breakers are original. There are signs of rust on the enclosure. Typically outdoor environments will accelerate the degrading of panelboards and more importantly the associated breakers. There are signs of rodents entering the panelboard (Figure 6) which can also accelerate electrical failure such as rodents causing arcing across phases or chewing on electrical conductors and causing a failure. There are only 2 spare single pole spaces in the existing panelboard. No arc flash or short circuit labels were posted on any of the panelboards as required per NFPA 70E.

Figure 5 – Main Electrical Service in Mechanical yard.

1. Provide new main panelboard “MS-1” and disconnects for associated condensing units CU-1, CU-2, and CU-3.
2. Provide new panelboard “A” and new disconnects for associated air handling units AHU-1, AHU-2, and AHU-3.
3. Provide short circuit and arc flash hazard assessment study.
4. Provide arc flash labels at all panelboards per NFPA 70E requirement.
5. Provide new surge protective devices at panelboards to protect new HVAC system components.

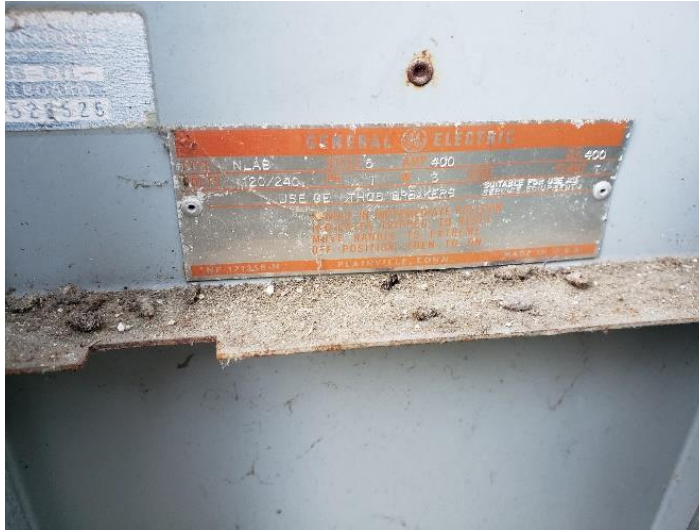
Figure 6 – Panelboard “MS-1” Nameplate & Debris

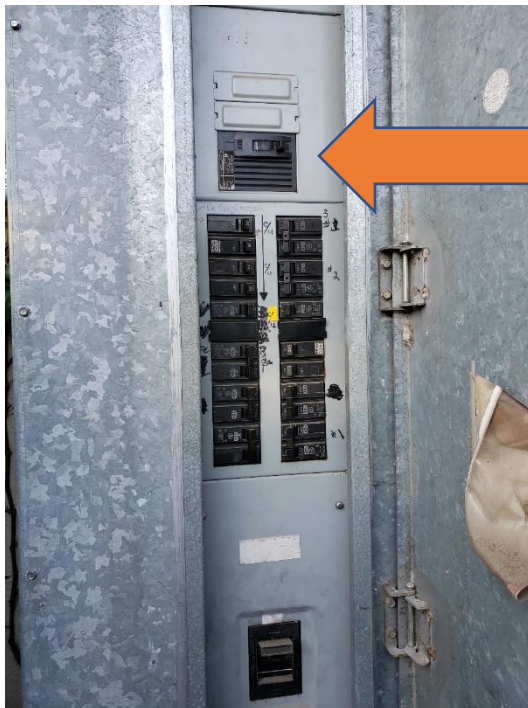
2. Existing General Electric type NLAB panelboard “A” 225A single phase three wire. The panelboard is in attic/mezzanine electrical room. Attic access located in Corridor 113 by way of an attic ladder and stairs. The panelboard is fed from a 150A/2P breaker in panelboard “MS-1” (Figure 7). The panelboard serves the three air handling units #1, #2, and #3 with 20A/1P breakers. There is no spare capacity in the existing panelboard. The panelboard is roughly 34 years old and is beyond useful life expectancy.

Figure 7 – Panelboard “MS-1” sub-feed breaker to Panelboard “A”.

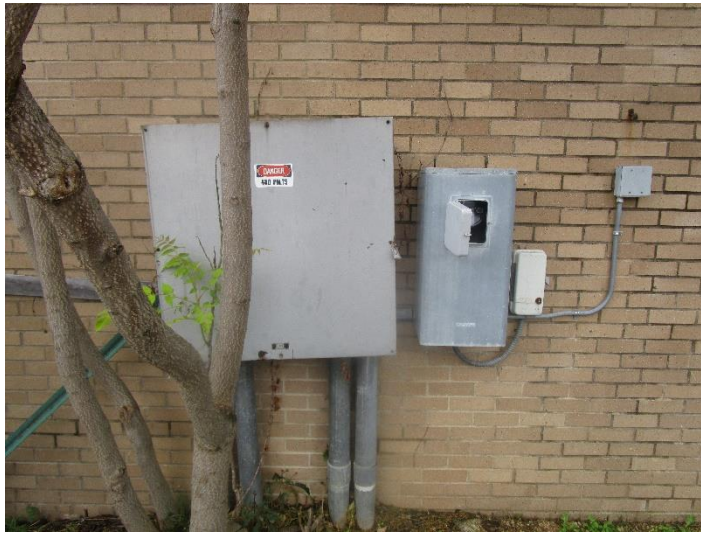
1. The main electrical service is fed from Austin Energy's 12.47kV distribution to a pad mounted three phase 500kVA Austin Energy transformer. The secondary main feeder enters through a current transformer enclosure with metering (Figure 8). Panelboard "P1" is a 600A ITE Series 5 480/277V 3 phase 4 wire panelboard located in the main electrical room (Figure 9). This panelboard serves the motor control center "MCC-1" located in the boiler/chiller building with a 300A/3P breaker (Figure 10). Panelboard

“P1” was manufactured in 1974 and is roughly 46 years old. There is no main disconnect on the exterior of the building for emergency personnel.

Figure 8 – Main Electrical Service and Meter

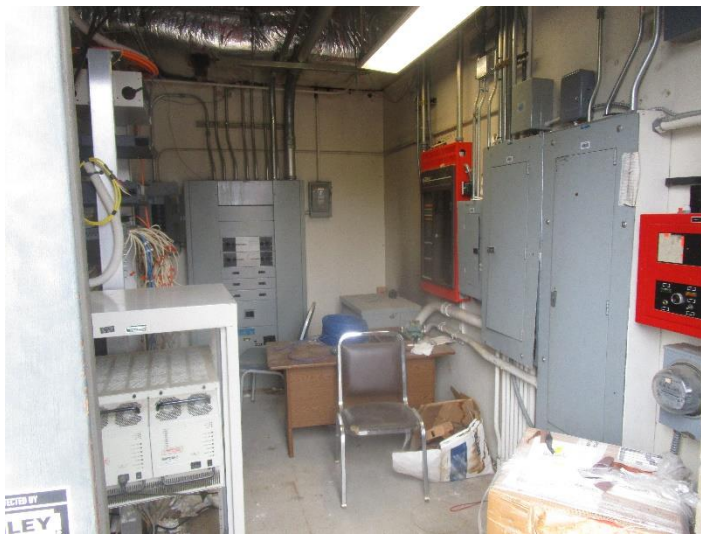
Figure 9 – Main Electrical Room

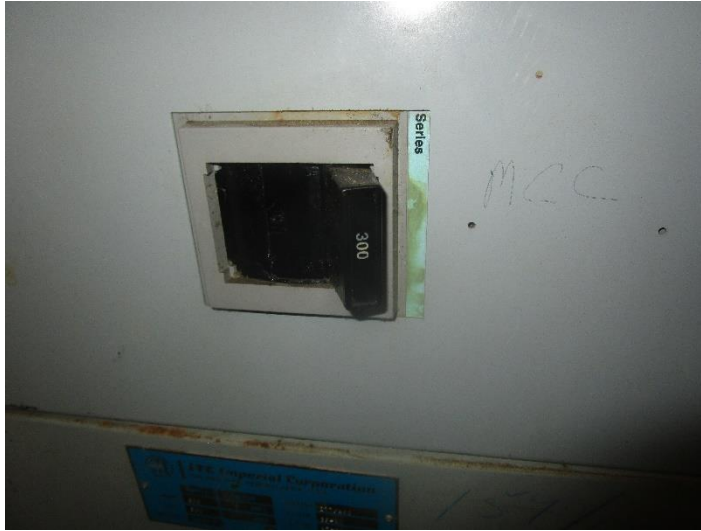
Figure 10 – Breaker to Motor Control Center “MCC-1”

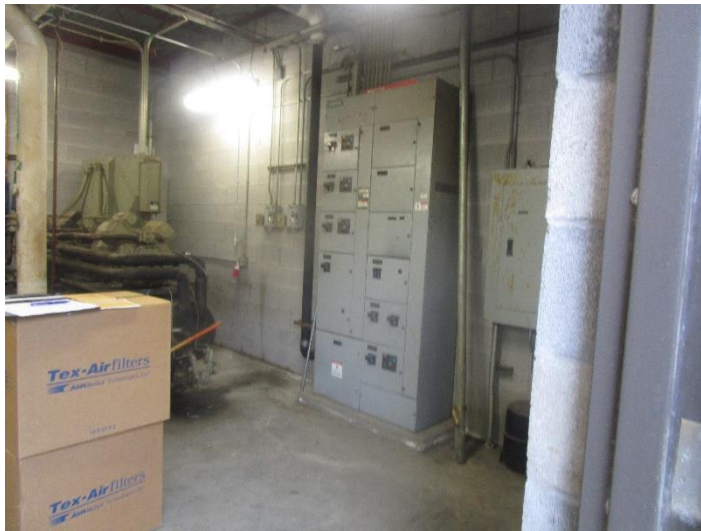
2. Existing Motor Control Center MCC-1 is a 2 section Siemens Model 95 600A 3 Phase 3 Wire (Figure 11). The MCC serves the hot water pumps HWP No. 1 and HWP No. 2, chilled water pumps CHWP No. 1 and CHWP No. 2, and the chiller CHILLER No. 1. There are signs of an arc flash event inside one of the compartments (Figure 12).

Figure 11 – Motor Control Center MCC-1

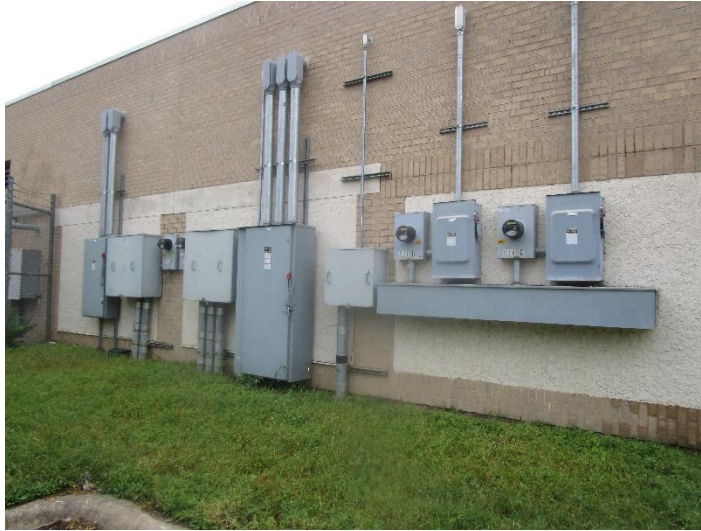
1. The main electrical service is fed from Austin Energy's 12.47kV distribution to a pad mounted three phase 300kVA Austin Energy transformer. The secondary main feeder enters through a current transformer enclosure with metering and serves four separate 120/208V three phase electrical services "211A", "211B", "211C", and "211D" (Figure 2). Main service "211A" has a 600A disconnect "HS1" on the exterior of the building. Main service "211B" has an 800A disconnect "DP" on the exterior of the building (Figure 3). Main services "211C" and "211D" have two 200A disconnects on the exterior of the building (Figure 4). Most of the HVAC equipment is served from "211A" and "211B" associated downstream panelboards.

Figure 2 – Main Electrical Services.211A, 211B, 211C, & 211D

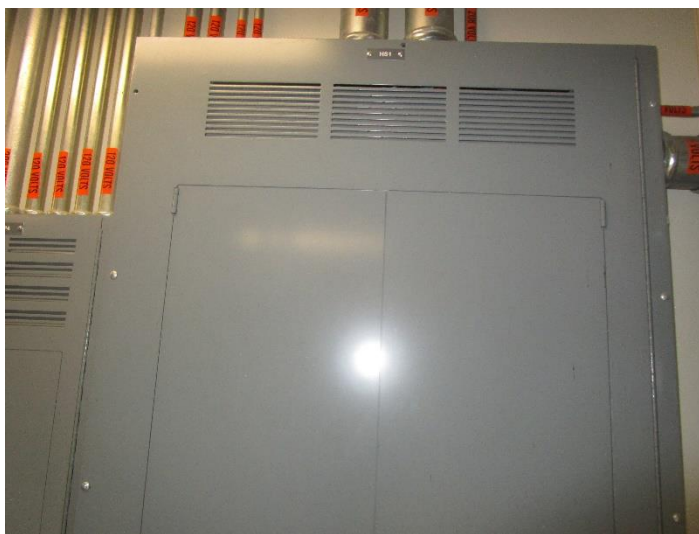
2. The interior mechanical room adjacent to the mechanical yard has associated panelboards “HS1” and “DP”. Panelboard “HS1” is a 600A square D type HCP 120/208V three phase 4 wire panelboard with main circuit breaker (Figure 5). The chiller is served from this panelboard along with associated chilled water and hot water pumps and other miscellaneous loads. Panelboard “DP” is an 800A square D I-Line 120/208V three phase 4 wire panelboard with main circuit breaker (Figure 6). This serves panelboard “P4” which is a 400A Square D type NQ 120/208V three phase 4 wire panelboard (Figure 7). Both of the roof top units “RTU-1” and RTU-2” and associated variable air volume units are fed from this panelboard.

3. The electrical service appears to have been updated with the last ten years. The associated panelboards and disconnects appear to have been update during this time period. The panelboards do not have arc flash or short circuit labels posted on any of the panelboards as required per NFPA 70E.

Figure 5 – Panelboard “HS1”

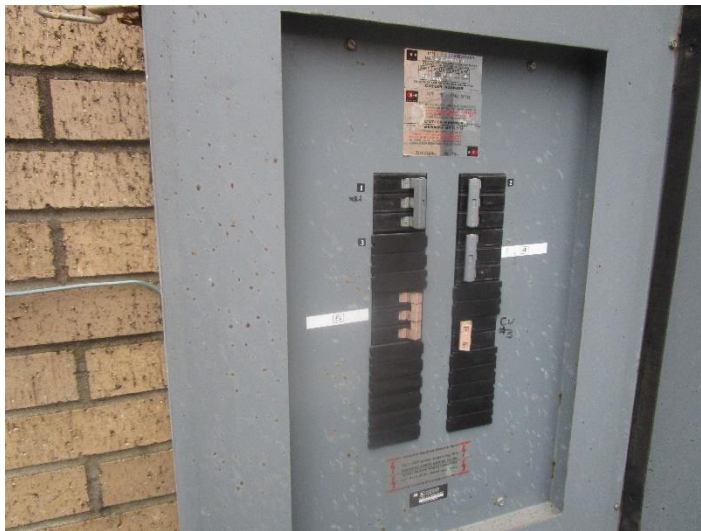
2. Panelboard "Elec-panel-1" is a 225A Cutler Hammer Type PB three phase, 4 wire, 120/240V panel. This panel serves the existing condensing units #1, #2, #3, #4, and #5 with 3 phase breakers to #1, #2, #4, and #5. Condensing unit #3 is served with a 2-pole breaker (Figure 5). The panelboard and most of the existing circuit breakers are roughly 36 years old and are beyond their life expectancy. Some of the existing branch breakers have been replaced. There were signs of rust on the enclosure and the outdoor environment can accelerate the degrading of the panelboard and more importantly the

associated breakers. No arc flash or short circuit labels were posted on any of the panelboards as required per NFPA 70E

Figure 5 – Panelboard “Elec-panel-1” located in Mech yard

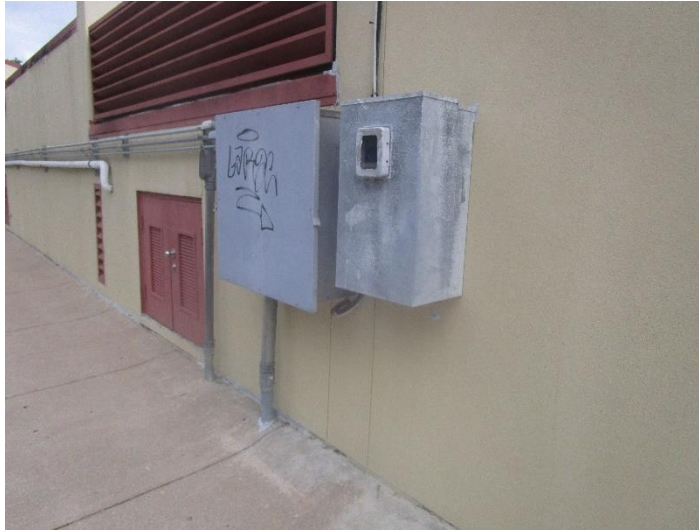
1. The main electrical service is fed from Austin Energy’s 12.47kV distribution to two-pole mounted single phase 25kVA transformers. The configuration is an open Hi-Leg Delta configuration providing 120/240V three phase electrical service. The secondary transitions to underground 4” conduit into a current transformer enclosure and associated metering (Figure 1).

Figure 1 – Main Electrical Service and Meter.

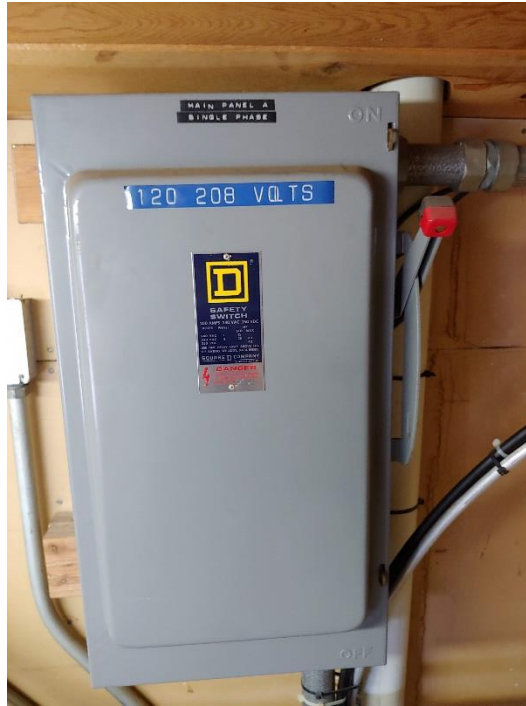
2. The small mezzanine electrical/mechanical room has a wireway which serves two 30A 3 Phase disconnects for condensing units #1 and #2 (Figure 2). Along with the main 200A disconnect to Panelboard “A” (Figure 3). There is no main disconnect readily accessible on the exterior of the building for emergency personnel.

Figure 3 – Disconnect to Panelboard “A”.

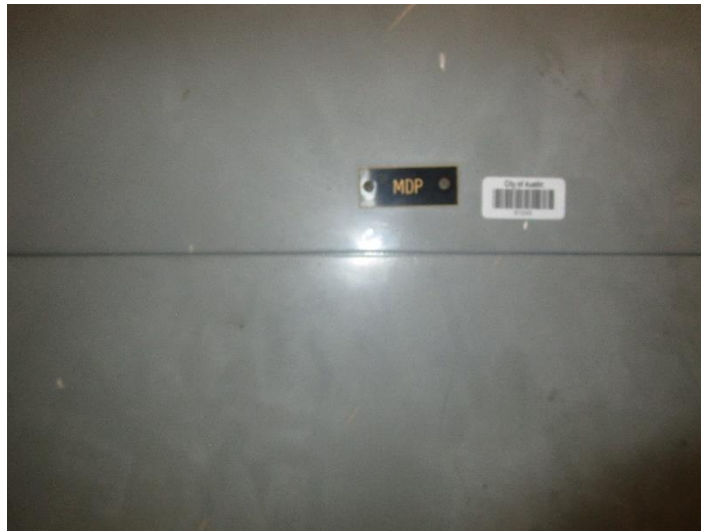
2. The interior electrical room has associated panelboards and motor control center. Main panelboard “MDP” is an 800A square D I-Line 120/208V three phase 4 wire panelboard with main lug only (Figure 9). The existing exterior air-cooled chiller is served from a 350A/3P breaker which is oversized for the 250A chiller. Motor control

center “MSC2” is an 100A Square D I-Line type HCM 120/208V three phase 4 wire panelboard (Figure 10). The motor control center has associated NEMA size 0 starters that serve the AHUs 1 thru 9 and chilled and hot water pumps. These panelboards appear to be original to the building and are roughly 40 years old and beyond their useful life expectancy. The dead front of the motor control center was missing so the possibility of rodents entering the motor control center is highly likely. This can cause electrical failures by way of rodents causing arcing across phases or chewing on electrical conductors and causing a failure. There is currently no main disconnect on the exterior of the building which does not meet the COA electrical requirements and is intended for the use of first responders and emergency personnel. No arc flash or short circuit labels were posted on any of the panelboards as required per NFPA 70E.

Figure 9 – Main Distribution Panel “MDP”.

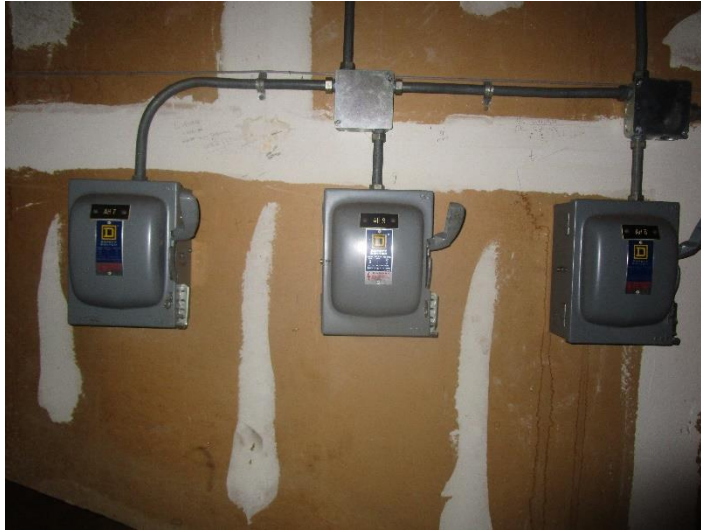
3. The AHUs 1 thru 9 are in the mezzanine area along with the associated chilled and hot water pumps (Figures 11 and 12). The disconnect switches are 30A, 3 phase disconnects that are original to the building and beyond useful life.

Figure 11 – Air Handling Unit disconnect switches

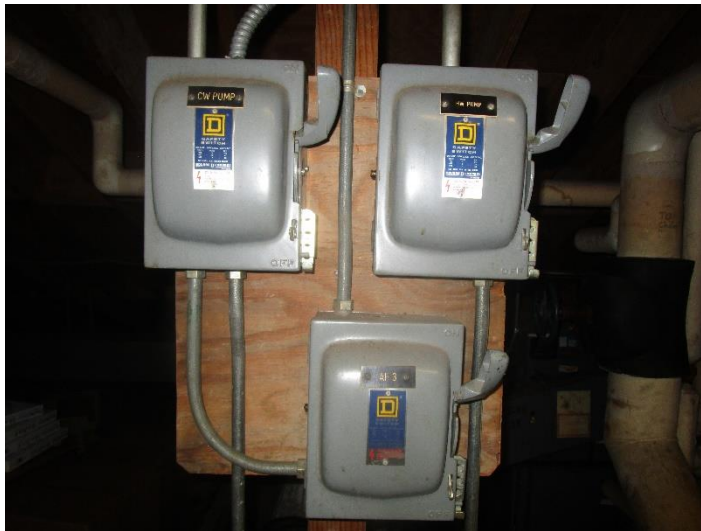
Figure 12 – Hot and Chilled Water Pumps disconnect switches

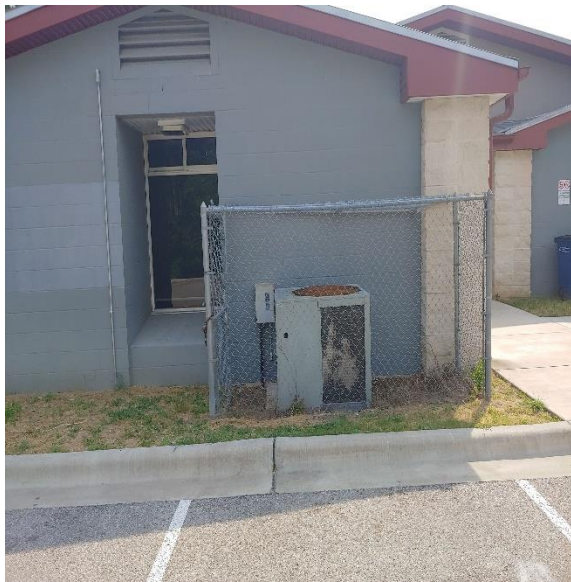
2. The AHUs provide heat to the building by natural gas fired furnaces. Raw (unconditioned, ambient temperature) outdoor air is provided to the building by air direct ducted to the return side of the AHUs. Residential AHUs are not designed to condition raw outdoor air and should not be used for that application.
3. Condensing unit #1 was manufactured in 2013 and serves AHU #1. Condensing unit #2 was manufactured in 2000 and serves AHU #2 and AHU #3. Industry expected equipment service life for residential DX split system condensing units is 15 – 20 years. The condensing unit #1 is 7 years old and is within its useful life expectancy. Condensing unit #2 is 20 years old and beyond its useful life expectancy.

Figure 4 – Condensing Unit #2

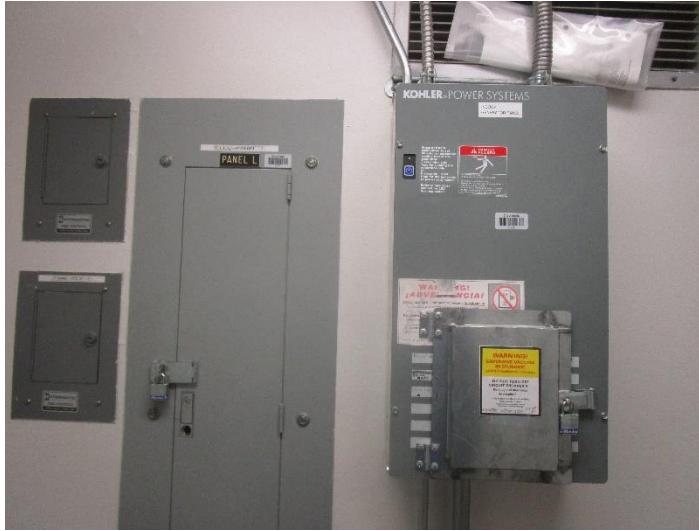
2. Existing Panelboard “L” appears to be a 200A GE 3 Phase 4 Wire panelboard which feeds “Panel P”. There were no keys available to access the panelboard (Figure 7).

Figure 7 – Panelboard “L”

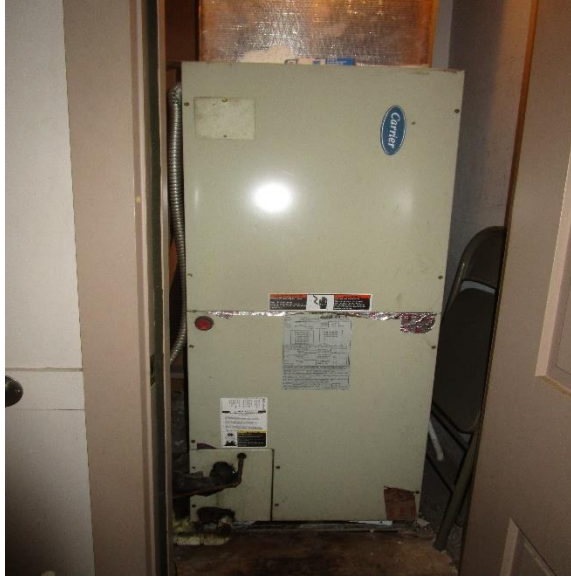
Figure 1 – AHU #1 in Mechanical Closet.

1. The Building Heating, Ventilation, and Air Conditioning (HVAC) is provided by one residential-type Direct Expansion (DX) heat pump system Air Handling Unit (AHU) manufactured in 1993 (AHU #1). AHU #1 is in a mechanical closet accessed via the corridor. Associated condensing unit is in behind the building. Heating is provided by way of electric heat strips in the air handling unit. Industry expected equipment service life for residential DX heat pumps system AHUs is 15 years. AHU #1 has been in service for 27 years and is beyond its expected service life. The AHU is controlled by wall-mounted programmable thermostats. No monitoring control system was observed.

1. Replace AHU-1, and its associated thermostat.
2. Replace Condensing Unit #1 and its associated refrigerant piping.
3. Provide an air cleaning device such as UV-C lamps or bipolar ionization systems at all AHUs.
4. Provide a HVAC control system to facilitate remote monitoring and control.
5. Provide a minimum MERV 13 air filter in each AHU.
6. Clean all existing ductwork and air devices utilizing an aerosol biocide.

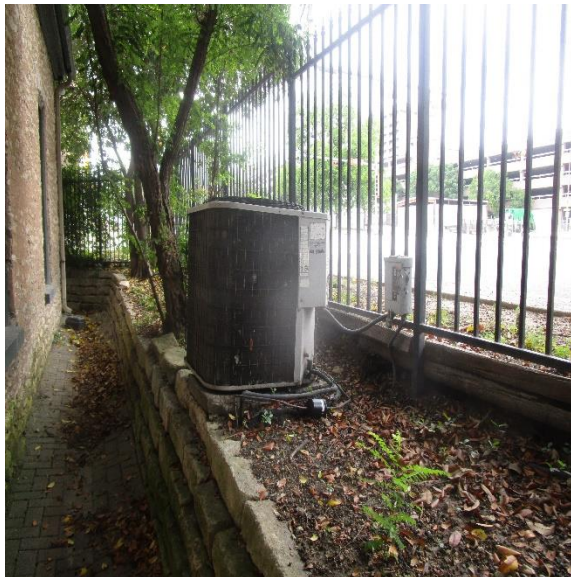
Figure 2 – Condensing Unit #1.

2. Condensing unit #1 was manufactured in 1993 and serves AHU #1. Industry expected equipment service life for residential DX split system condensing units is 15 – 20 years. The condensing unit #1 is 27 years old and is beyond its useful life.

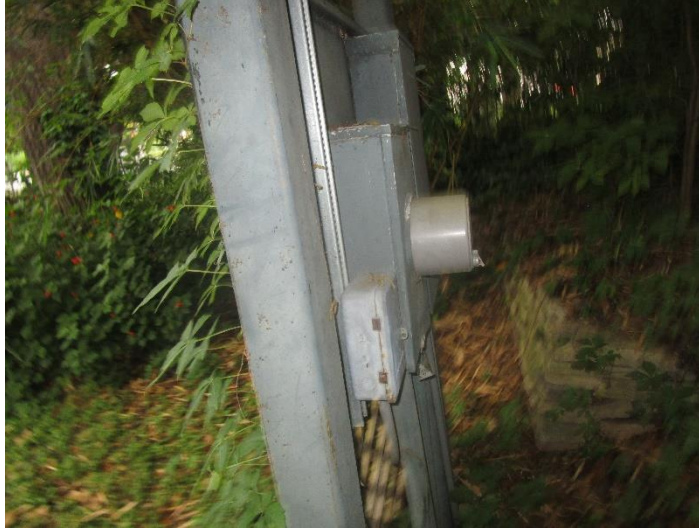
Figure 3 – Main Electrical Service in Courtyard.

1. The main electrical service is fed from Austin Energy's 12.47kV distribution to a pole mounted three single phase 25kVA transformer and then transitions to underground to a 100A, 120/208V three phase electrical service exterior to the building (Figure 3). The main panelboard is a 200A GE 120/208V 3 Phase 4 Wire panelboard with associated metering (Figure 4). The existing electric heat strips in the air handling unit and interior panelboard are fed from this panelboard. The panelboard and most of the

existing circuit breakers are roughly 34 years old and are beyond their life expectancy. Some of the existing branch breakers have been replaced however the panelboard is not clearly visible for emergency personnel. No arc flash or short circuit labels were posted on any of the panelboards as required per NFPA 70E.

3. Provide new surge protective devices at disconnect and panelboard to protect new HVAC system components.
4. Provide short circuit and arc flash hazard assessment study.
5. Provide arc flash labels at all panelboards per NFPA 70E requirement.

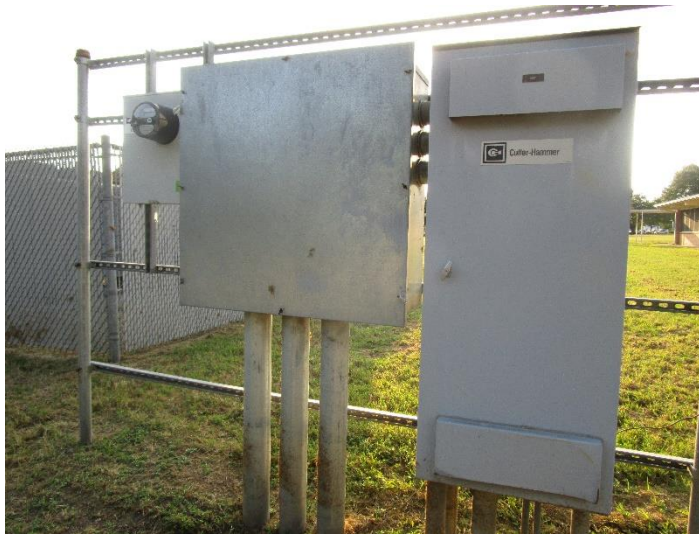
Figure 5 – Main Distribution Panel “MDP”

1. The main electrical service is fed from Austin Energy's 12.47kV distribution to a pad mounted three phase 500kVA transformer. The service then transitions underground and feeds a CT enclosure with associated metering. The main distribution panel "MDP" is an 800A, 480/277V Cutler-Hammer 3 Phase, 4 Wire (Figure 5).

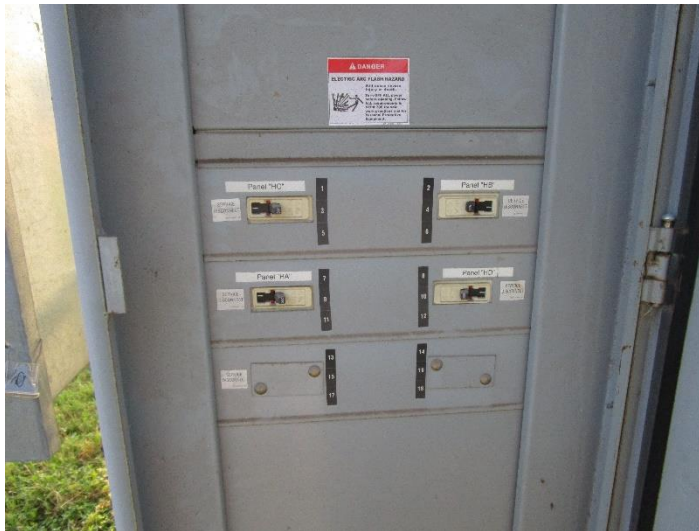
Figure 6 – Panelboard “MDP”

2. Panelboard "MDP" serves the associated buildings A, B, C, and D. The panelboard is approximately 17 years old and has signs of rust and age due to exposure to the elements (Figure 6). No arc flash labels were present as required per NFPA 70E.

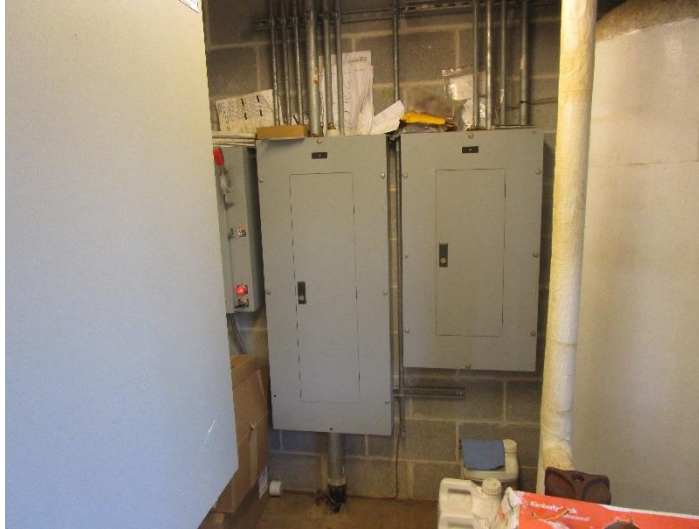
Figure 7 – Panelboards “HC” and “LC”

3. The main electrical service inside the mechanical building is fed from Main Distribution Panel "MDP" circuits 1, 3, 5 with a 200A/3 pole breaker. The main panelboard "HC" SIEMENS 225A type PRL2A 480/277V 3 Phase 4 Wire panelboard (Figure 7). The panel serves the Chiller with a 200A/3P breaker which is oversized

per the Chiller nameplate. The nameplate recommends a maximum over current device of a 150A/3P breaker. The panelboard also serves two chilled water pumps CHWP-1 and CHWP-2 and two hot water pumps HWP-1 and HWP-2. The panelboard was manufactured in 2003 and is 17 years old and has signs of rust and age due to exposure to the elements. No arc flash labels were present as required per NFPA 70E.

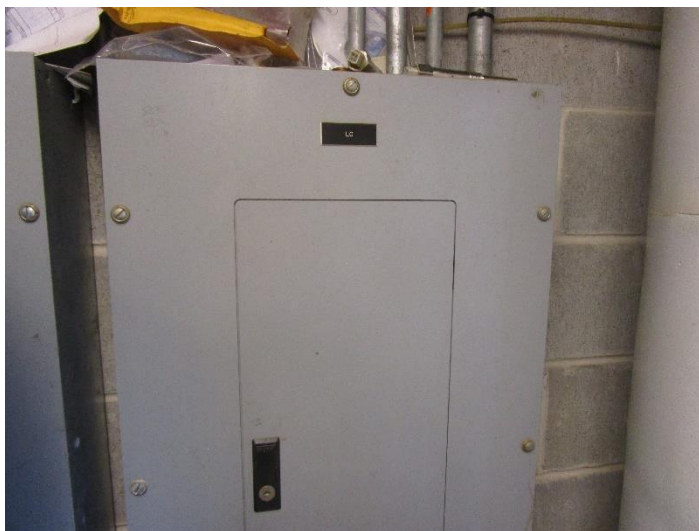
Figure 8 – Panelboard “LC”

4. The downstream 120/208V 3 Phase 4 Wire Panelboard “LC” SIEMENS type PRL1a 100A with 60A/3 pole main breaker (Figure 8). The panel is fed from a 15kVA transformer and serves various loads and the chiller controls. The panel was also manufactured in 2003 and has signs of rust and age due to harsh conditions. No arc flash labels were present as required per NFPA 70E.

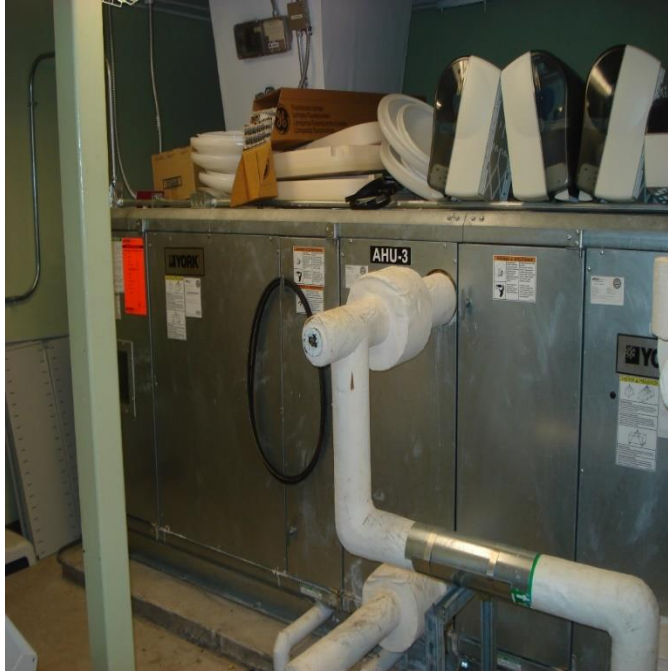
Figure 1 – AHU-3

1. The Building Heating, Ventilation, and Air Conditioning (HVAC) is by chilled and heating water produced at and pumped from nearby Building D. Airside systems are comprised of a Variable Air Volume (VAV) Air Handling Unit (AHU). Primary air from the AHU serves medium pressure ductwork upstream of VAV terminal units. The VAV terminal units modulate airflow and heating water (to integral heating coils and control valves) as required to meet zone temperatures.
2. AHU-3 is manufactured by York in 2003 and is comprised of the following components: Mixing section, filters, cooling coils, fan with variable speed drive (VSD). Corrosion was observed at the lower edges of the casing at the cooling coil sections. Inside the cooling coil section, corrosion was observed. This could indicate a clogged drainpipe.

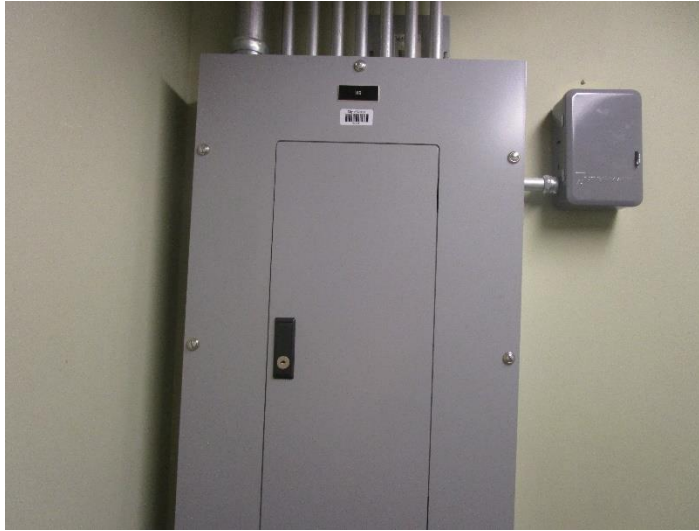
Figure 2 – Panelboard “HB”

1. The main electrical service is fed from building D Main Distribution Panel “MDP” circuit 2, 4, 6 with a 125A/3 pole breaker. The main panelboard in building C is in electrical room C.13. The main panelboard “HB” is a SIEMENS 225A type PRL2A 480/277V 3 Phase 4 Wire panelboard (Figure 2). The air handling unit “AHU-3” is served from this panelboard by a 20A/3 pole breaker on circuits 7, 9, 11. The panelboard was manufactured in 2003 and is 17 years old and appears in good condition. No arc flash labels were present as required per NFPA 70E.

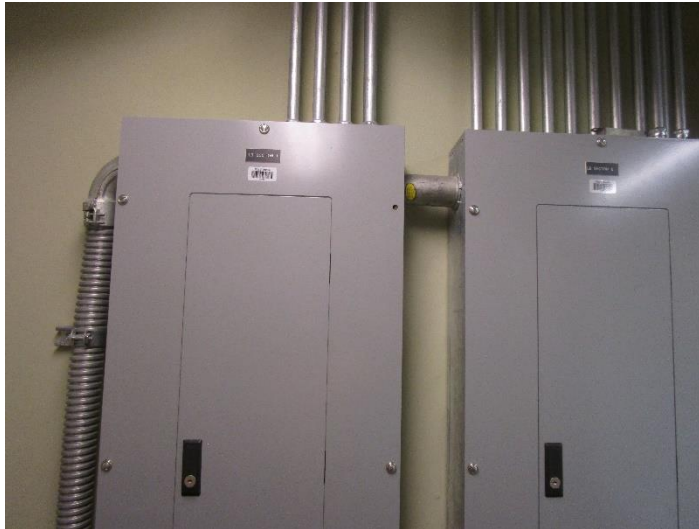
Figure 3 – Panelboard “LB” Section 1 & 2

2. The downstream 120/208V 3 Phase 4 Wire Panelboard “LB” is a 2 Section SIEMENS type PRL1A 225A with 175A main breaker (Figure 3). The panel is fed from a 50kVA transformer and serves various loads and the associated HVAC controls. The panel was also manufactured in 2003 and appears to be in good condition. No arc flash labels were present as required per NFPA 70E.

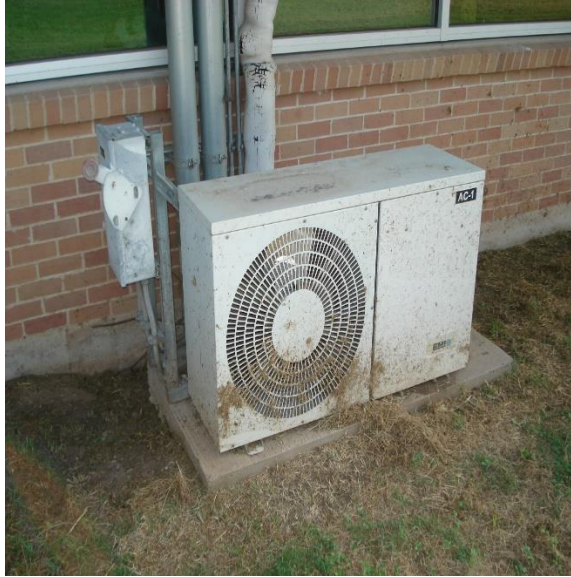
Figure 3 – Mini Split Condensing Unit

3. VAV boxes were observed to be in good condition with no notable deficiencies.
4. The ductwork and air devices in Building E were observed to be in good condition.
5. A Direct Expansion (DX) 'Mini-Split' heat pump systems “cools” a server room with an approximate capacity of 2 nominal Tons. The associated condensing unit is located outside. Both the indoor unit, condensing unit, and associated refrigerant piping and insulation appear to be beyond their useful life.

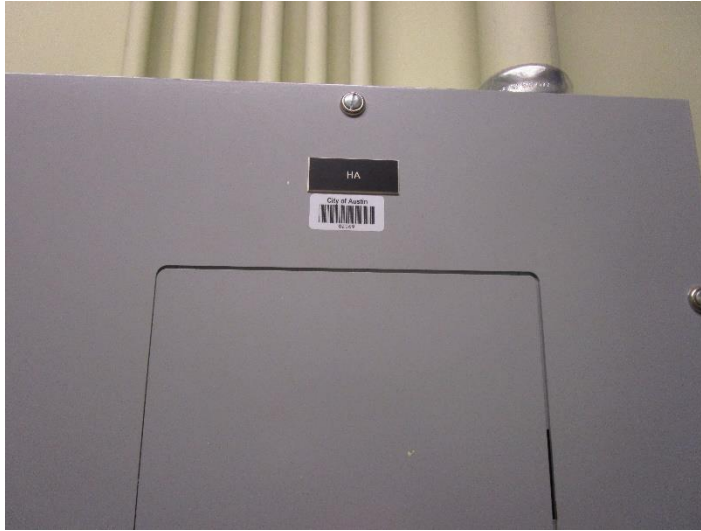
Figure 4 – Panelboard “HA”

1. The main electrical service is fed from Building D Main Distribution Panel “MDP” circuit 7, 9, 11 with a 200A/3 pole breaker.
2. The main panelboard in building E is located in electrical room E.13. The main panelboard “HA” is a SIEMENS 225A type PRL2A 480/277V 3 Phase 4 Wire panelboard (Figure 4). The air handling units “AHU-1” and “AHU-2” are served from 20A/3 pole breakers on circuits 13, 15, 17 and 14, 16, 17. The panelboard was manufactured in 2003 and is 17 years old and appears in good condition. No arc flash labels were present as required per NFPA 70E.

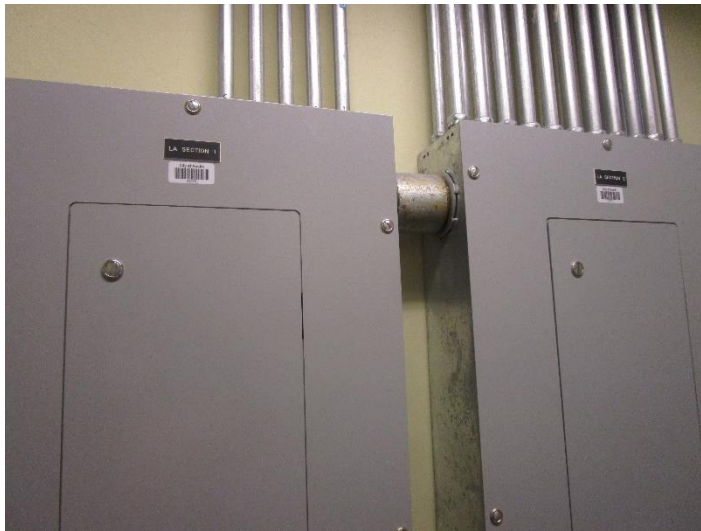
Figure 5 – Panelboard “LA” Section 1 & 2

3. The downstream 120/208V 3 Phase 4 Wire Panelboard “LA” is a two-section SIEMENS type PRL1A 250A with 250A main breaker (Figure 5). The panel is fed from a 75kVA transformer and serves various loads and the associated HVAC controls. The panel was also manufactured in 2003 and appears to be in good condition. No arc flash labels were present as required per NFPA 70E.

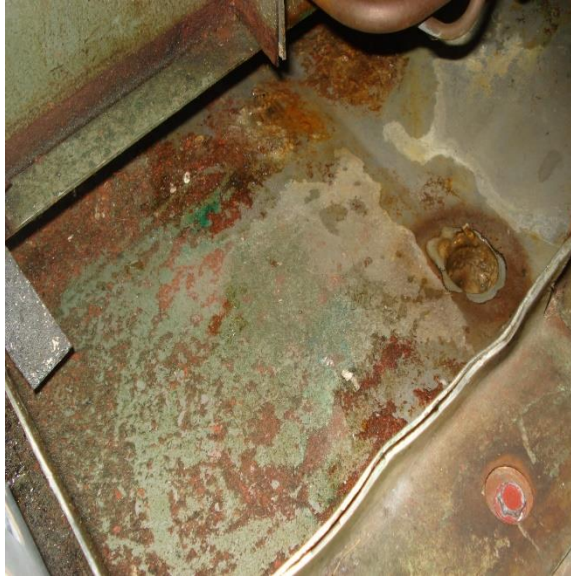
Figure 1 – AHU-1 Internal at Cooling Coil

1. The Building Heating, Ventilation, and Air Conditioning (HVAC) is provided by a Direct Expansion (DX) split system Air Handling Unit (AHU) manufactured in 1993. The AHU is a single zone system serving the entire area of the building and is in a mechanical room. The AHU utilizes a variable speed drive for fan motor control and incorporates an airside economizer control sequence. The refrigerant used in this machine is R-22. Building heat is provided by an electric heating element in the AHU.
2. Corrosion was observed around the bottom edges of the AHU casing. The fan and motor were observed to be noisy during operation. Industry expected equipment service life for AHUs is 20 years. The AHU has been in service for 27 years and is beyond useful life.

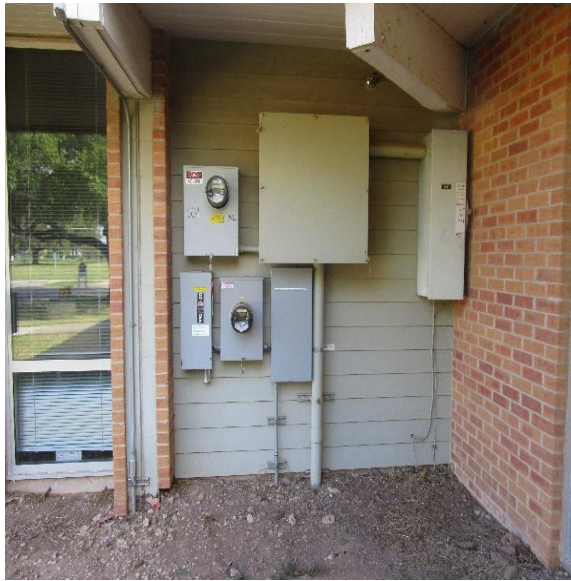
Figure 3 – Service Entrance and associated Metering

1. The main electrical service is fed from Austin Energy's 12.47kV distribution to three pole mounted single phase 50kVA transformers. The service transitions underground to feed a current transformer enclosure and associated meters and main disconnect (Figure 3).

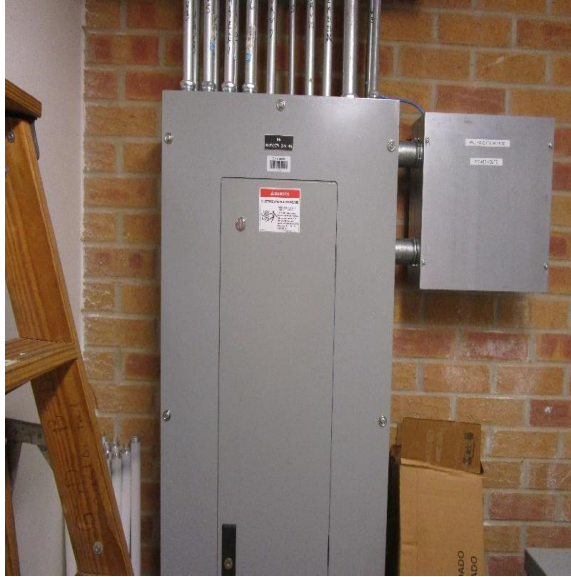
Figure 4 – Panelboard “HA”

2. The interior main panelboard "HA" is a Cutler-Hammer 400A 480/277V 3 Phase 4 Wire Panelboard (Figure 4). The panel was manufactured in 2005 so roughly 15 years old and in good condition. The panel serves the air-cooled chiller ACCU-1 the air handling unit AHU-1 and various variable air volume units. No arc flash labels were present as required per NFPA 70E.

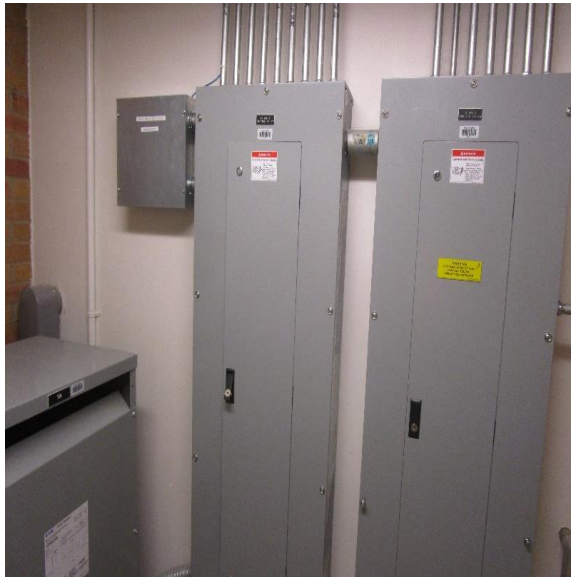
Figure 5 – Panelboard “LA” Section 1 & 2

3. The downstream 120/208V 3 Phase 4 Wire Panelboard “LA” is a 2 Section SIEMENS type PRL1A 225A with 175A main breaker (Figure 5). The panel is fed from a 50kVA transformer and serves various loads and the associated HVAC controls. The panel was also manufactured in 2003 and appears to be in good condition. These panels serve various loads including the controls for the HVAC system. No arc flash labels were present as required per NFPA 70E.

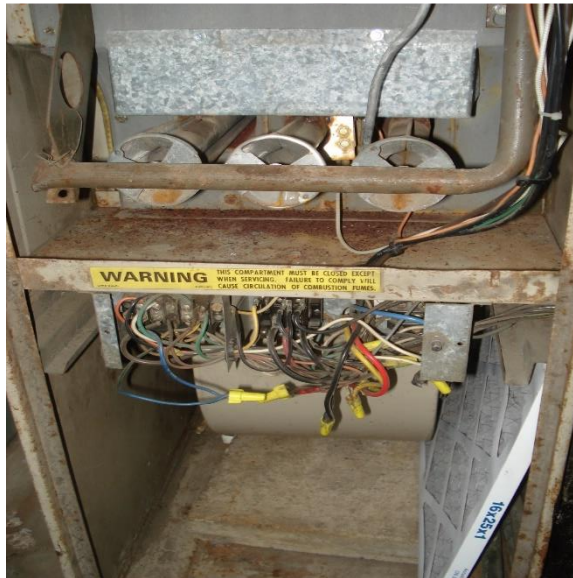
Figure 1 – Internals of AHU-1.

AHU-1 and the associated condensing unit appears to be building original (1982). They were observed to have areas of rust developing on equipment casings. Refrigerant pipe insulation was observed to be in poor condition. Industry expected

equipment service life for residential DX split system AHUs is 15 years. AHU-1 has been in service for 38 years and is beyond useful life.

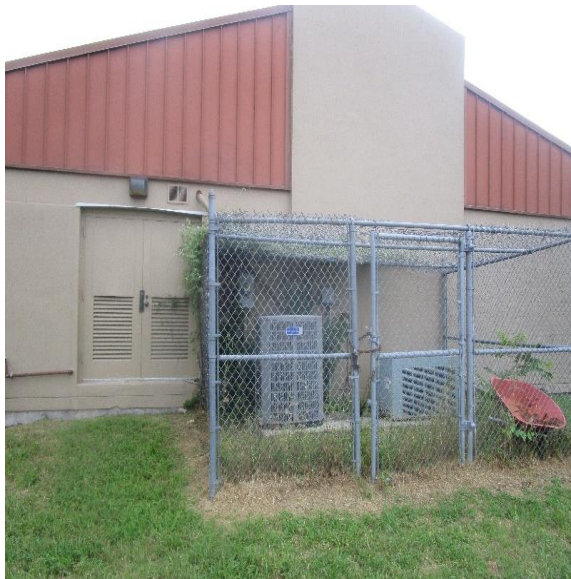
Figure 4– Main Electrical Service Fenced Area.

1. The main electrical service is fed from Austin Energy's 12.47kV distribution to three pole mounted single phase 25kVA transformers and then transitions underground to feed a 200A, 120/208V 3 Phase 4 Wire Main Disconnect and meter in the fenced in area (Figures 4 & 5).

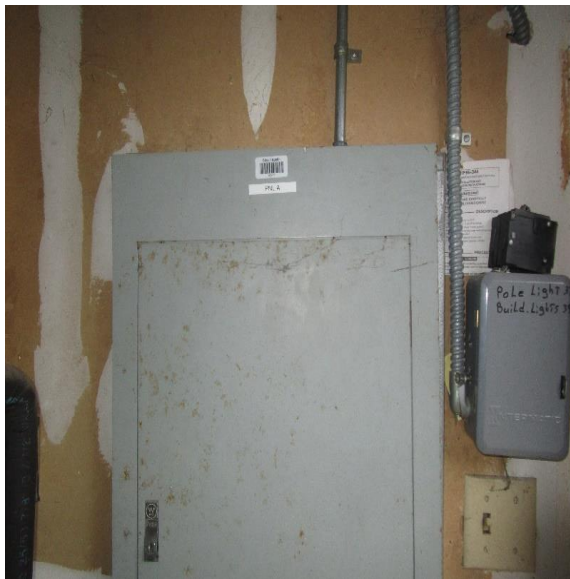
Figure 6 – Main Panelboard “A”.

2. The interior main panelboard “A” is a Westinghouse 225A 120/208V 3 Phase 4 Wire panelboard. The panelboard appears to be original to the building so approximately 38 years old and in need of replacement. The panelboard serves the two condensing units and air handling units. No arc flash or short circuit labels were posted on any of the panelboards as required per NFPA 70E.
