Neill-Cochran House Museum Slave Quarters Project  
City of Austin Certificate of Appropriateness Application 2023

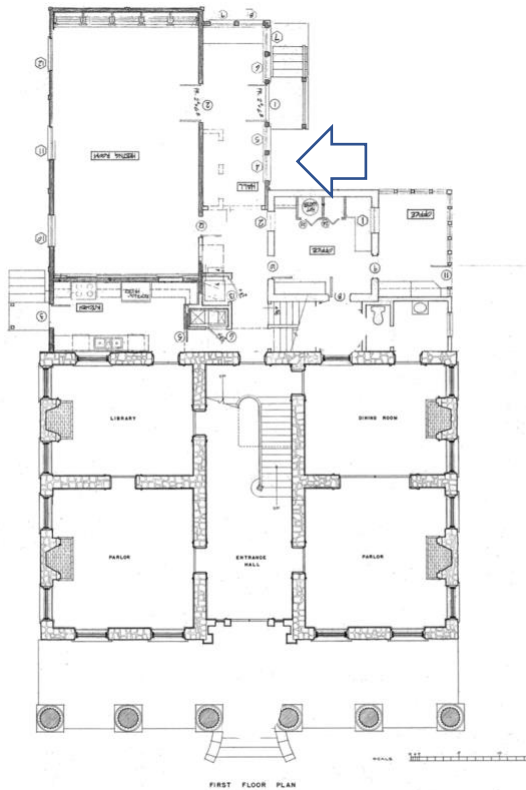
The arrow shows the location of the existing lift as well as the location where the new lift will be placed.

The NCHM has also received funding from the Heritage Grants program to replace our aging and unreliable ADA lift. The existing lift is connected to the stairs that enter at the back of the 1977 addition to the historic main house. The existing lift is not connected to the 1856 structure or the 1900 addition, and the new lift will not impact the historic structure either.

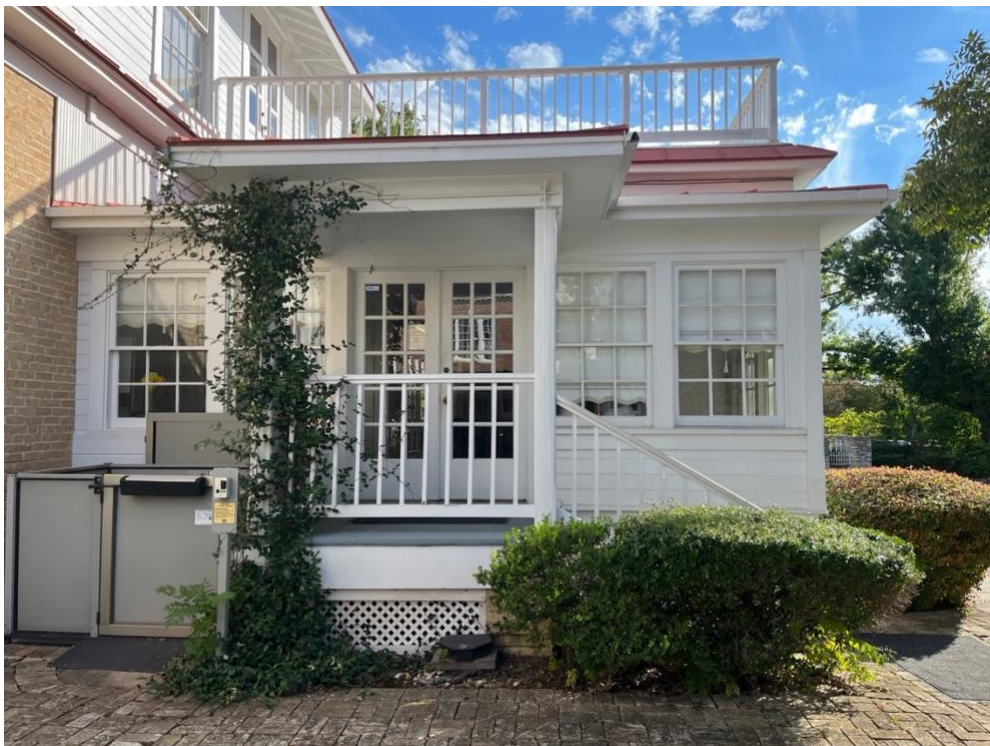
Below: a photograph of the existing lift.
