Austin Parks and Recreation Department

Barton Springs Pool Tree

September 25, 2023

Review of Reports and communications from the community

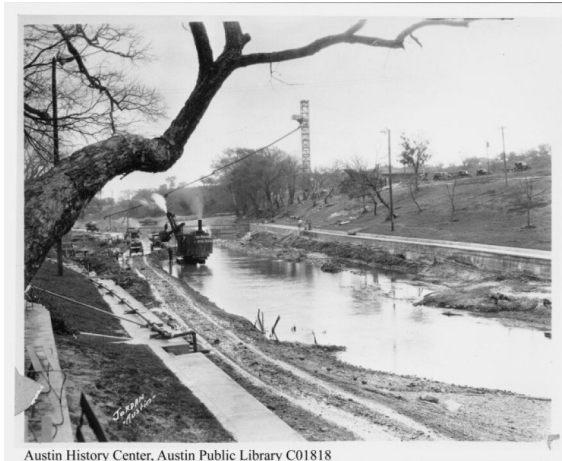
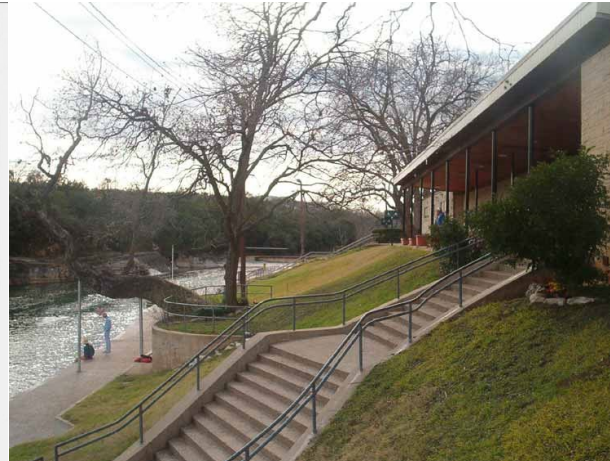
- PARD Forestry staff agree with the consulting arborists that the safety hazards are too great and tree removal is needed
- Community support for honoring the tree
- Work with community on how best to honor this tree

- Option 1 – Follow recommendation to remove the tree and solicit public comments on how best to honor/memorialize the tree
 - Reduces risk
 - Allows ADA access to reopen quickly
 - Unrestricted pool use
 - Minimizes potential for fungus to spread
