**EMMA S. BARRIENTOS**  
**MEXICAN AMERICAN CULTURAL CENTER**  
**Phase 2 Improvements**  
**MACC Advisory Board Update**

**Heidi Tse**  
**Capital Delivery Project Manager**  
**February 4, 2026**

## Heating Hot Water Loop Leak

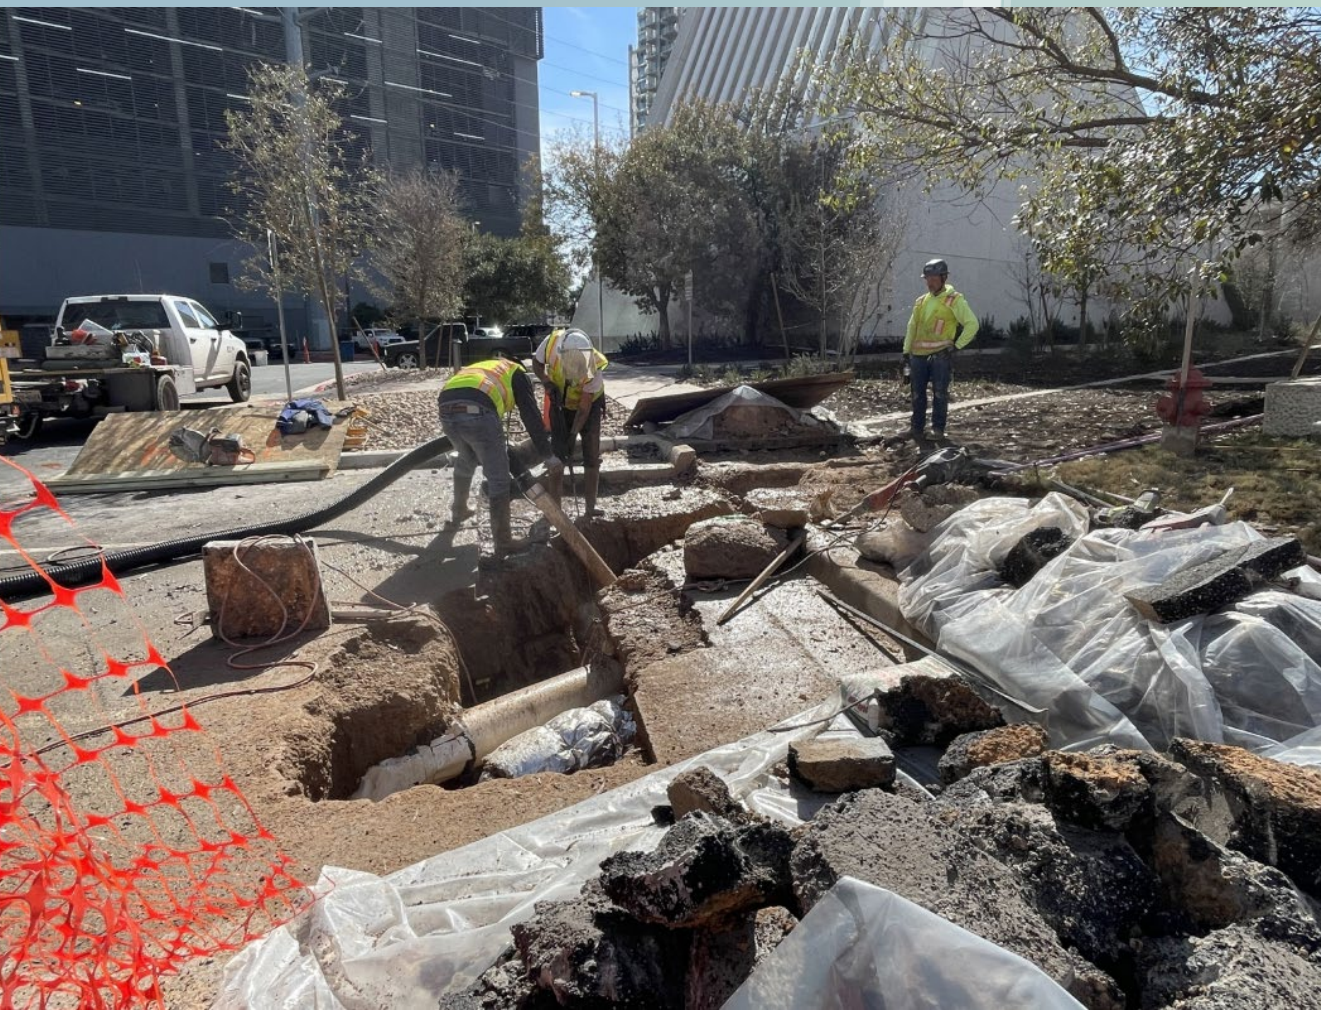
The pipe has deteriorated to the point that 6" steel ductile iron is peeling off as layers with the 2" insulation. The picture indicates rust and stress corrosive cracks (fine brittle cracks formed by combined stress and the corrosive wet environment).
