**HISTORIC LANDMARK COMMISSION  
MARCH 28, 2016  
DEMOLITION AND RELOCATION PERMITS  
HDP-2016-0011  
306 RIDGEWOOD ROAD**

**Visible Structural Condition Inspection  
at  
306 Ridgewood, Austin, Texas 78746**

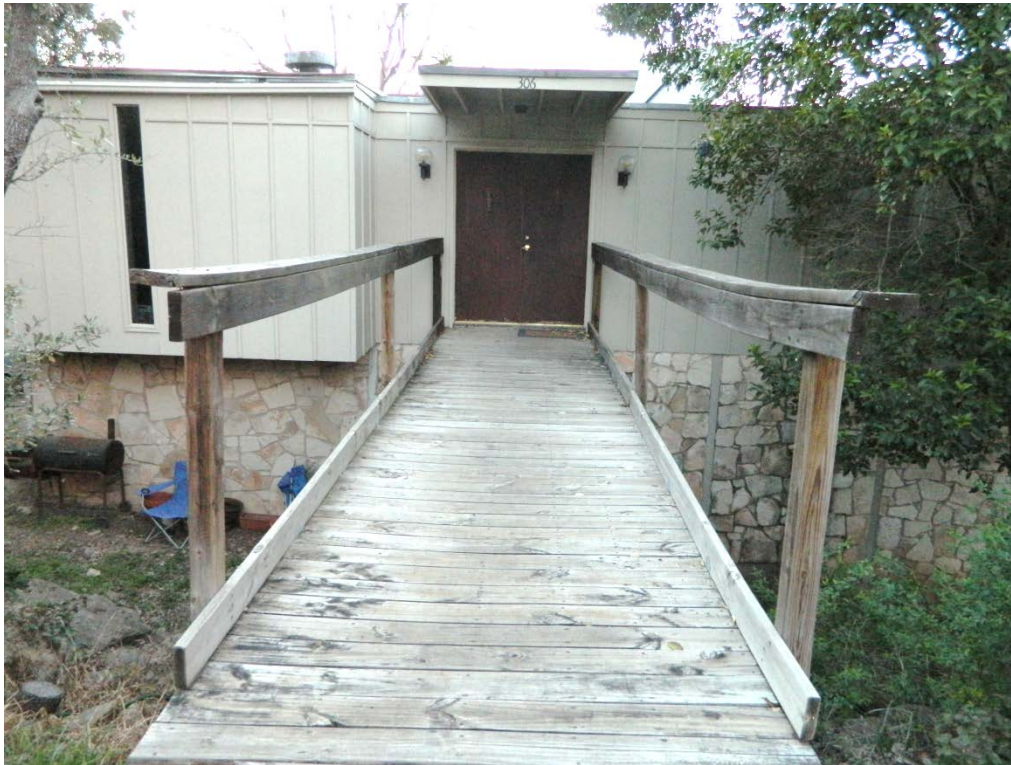
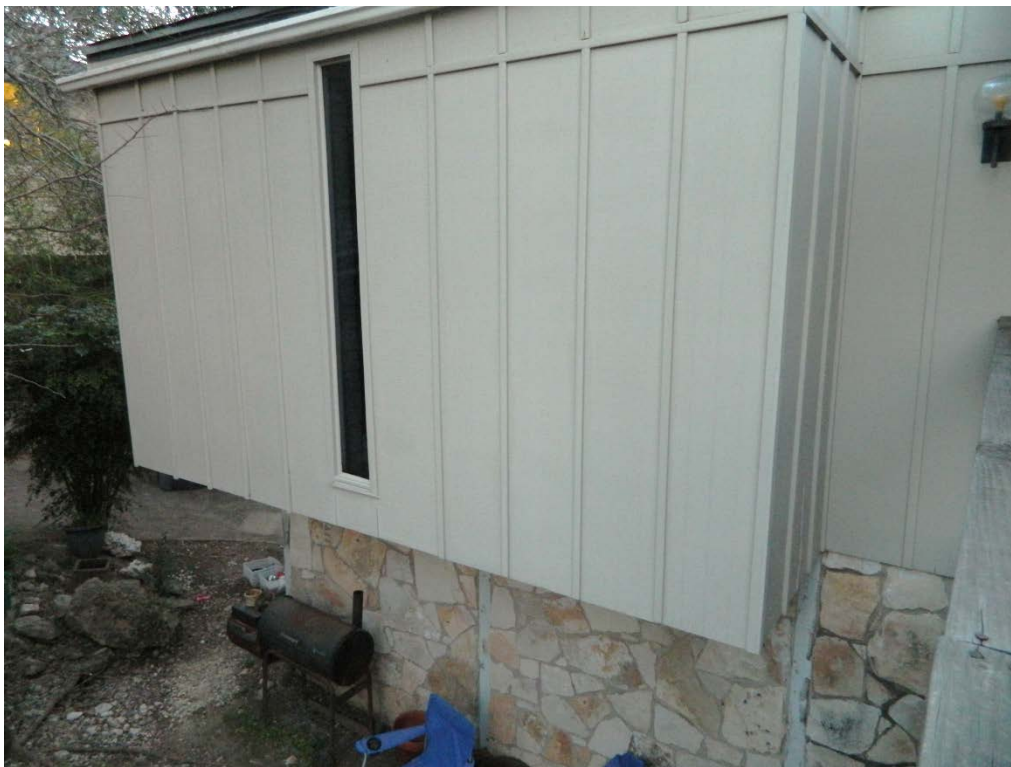
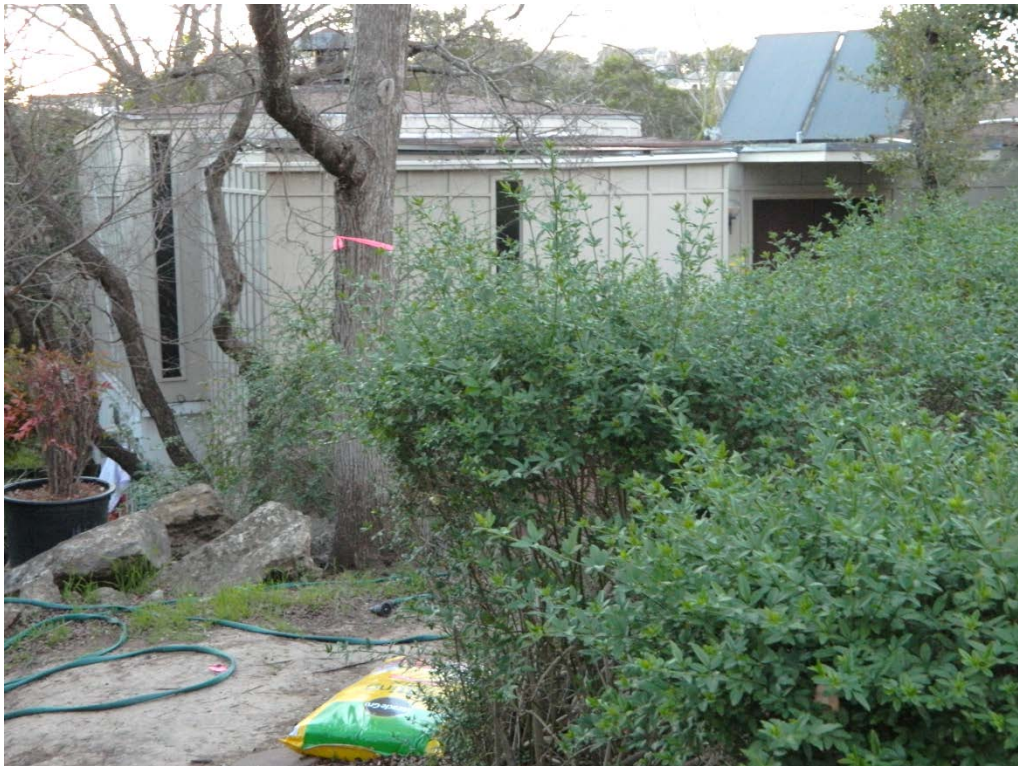
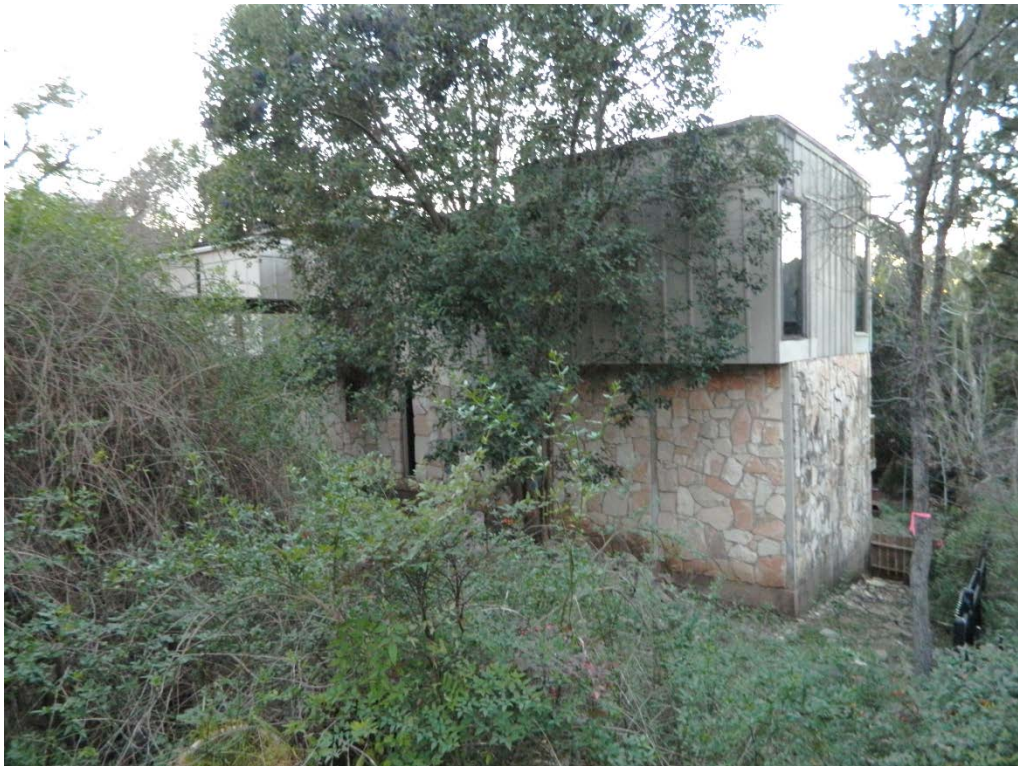
306 Ridgewood Road  
ca. 1969

Two-story, rectangular-plan, rock veneer and wood-sided frame house with a recessed entryway covered by a partial-width flat-roofed entry hood; double-leaf front doors; flat roof; tall, fixed-sash narrow fenestration.
