Waller Creek Corridor Framework Plan

Block-by-Block Enlargements

WALLER CREEK CORRIDOR: PROJECT SEGMENTS

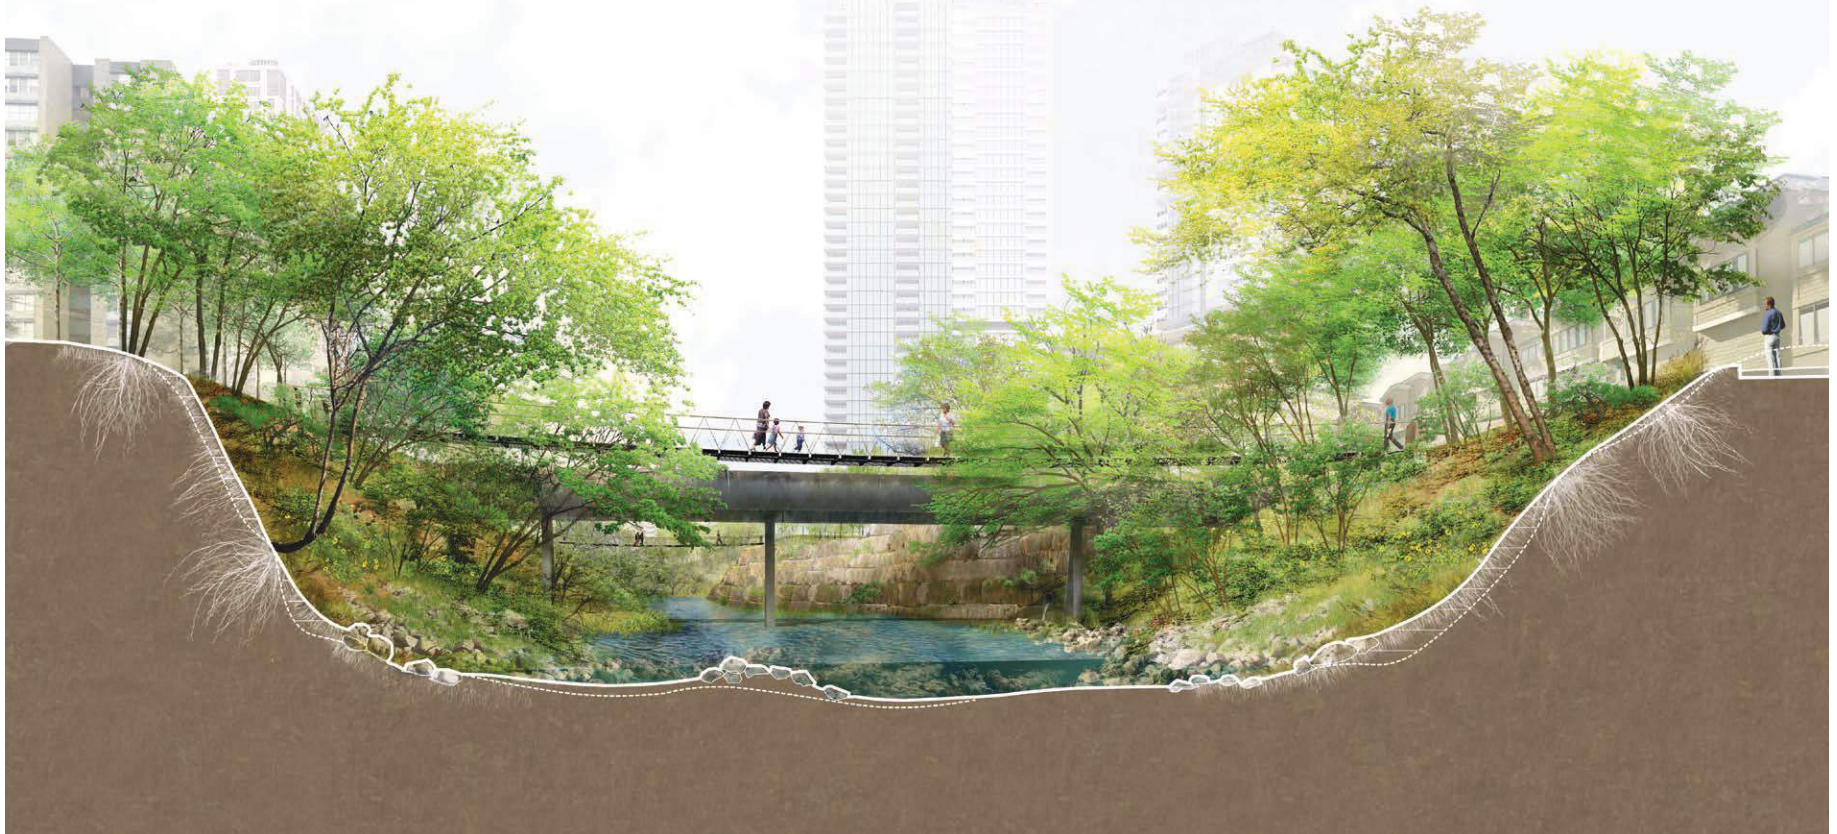
A LATTICE OF BRIDGES

The proposal to exaggerate pedestrian connectivity in this location with five bridges at the top of the creek banks, seeks to transform the perception of the creek as a barrier into the creek to that of an incubator of urban connectivity, both between the emerging developments on either bank but also between the Lake and the downtown.

A Lattice Bridge will span over an existing 42-inch aerial wastewater line, transforming this eyesore and unattractive nuisance into an invitation to experience one of the most robust and ecologically rich segments of the creek. Bridge abutments will require careful coordination with vertical and horizontal utility easements and careful integration with the construction methodology of the slope restoration.

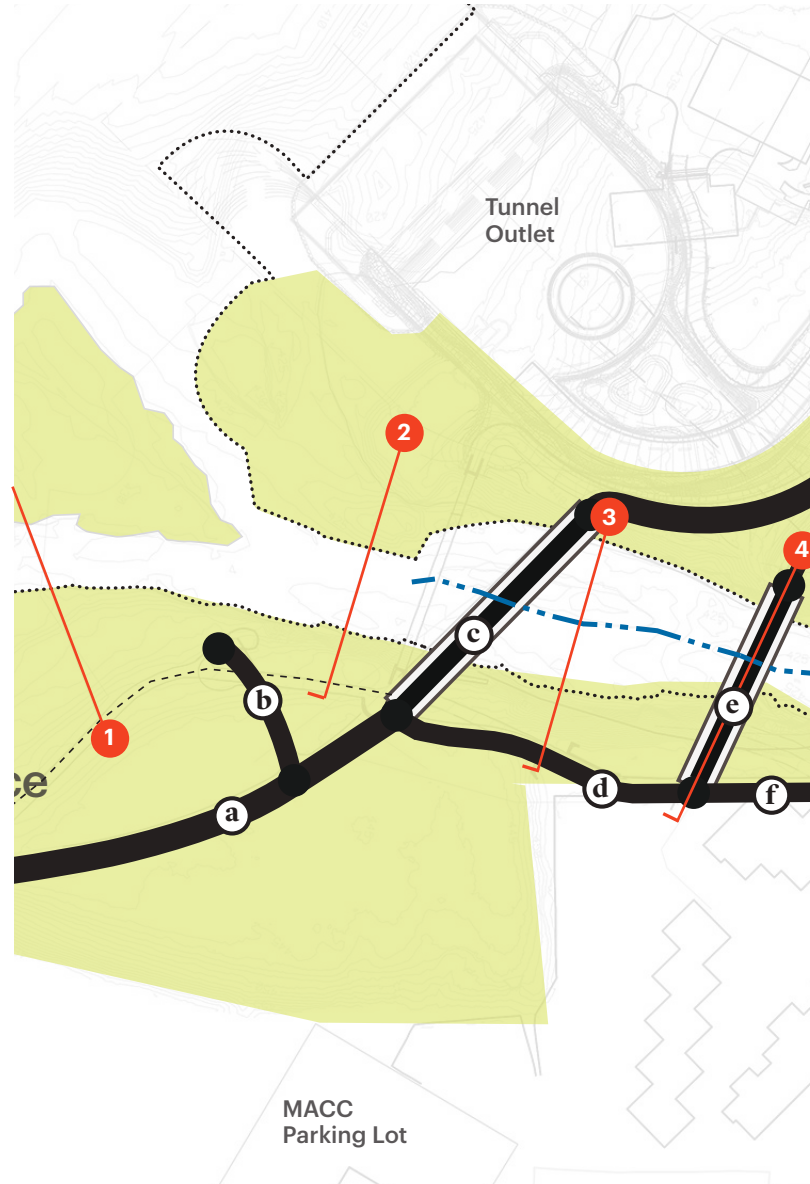
CREEK MOUTH

TRAIL ALIGNMENT

- a. Realignment of existing Butler Hike & Bike Trail to better align with creek crossing and improve sightlines.
- b. Trail spur to access existing memorial benches. Prior to any potential future relocation, dedication terms should be confirmed.

- c. Lattice Bridge replaces existing pre-cast bridge. New alignment eliminates "T" intersection and improves sightlines. Views from bridge to existing islands below offer opportunities for watching wildlife from above without disturbing habitat.

- Zone 3 Assessment performed along Waller Creek from Red River to 3rd Street on June 5, 2014.
- Overall assessed condition is FAIR. (Riparian Zone = FAIR, Geomorphology = FAIR, Aquatic Habitat = GOOD)
- Improvements should increase the overall assessed condition to GOOD or EXCELLENT.
- Consider increasing the vegetation coverage within the riparian area and the in-stream canopy cover, using log structures and natural materials such as native vegetation and rock to provide a stable channel form, and providing floodplain connectivity to improve stream function.

- Existing slopes on both banks are to be preserved or restored.
- Large expanses of existing lawn on both banks can transition to riparian planting at trails.
- Invasive giant reed is to be removed and replaced with planting in character with native riparian habitat.

- 10 Heritage Trees on this block.
- 3 Heritage Trees near Town Lake Villas in poor condition.
- 3 Heritage-class trees in good condition near memorial benches.
- Dense stand of invasive giant reed on west bank hinders visibility from trail and collects litter.
- Overstory dominated by black willow and hackberry.
- Midstory dominated by hackberry, box elder, poison ivy, and mustang grape.

- A major power transmission line crosses Waller Creek just before it reaches Lady Bird Lake. There is no intention to relocate this line, however, easements and foundation extents for pylons must be confirmed before designing micropile foundations for the southernmost Lattice Bridge (c).
- 42" wastewater line (approximately 60" diameter casing) crosses the creek at the intermediate Lattice Bridge (5). Vertical and horizontal utility easements must be carefully considered in Bridge abutment design.

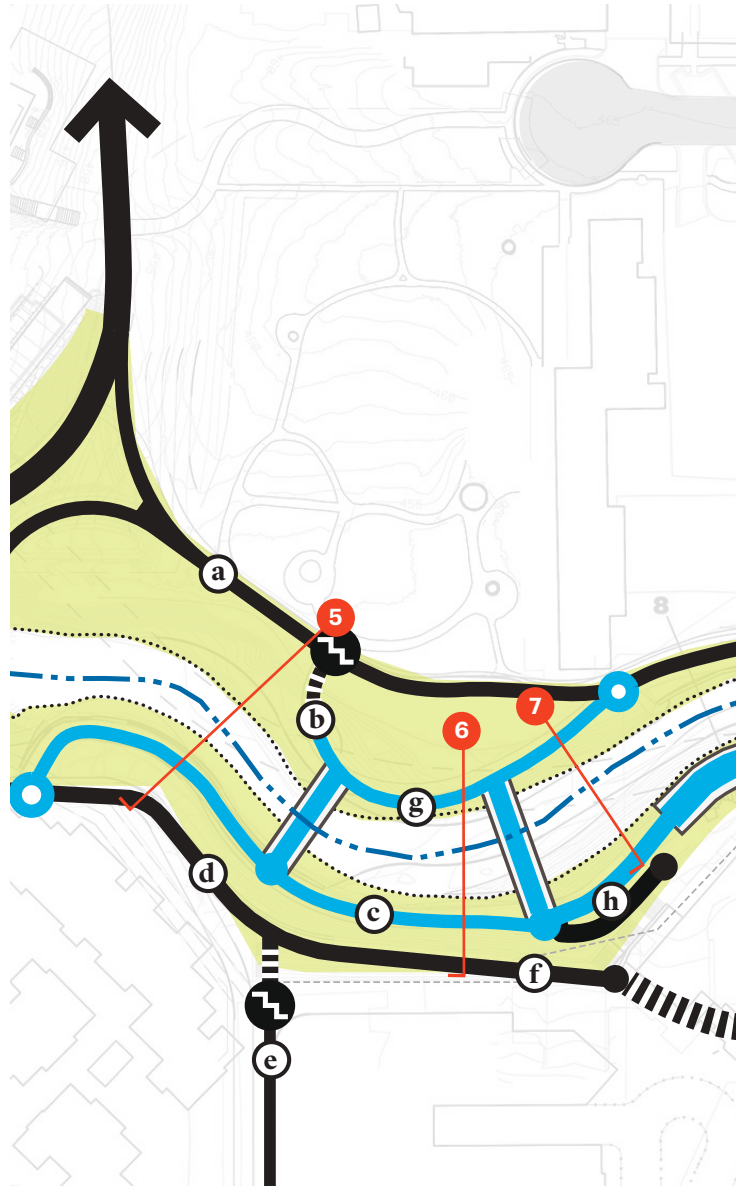
LATTICE BRIDGES AT FORMER DAVIS STREET ROW

TRAIL ALIGNMENT

- a. New trail within footprint of existing trail. Grades to be modified to connect at <5% to new trails at Waller Creek Tunnel Outlet facility.
- b. Stairs needed to connect existing top-of-bank trail to grades compatible with existing adjacent Heritage Trees and provide access to mid-slope Lattice Bridges.

- 7 Heritage Trees on this block. 2 on the west bank are in poor condition.
- Mid-slope trail on east bank (e) runs alongside grove of Heritage Trees; critical root zones to be verified before or during trail design.

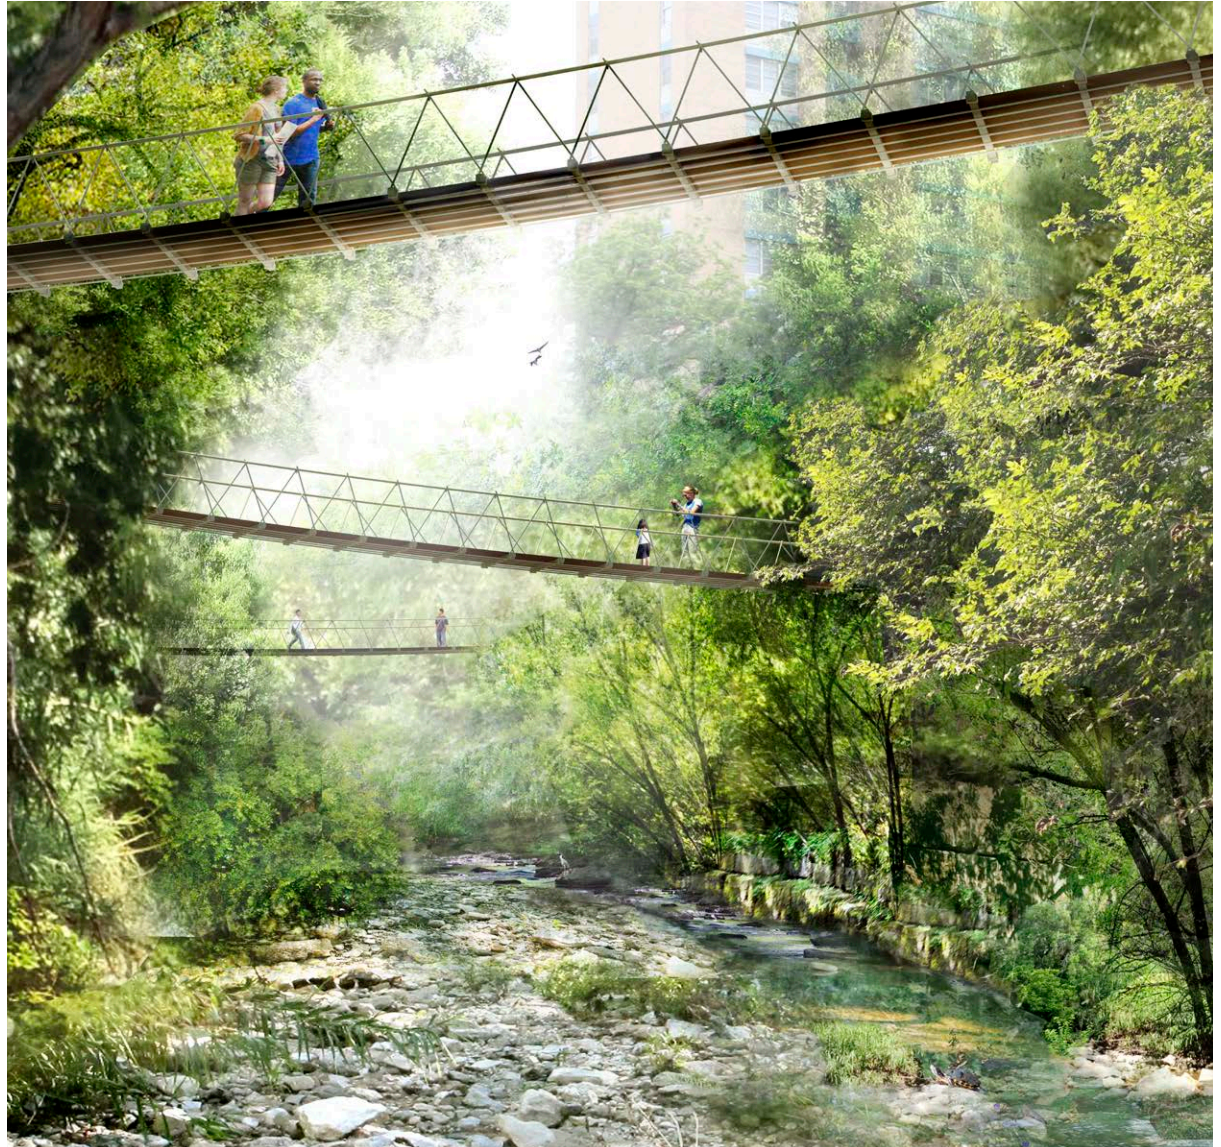
LATTICE BRIDGES AT WILLOW STREET ROW

The importance of access, seeing, and being seen cannot be underestimated in urban spaces like Waller Creek. Seeing others on nearby bridges reinforces a sense of safety, and fosters new east-west connectivity that will become increasingly important as the Rainey Street district evolves from a neighborhood of low-rise, single family homes into a district currently anticipated to house a 35% increase in the downtown population. These bridges will connect this enclave of high density to the rest of the downtown waterfront.

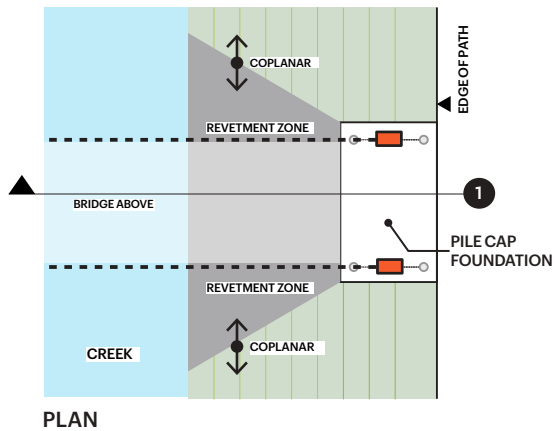
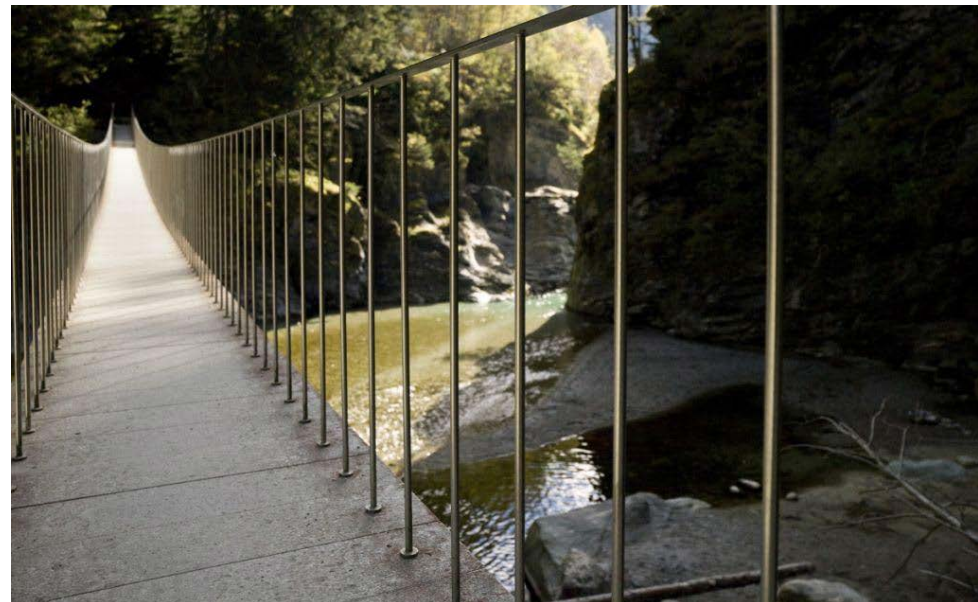
THE LATTICE BRIDGE ABUTMENT

With a relatively small footprint, each abutment and its visible revetment will be carefully integrated into the engineered earthen slopes. This bridge type is advantageous for this site as the abutments help slope stability.

The Suransuns Footbridge, Switzerland

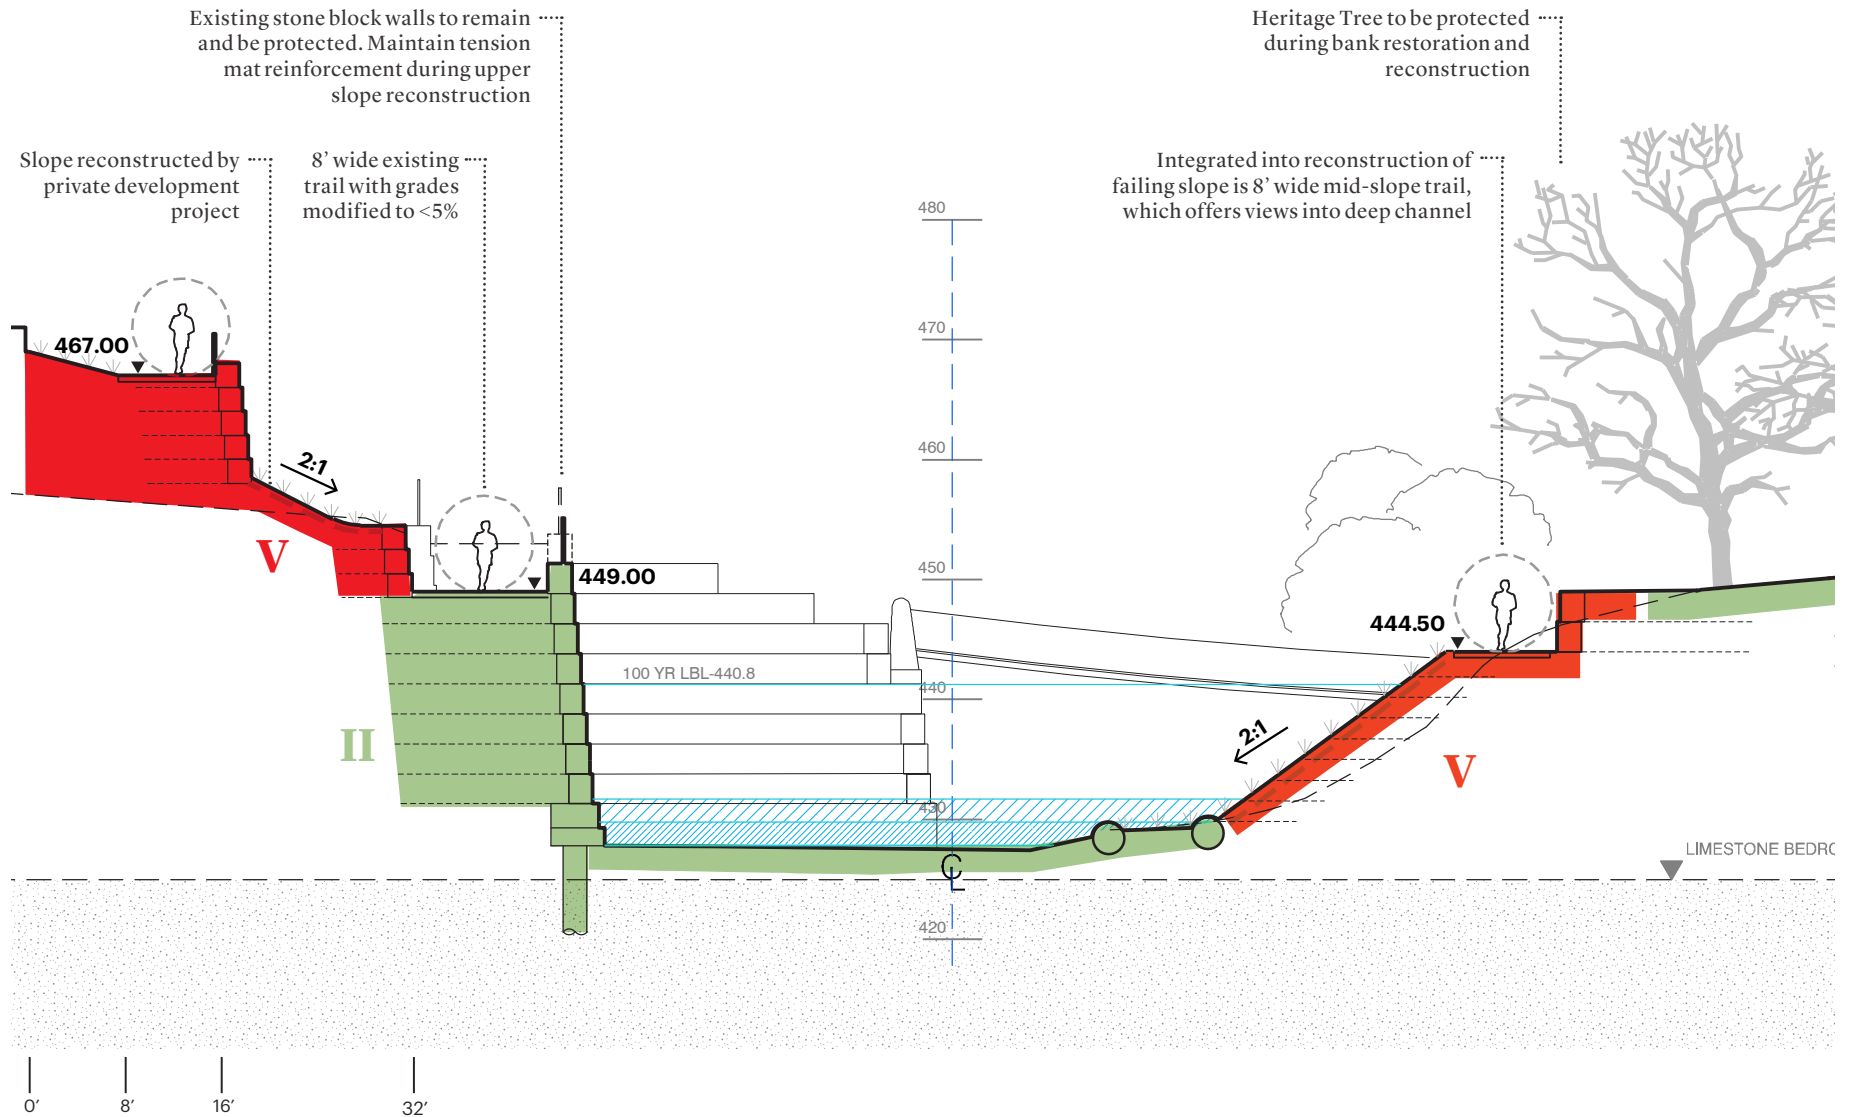
MODIFICATION TO EXISTING BLOCK WALLS

Existing “butter block” stone walls frame trails that exceed universal design standards in several locations. The selective removal of blocks enables re-grading these trails. The above example is located at the north end of the existing wall that meets the Waller Park Place property. This adjustment opens up accessible routes to both Red River and the creek trail below Cesar Chavez from the existing trail.

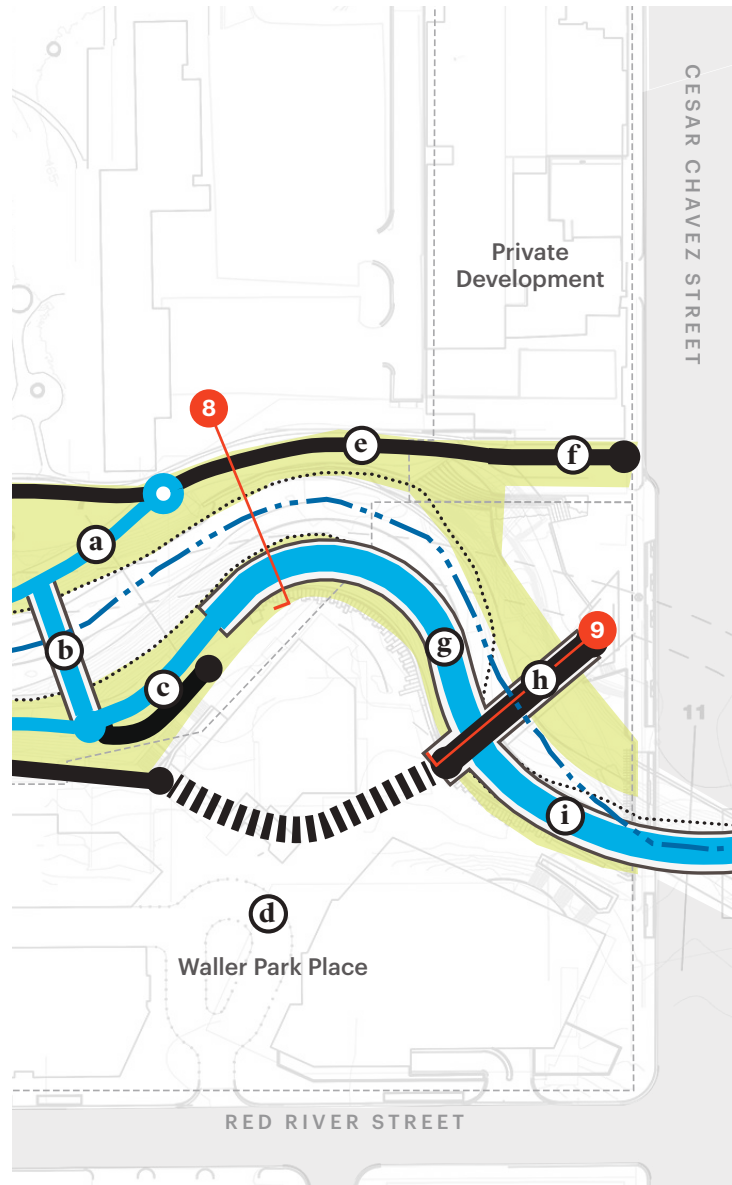
WILLOW STREET ROW TO CESAR CHAVEZ

TRAIL ALIGNMENT

- a. Mid-slope trail is integrated with reconstruction of failed concrete/gabion slope. This trail also offers opportunities for ecological/educational programming.

- h. Recommended alignment for privately developed bridge.
- i. Proposed elevated trail on east bank to pass under Cesar Chavez Bridge and cross to west bank.

- 2 Heritage Trees on this block at the top of the west bank. These are adjacent to an existing sidewalk to remain.
- 1 Heritage Tree has been assessed to be in "Poor Condition."
- The west bank contains areas of invasive species that

are on slopes to be preserved and restored. Detailed design will determine appropriate areas for thinning, removal and replacement.

- Outfall #602378 discharges from the east bank at Cesar Chavez Street. It may be reconfigured upon private redevelopment of the site, but in its current condition, it is a candidate for landscape treatment.
- Outfalls #631157 and #602539 discharge from an existing stone embankment on the west bank. These are moderately suitable for inline treatment, but require coordination with an adjacent development sites.

- Volunteer vegetation growing out of the existing stone walls should be left in place and protected. Woody vegetation should only be removed when it threatens to undermine the structural stability of the wall or create trail conflicts.

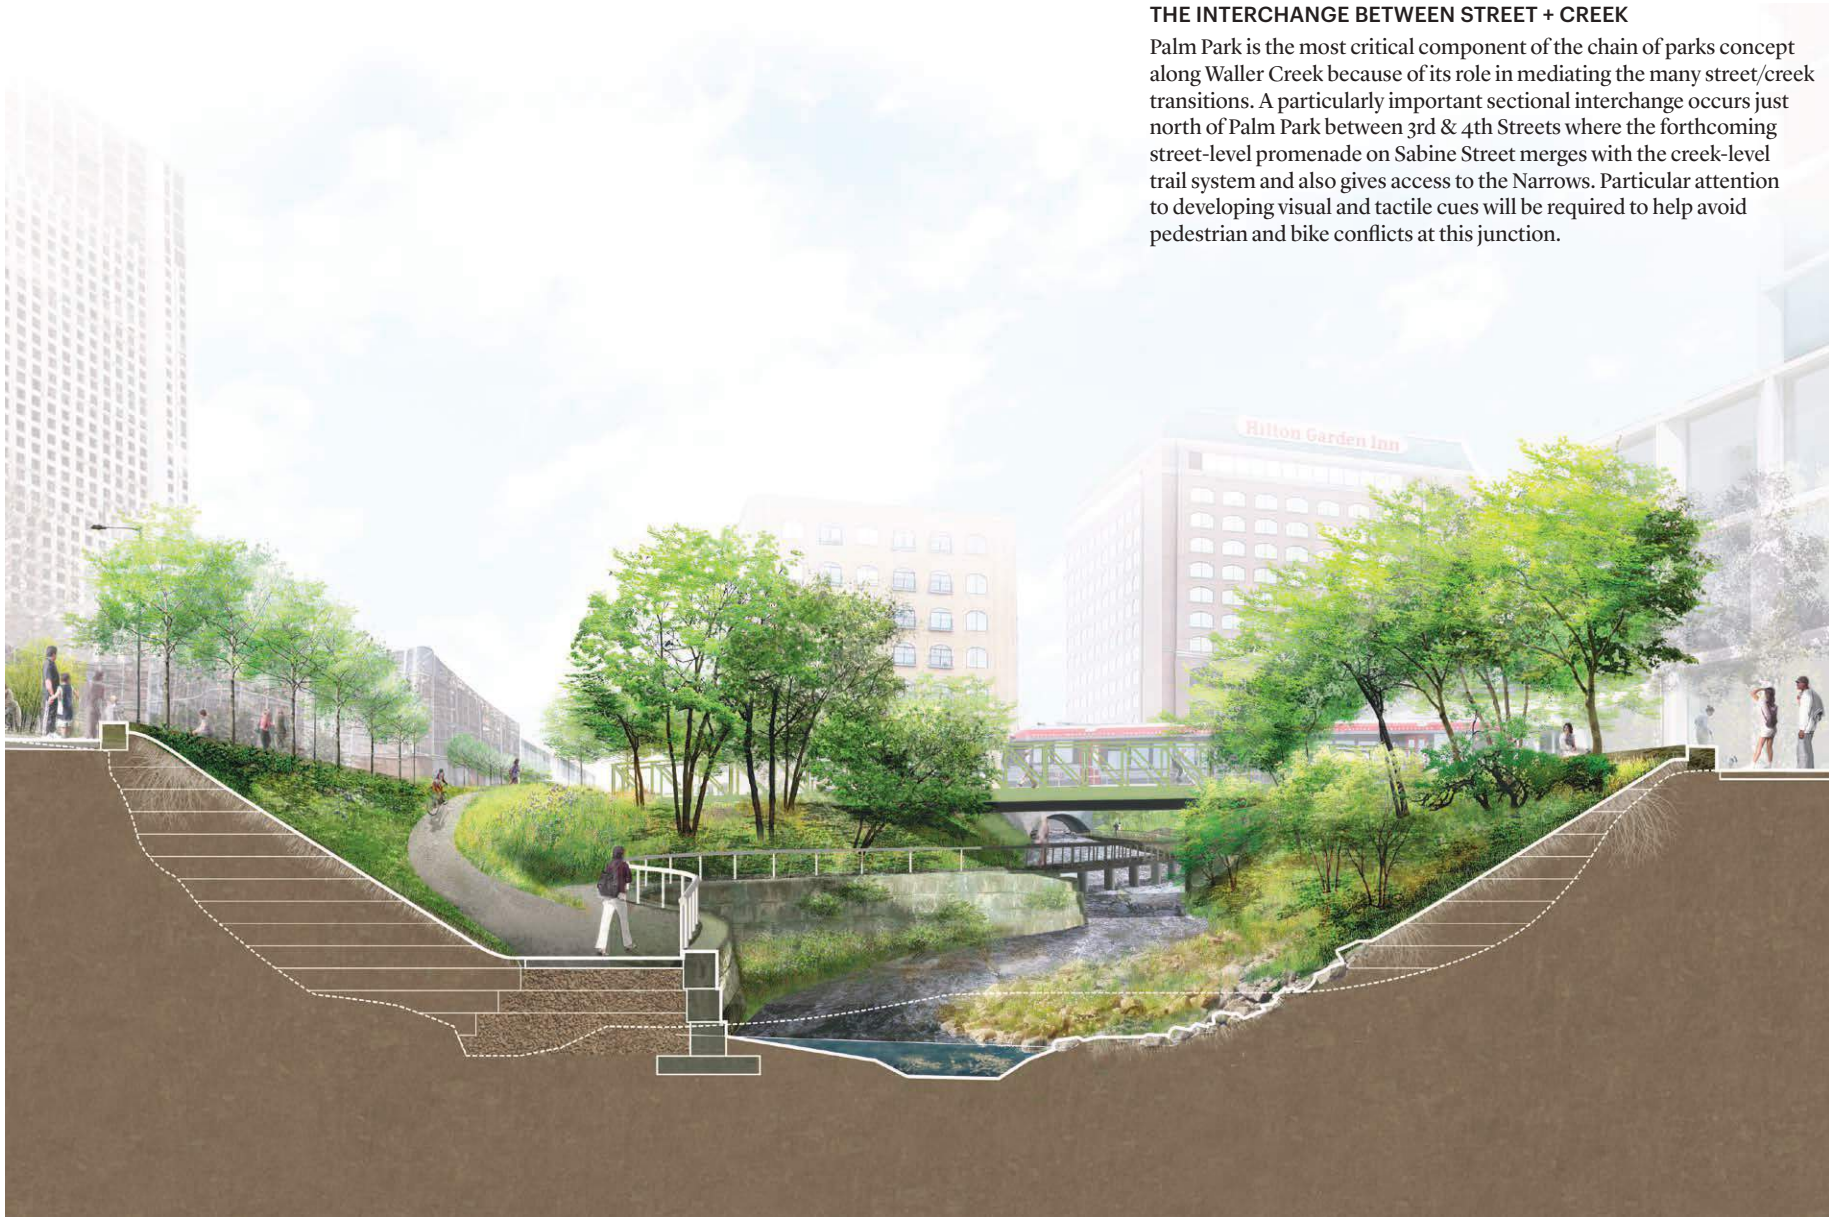
THE INTERCHANGE BETWEEN STREET + CREEK

Palm Park is the most critical component of the chain of parks concept along Waller Creek because of its role in mediating the many street/creek transitions. A particularly important sectional interchange occurs just north of Palm Park between 3rd & 4th Streets where the forthcoming street-level promenade on Sabine Street merges with the creek-level trail system and also gives access to the Narrows. Particular attention to developing visual and tactile cues will be required to help avoid pedestrian and bike conflicts at this junction.

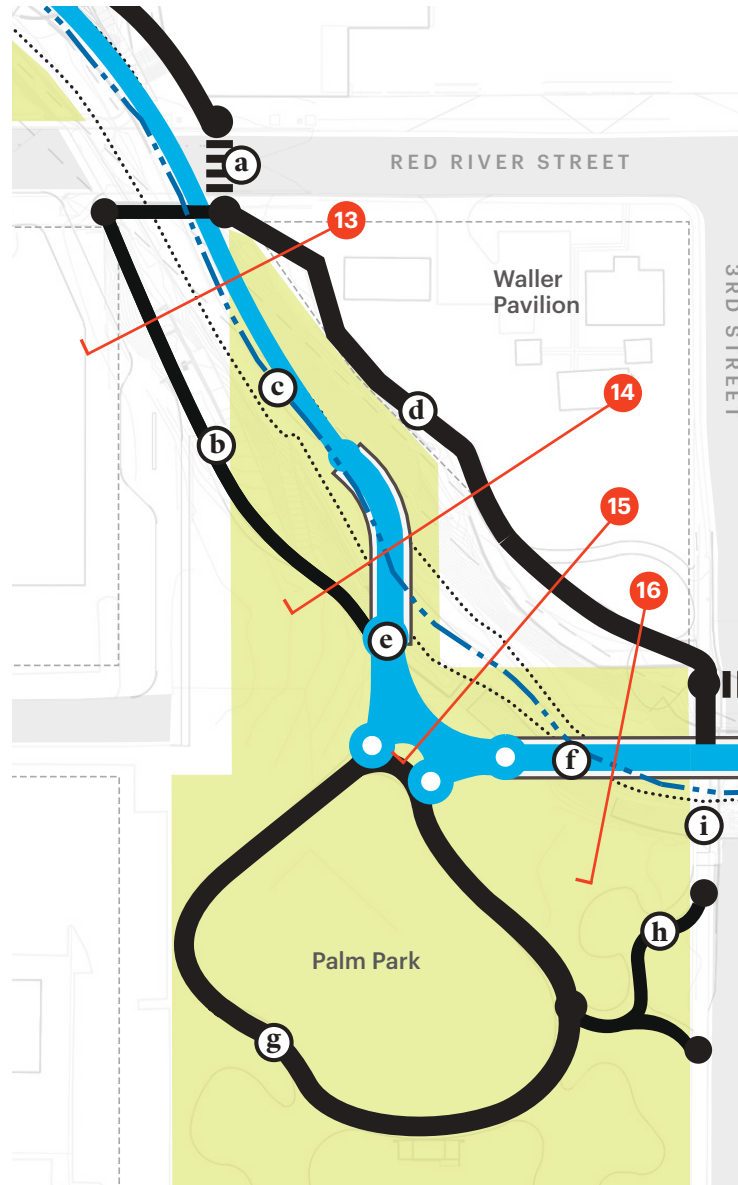
TRAIL NETWORK

- a. Street-level trail connection requires mid-block crossing at Red River Street (at former 2nd Street ROW).
- b. Trail connects Fairmont Hotel entrance to Palm Park. Requires coordination with Fairmont Hotel project.

- e. Creekside trail crosses from west to east bank and provides access to Palm Park. Gently sloping banks and trail will replace existing vertical retaining walls. Creekside trail is intended to promote a gradual and welcoming transition to Palm Park and also offer a bypass route during events.

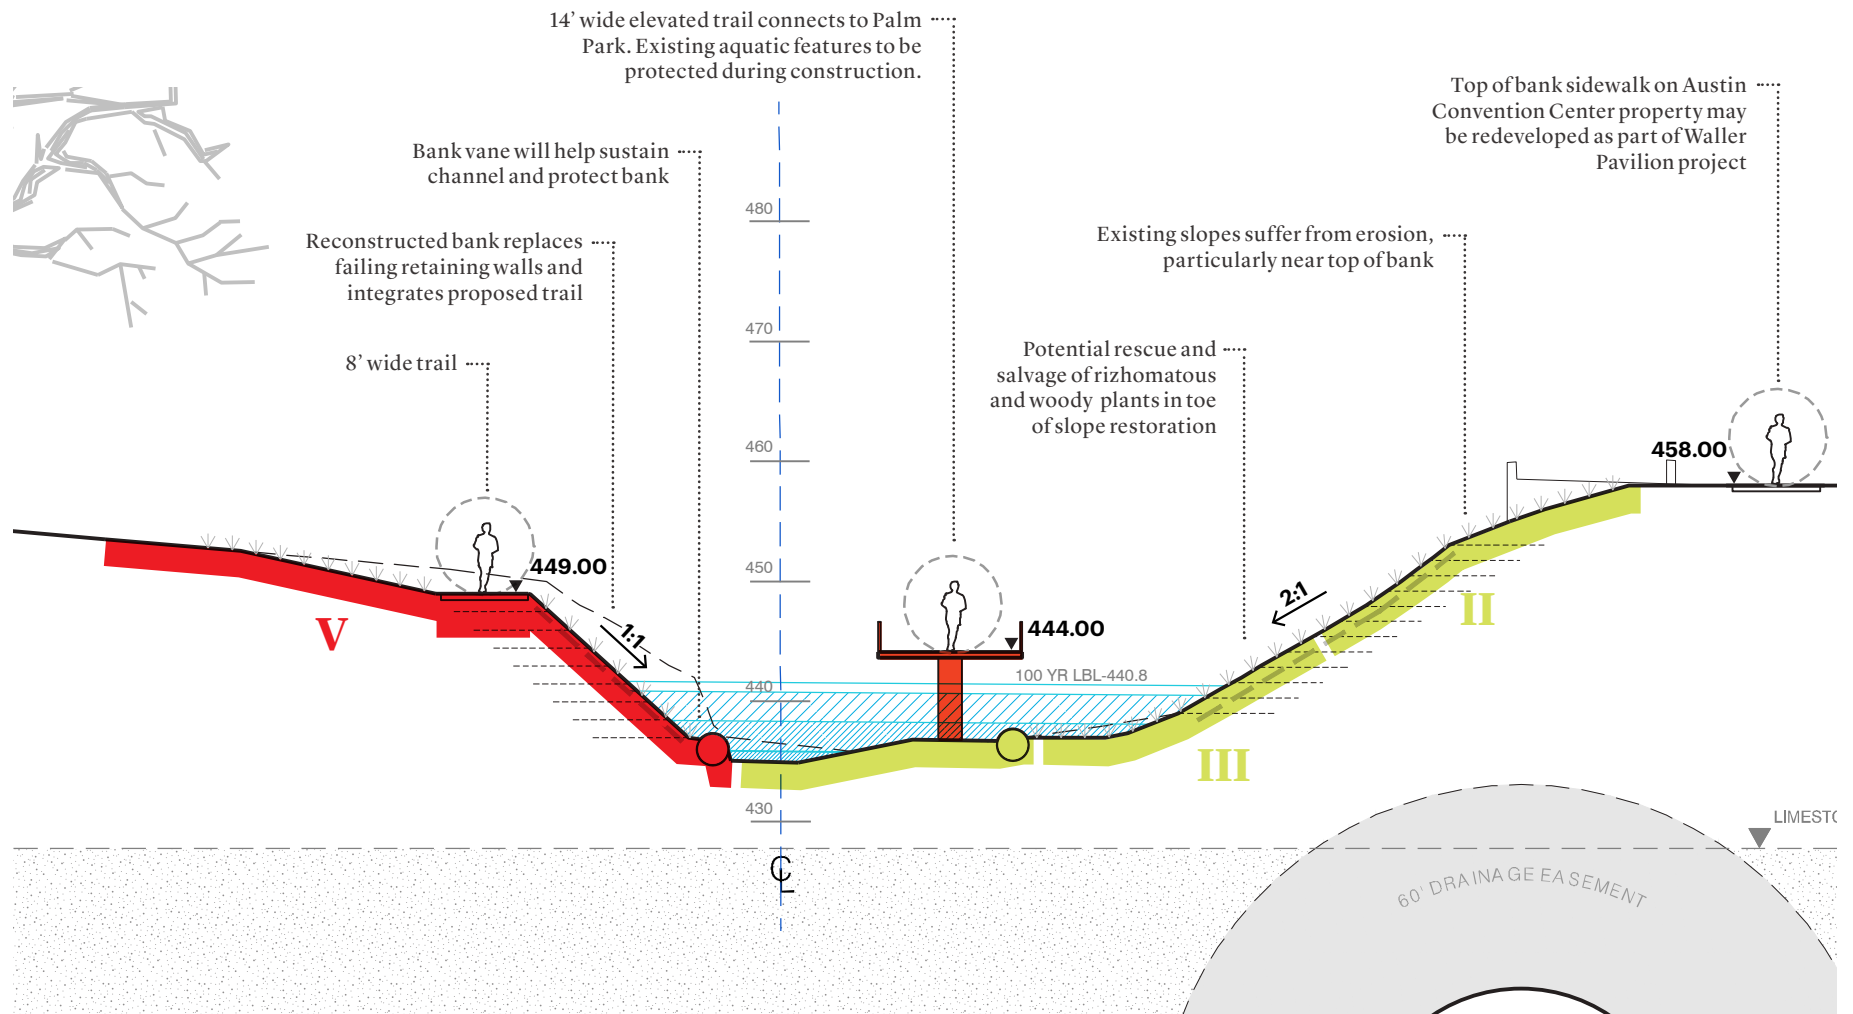
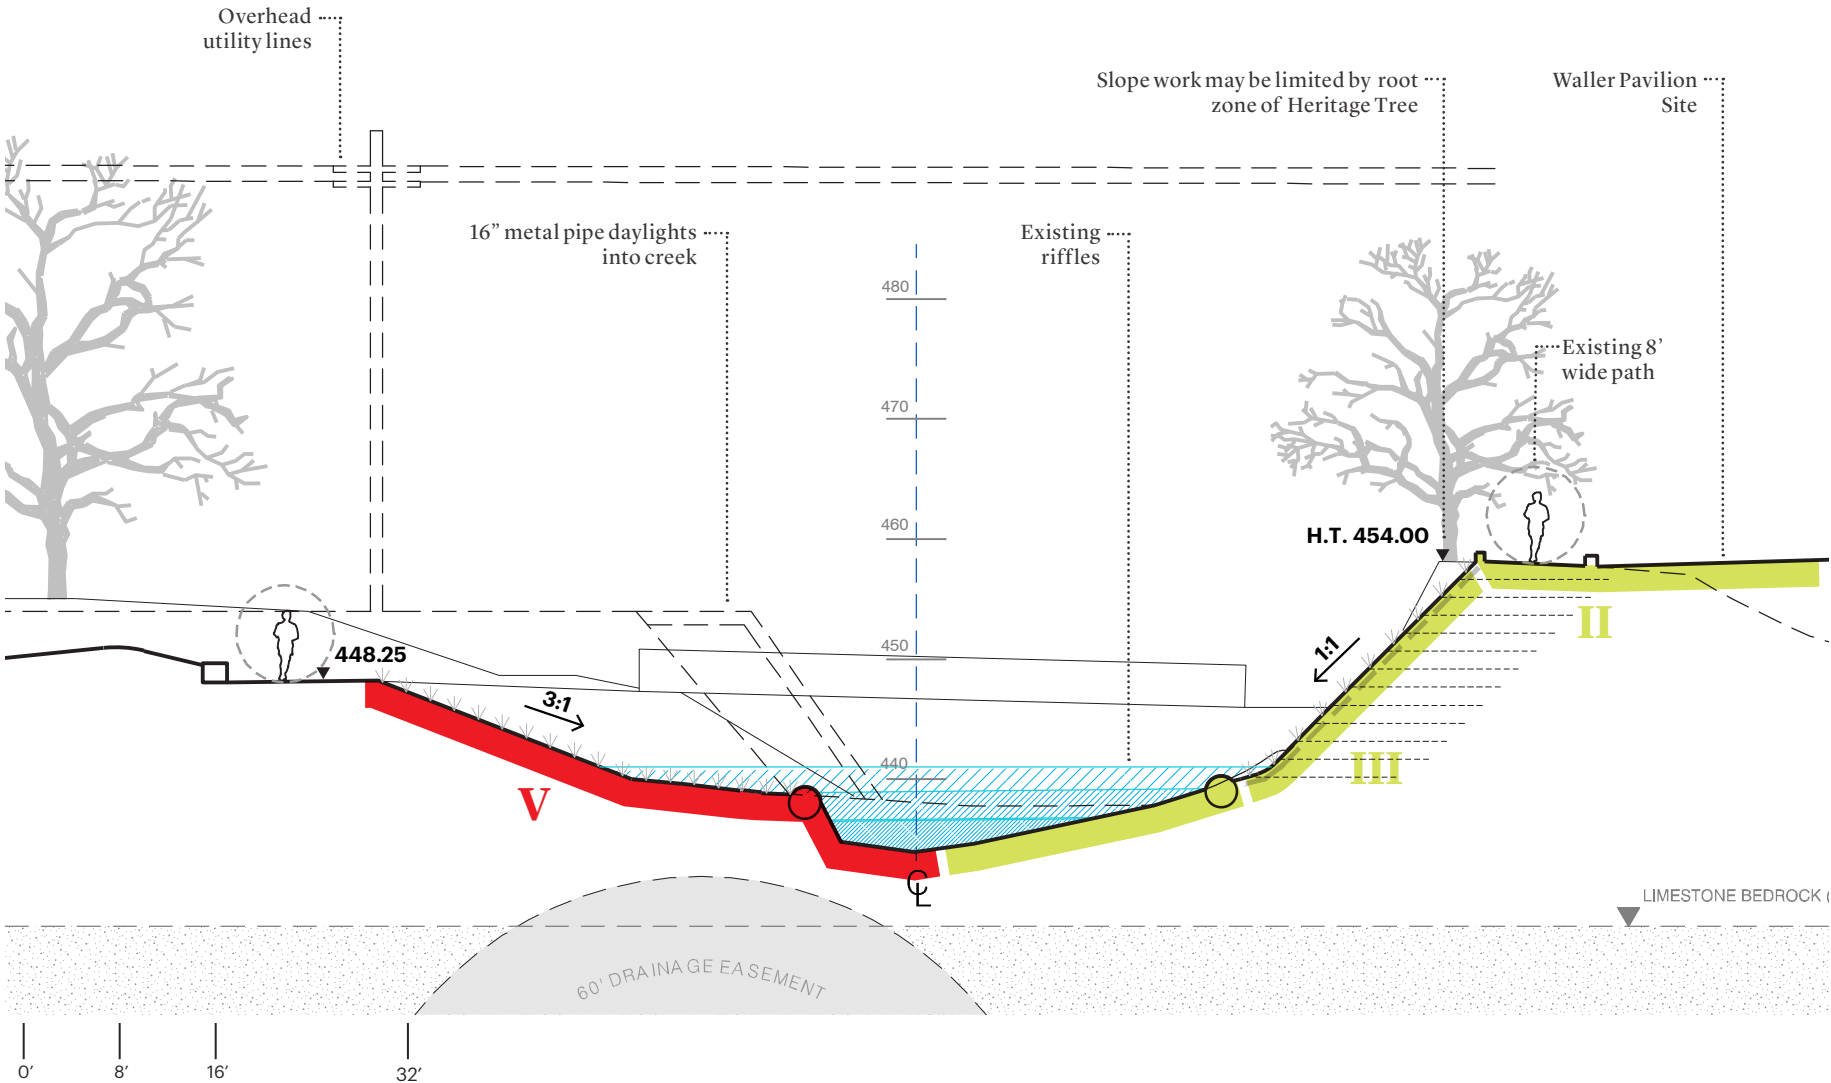
SECTION KEY

- On the east bank (Palm Park), existing vertical retaining walls are in poor condition and present a visual and physical barrier between the creek corridor and the park. These slopes will be reconstructed and integrated with the new trail system.
- Run-off from the Palm School parking lot currently flows across Palm Park via an open grass swale and may be contributing to bank erosion.

- On the west bank (Waller Pavilion/Austin Convention Center site), heavily eroded slopes will be restored and stabilized. Surface run-off from existing parking lots may be contributing to these conditions.
- Surface drainage improvements should be coordinated with bank reconstruction.

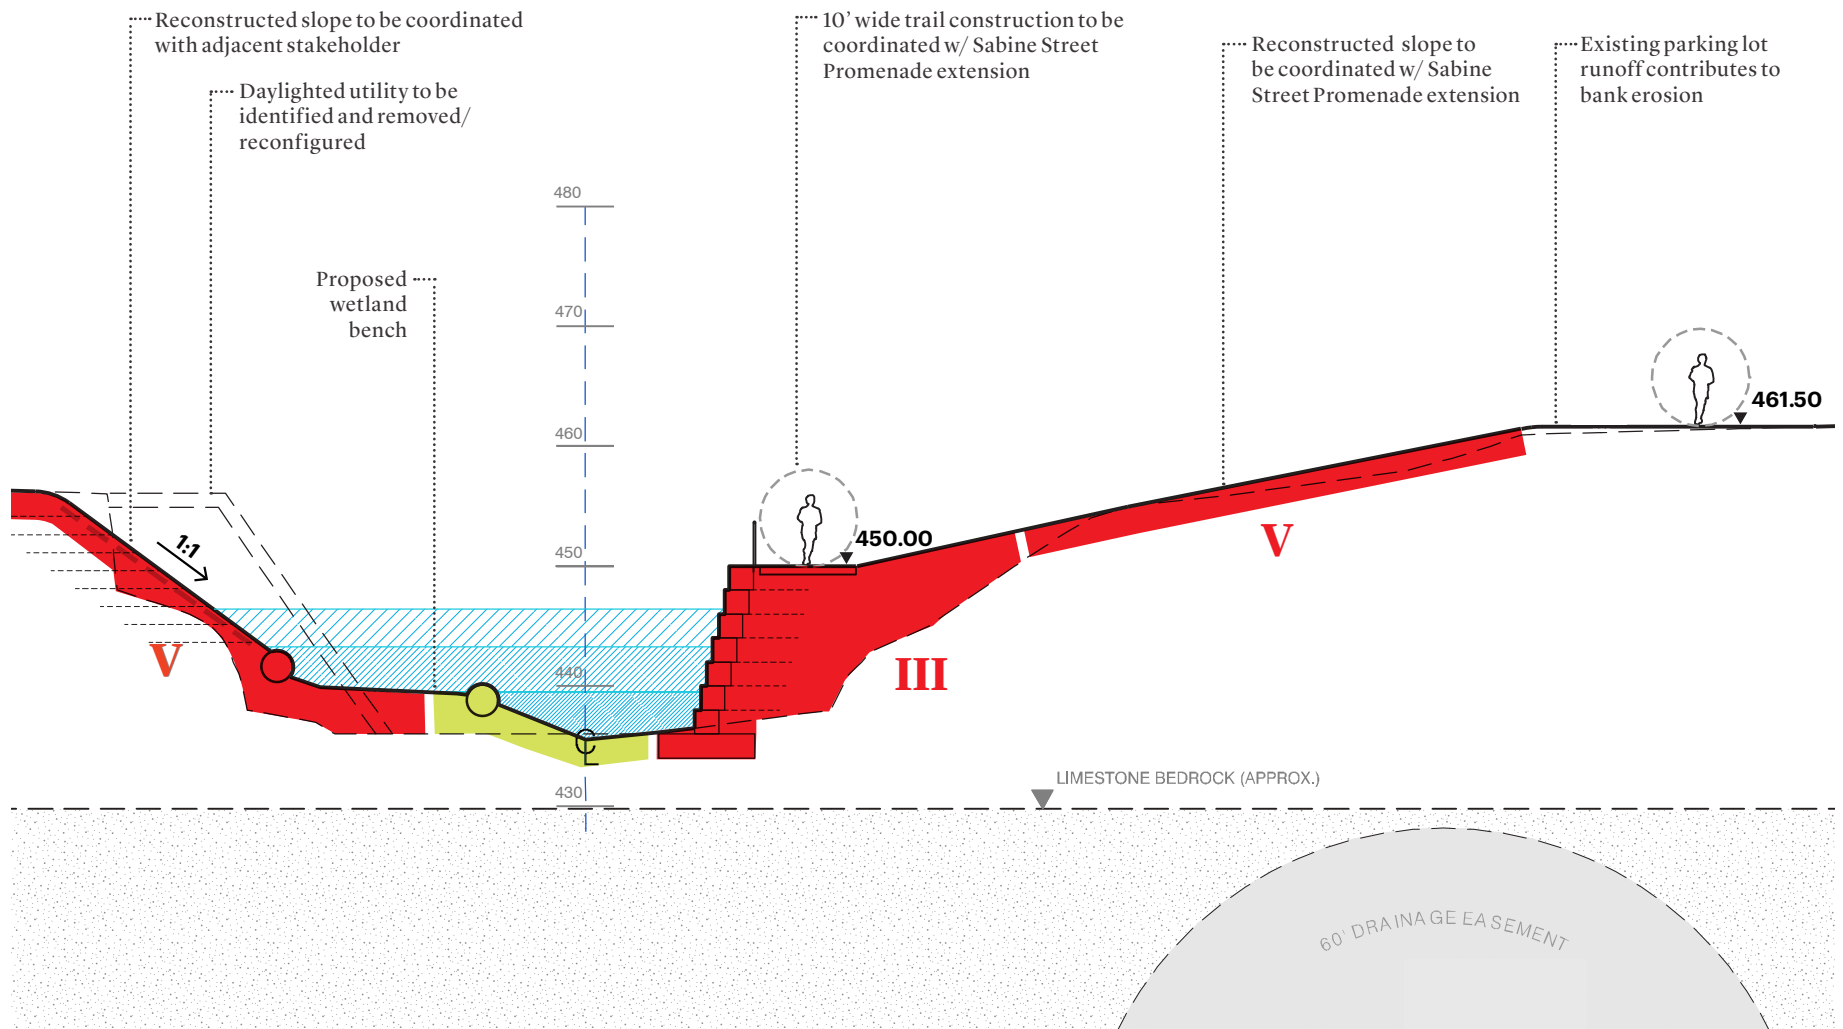
SECTION KEY

- There is an existing island and a pool-riffle sequence close to 3rd Street. These features should be preserved and protected during construction of trails and adjacent developments.
- Deep pools and emergent logs will be added to enhance aquatic habitat diversity.
- Wetland benches integrated into bank and channel reconstruction are placed to take advantage of the low-flow headwater like condition just downstream of the 4th Street Inlet.

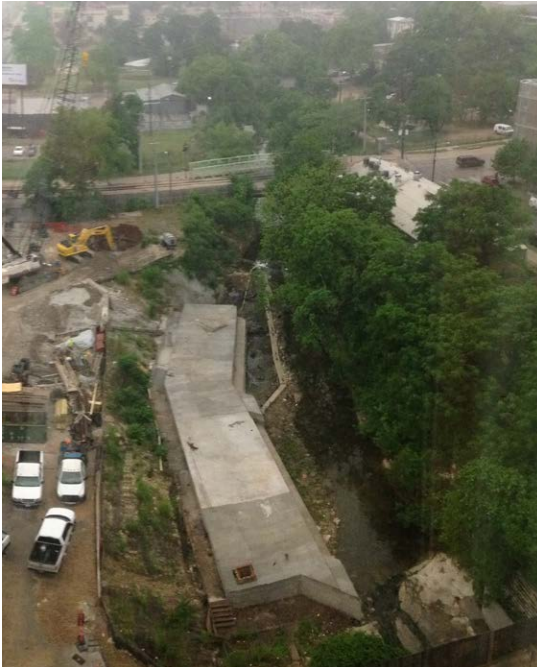
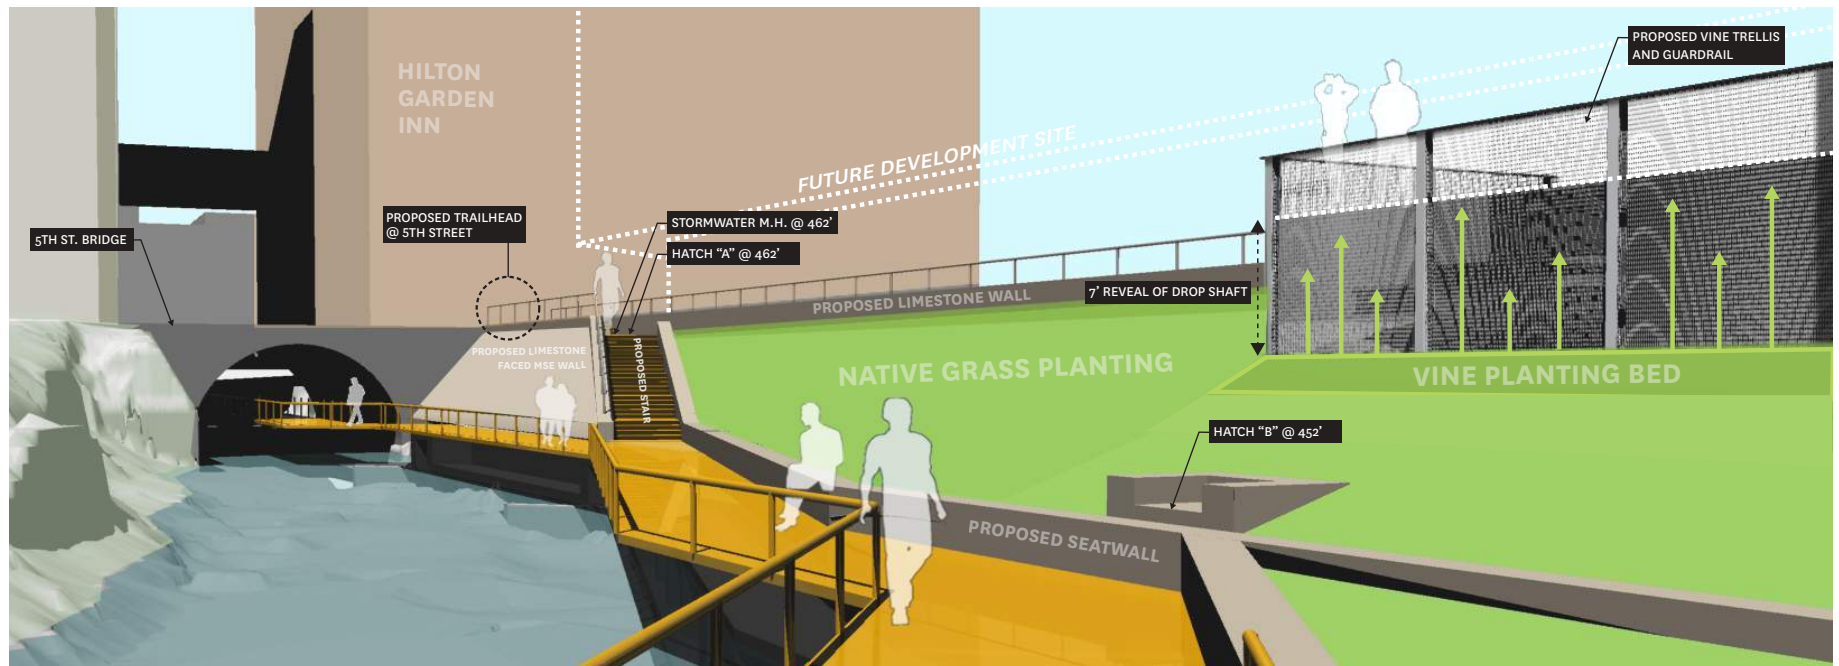
4TH TO 5TH STREETS

- The debris removal facility for the 4th Street Inlet will be maintained by WPD, requiring truck access from 4th Street.
- Access hatches for 4th Street Inlet are integrated into the slope adjacent to the proposed trail.
- 5th Street Bridge, previously not maintained to anticipate pedestrian access underneath, has potential safety issues due to its old masonry structure.
