Waller Creek Corridor Framework Plan

Block-by-Block Enlargements

WALLER CREEK CORRIDOR: PROJECT SEGMENTS

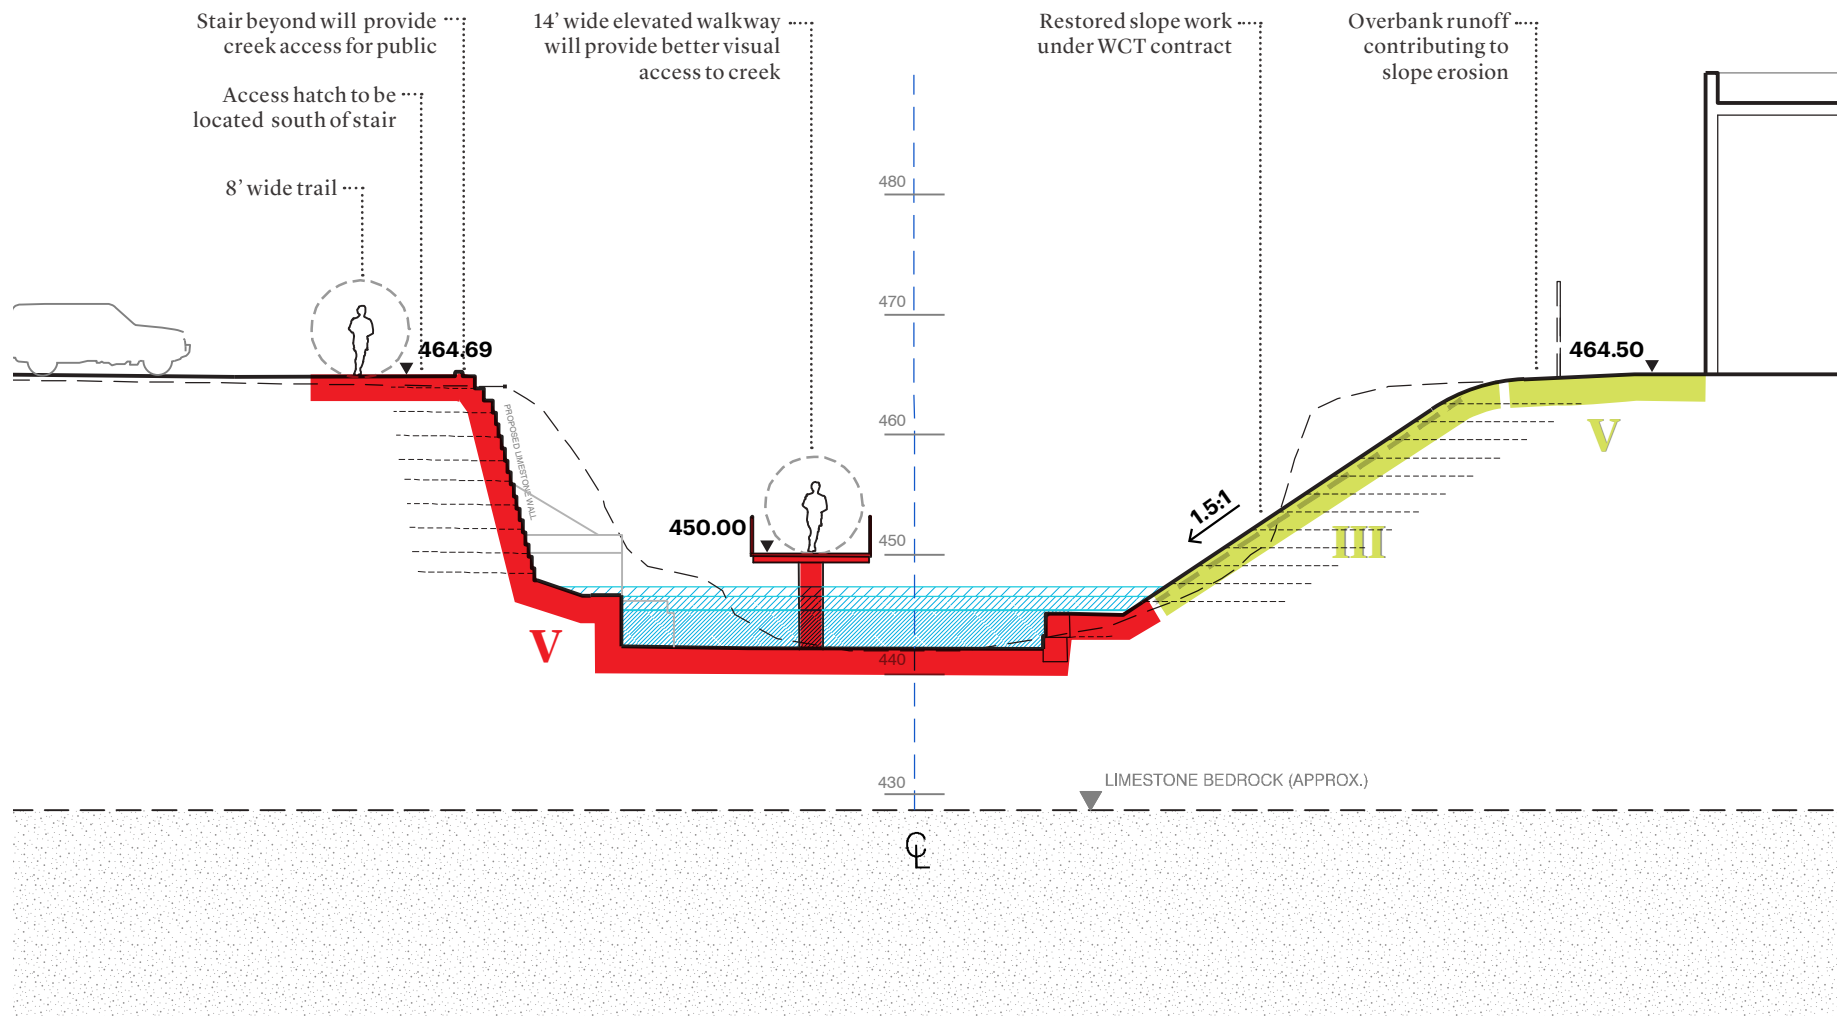
INTEGRATING TUNNEL INFRASTRUCTURE

During the development of the tunnel design and documentation, the 4th Street Inlet sponsored no public trail development in the surrounding area. Significant efforts have been devoted to modifying the tunnel contract to accommodate the future addition of a trailhead at 5th Street and a critical trail connection that would connect Palm Park to the northern creek-level trail system. This trail connection is conceived as a metal grating walkway so that the flood infrastructure beneath is revealed. The movement and sound of the creek waters entering the side-flow inlet would otherwise be imperceptible.

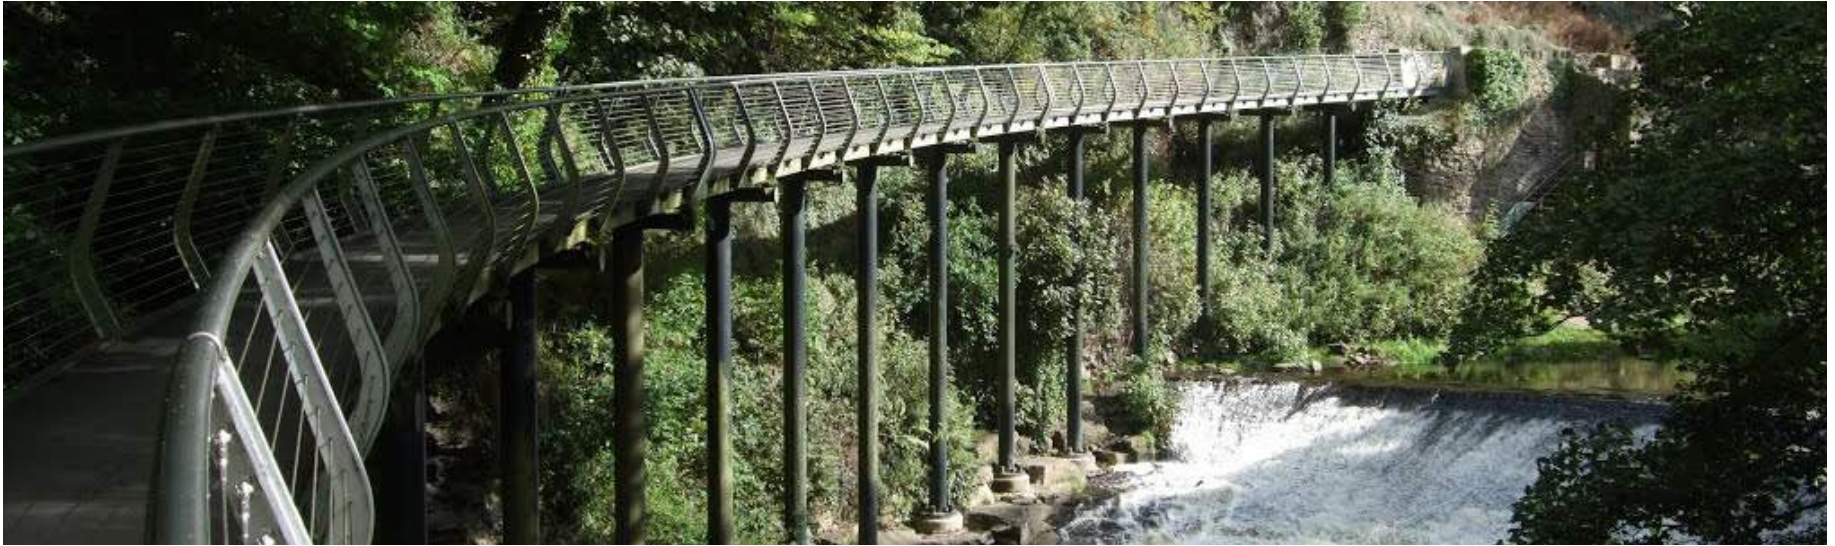
5TH TO 6TH STREETS

- High, vertical banks present a challenge to maintenance access to the channel.
- This block is expected to require a higher level of trash removal due to its proximity to the heavily used 6th Street commercial/entertainment corridor, as well as one of the few areas on the creek where there is programmed commercial space.
