History of Habitat Restoration and Management for Barton Springs and Austin Blind Salamanders (*Eurycea sosorum* and *Eurycea waterlooensis*)

SR-19-03, February 2019

Donelle Robinson Ph.D., City of Austin, Watershed Protection Department. 505 Barton Springs Road, Austin, TX 78704. Donelle.Robinson@austintexas.gov

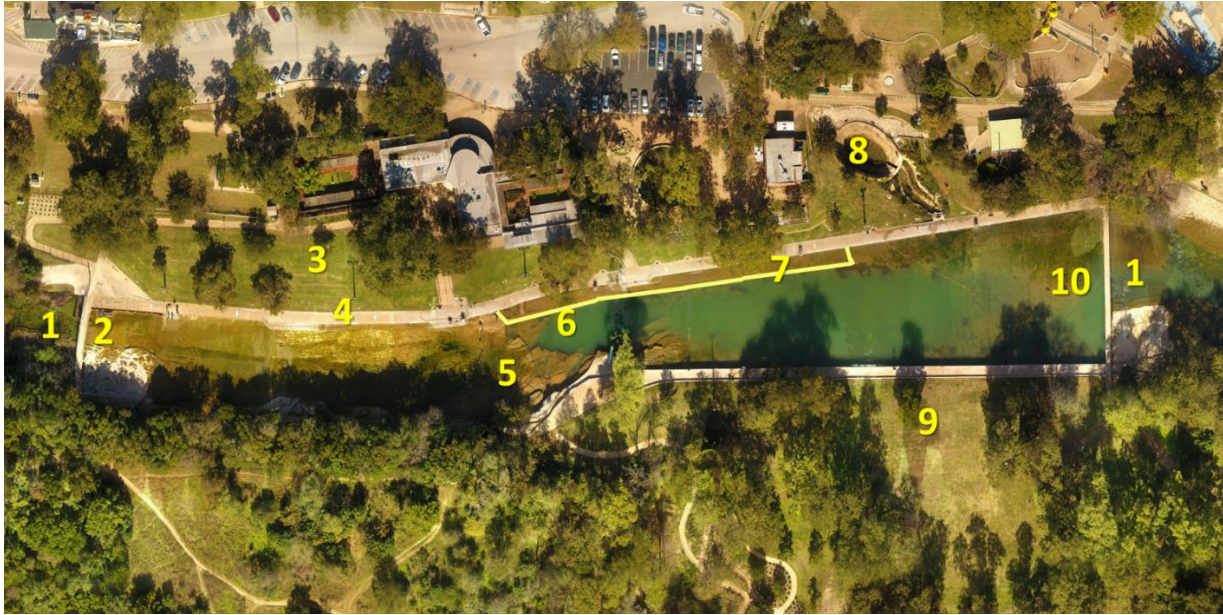
Figure 1. Aerial view of Barton Springs Pool during a full drawdown. Labels indicate: 1 Barton Creek, 2 upstream dam, 3 north lawn, 4 sidewalk with bypass tunnel underneath, 5 fissures, 6 Parthenia spring, 7 beach habitat (outlined), 8 Eliza spring, 9 south lawn, 10 downstream dam.

Barton Springs Pool is constructed around Parthenia Spring (also known as Main Spring) and consists of dams to increase water depth and concrete walls to form the sides of the pool (Figure 1). Prior to these modifications, Parthenia Spring was contiguous with the rest of Barton Creek (Figure 2). Most of the permanent modifications for Barton Springs Pool occurred in the 1920s-1930s, and the 1970s, though other changes, such as temporary dams and water diversion to mills along Barton Creek, have occurred since the 1800s (Limbaucher and Godfrey Architects 2008, City of Austin 1998, 2013). During construction of the pool, the creek area surrounding Parthenia Spring was deepened, leveled, and widened (City of Austin 2013). The bypass tunnel that runs underneath the north sidewalk was constructed in 1974 to divert Barton Creek water from entering the pool until Barton Creek's upstream flow reaches approximately 700 cubic feet per second. The bypass tunnel helps maintain higher water quality at Parthenia Spring by reducing pollutants from upstream from entering salamander habitat, especially during small rain events (City of Austin 2000). However, the dams have several negative impacts to the salamanders. The dams deepen the water and disconnect Barton Springs Pool from the rest of the Barton Creek ecosystem, which probably changes the composition of plants and animals that occur in salamander habitat. The dams also slow water flow, which reduces the natural flushing of sediment from substrate. Sediment can embed the substrate that salamanders need and decrease salamander abundance (Bendik and Dries 2018, Dries and Colucci 2018).

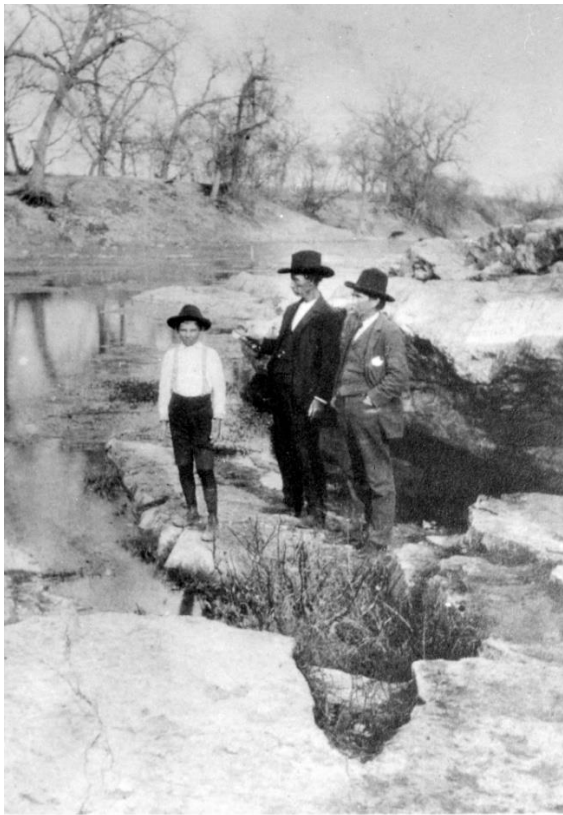
Figure 2. Barton Creek at Parthenia Spring before the water level was raised for Barton Springs Pool. Undated photo from the Austin History Center, C00078.

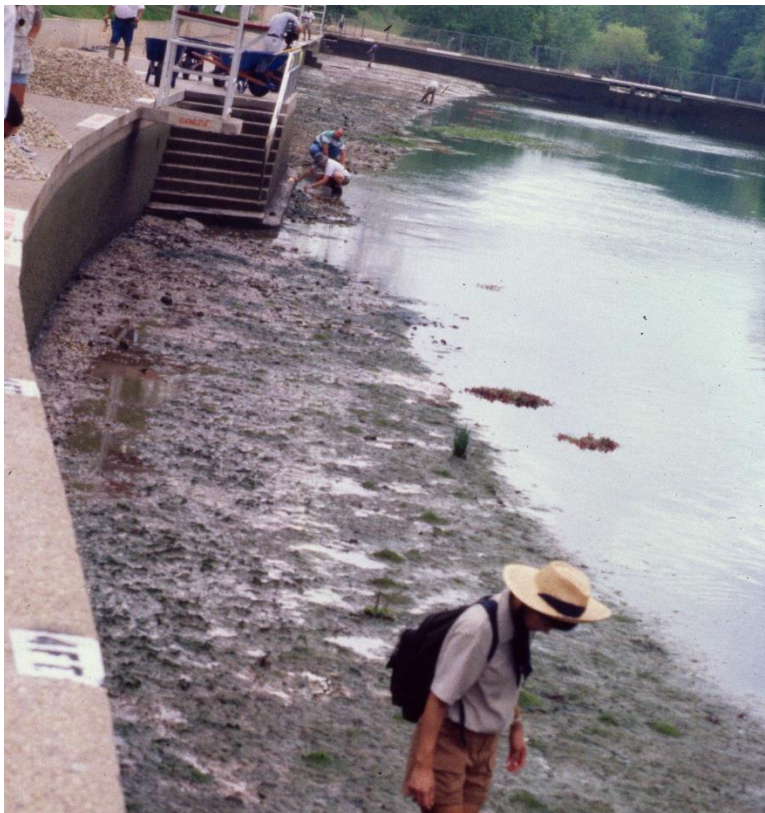
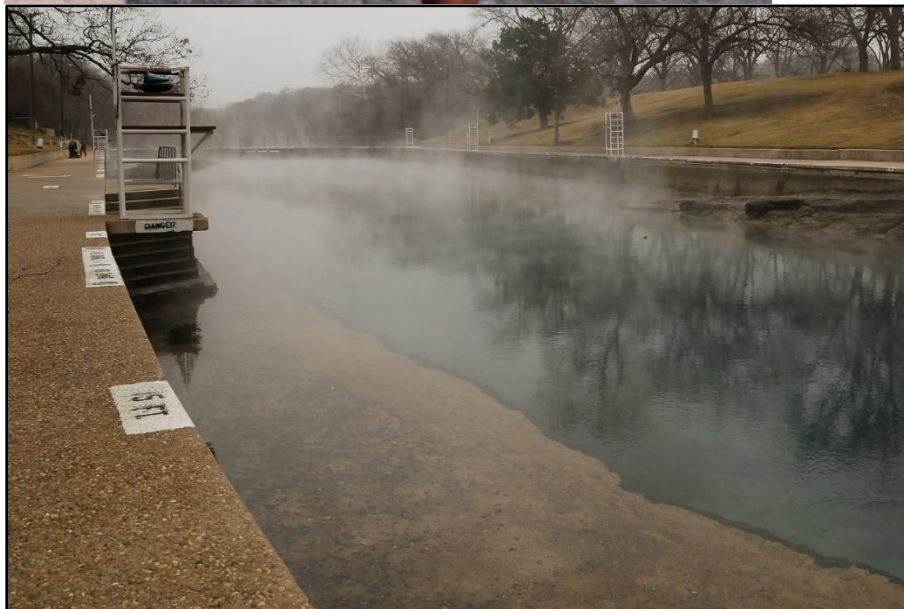
Figure 3. Beach area of the pool in 1998 before the beach depth was lowered (above) and after in 2008 (below). Both photos were taken during pool drawdowns.

Salamander habitat also occurs on a shallow concrete ledge along the north side of the pool called “the beach.” This area is heavily disturbed by swimmers, so the City made the beach deeper in 1999 to reduce habitat disturbance by swimmers and to prevent it from being dewatered when the pool water level is lowered for cleaning (Figure 3). Original plans were to lower the entire beach from 4 feet to a minimum depth of 6.5 feet, but this was not possible in some areas because it would destabilize the concrete-encased skimmer drain (City of Austin 2002) and the bypass wall. Consequently, substantial habitat disturbance still occurs. The biggest benefit of lowering the beach is that salamander habitat remains wetted during pool drawdowns. Adjustable gates were also installed in the downstream dam, which control the water level during

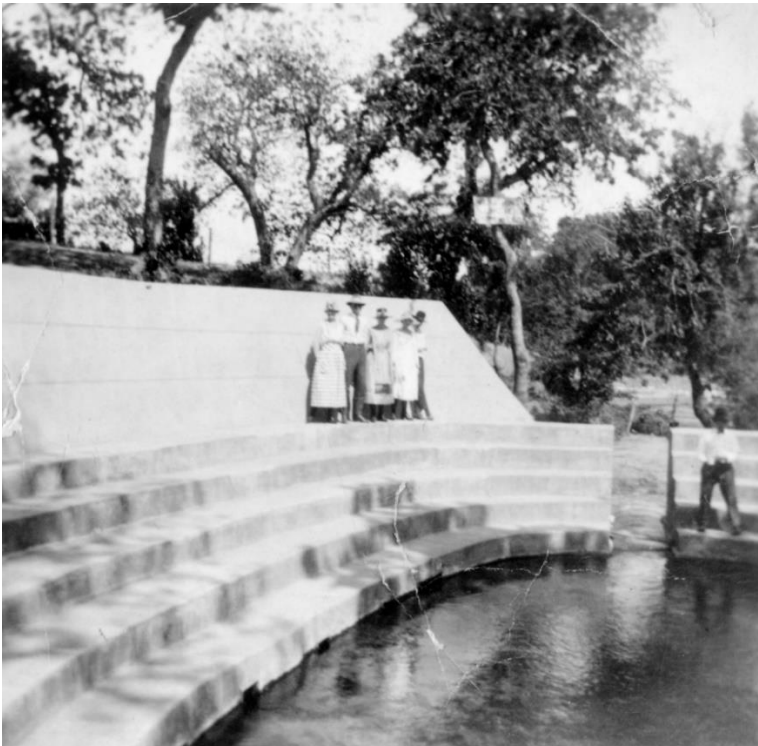
Figure 5. Eliza Spring in the early 1900s. The amphitheater was built but the surface stream remained and flowed to Barton Creek. Photo from the Austin History Center.

Eliza Spring (also known as Concession Spring, Polio Pit, Elks Spring, or Walsh Spring¹) is located on the north side of Barton Springs Pool. Eliza Spring and its salamander habitat were highly modified during the 1900s (Figures 4–7). An amphitheater was constructed around the spring pool by Andrew Zilker and used as a meeting space for the Elks Club (Figure 5, City of Austin 1998, 2013, Limbaucher & Godfrey Architects 2008). The date of construction is uncertain. It may have been constructed for an Elks Club gathering in 1904 (Limbaucher & Godfrey Architects 2008), although the date 1917 is the most recent date stamped into the concrete. During the 1920s, the stream that entered Barton Creek from Eliza Spring was enclosed into a pipe underneath the lawn of Barton Springs Pool, which decreased the amount of salamander habitat at Eliza Spring (Figures 6, 7, City of Austin 2013). In the 1970s, this pipe was connected to the bypass tunnel that flows into Barton Creek. Over time, the water in the amphitheater became deeper due to a failing pipe and a grate that often clogged with debris. The increased water depth increased sediment deposition and reduced the interstitial spaces available for salamanders and their prey. In the 1950s, concrete was poured to cover the bottom of the spring pool, restricting the spring outflow to holes left in the concrete floor and sides (City of Austin 1998, 2013). The higher elevation from the concrete floor may have increased the number of salamanders stranded during pool drawdowns before management changes in the HCP prevented the floor of the amphitheater from going dry.

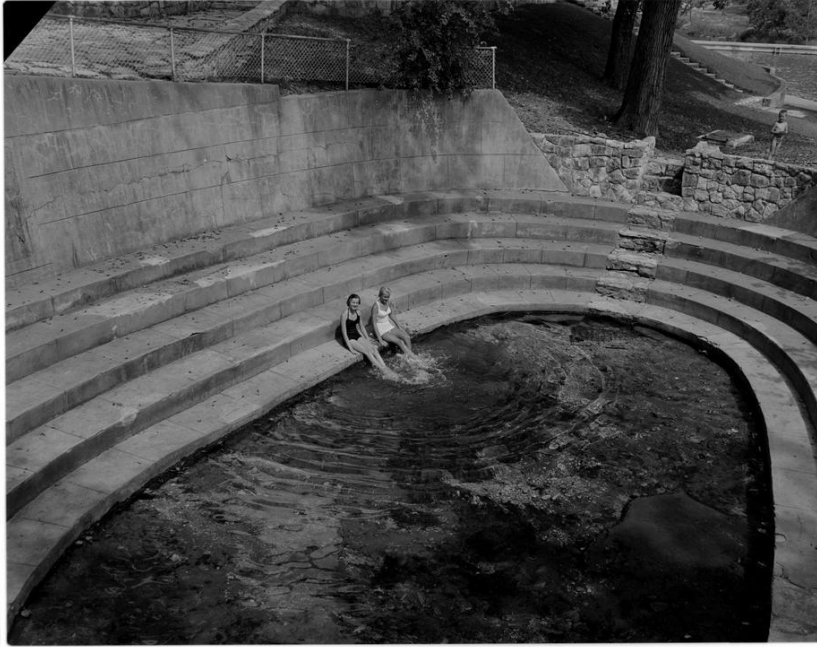
Figure 6. Eliza Spring in 1953. The spring flow was buried into a pipe underneath the lawn of Barton Springs and the amphitheater keyway filled in with masonry. A chain link fence was also added to the top of the amphitheater. The natural substrate in the spring pool can be seen. Photo from the Austin History Center.

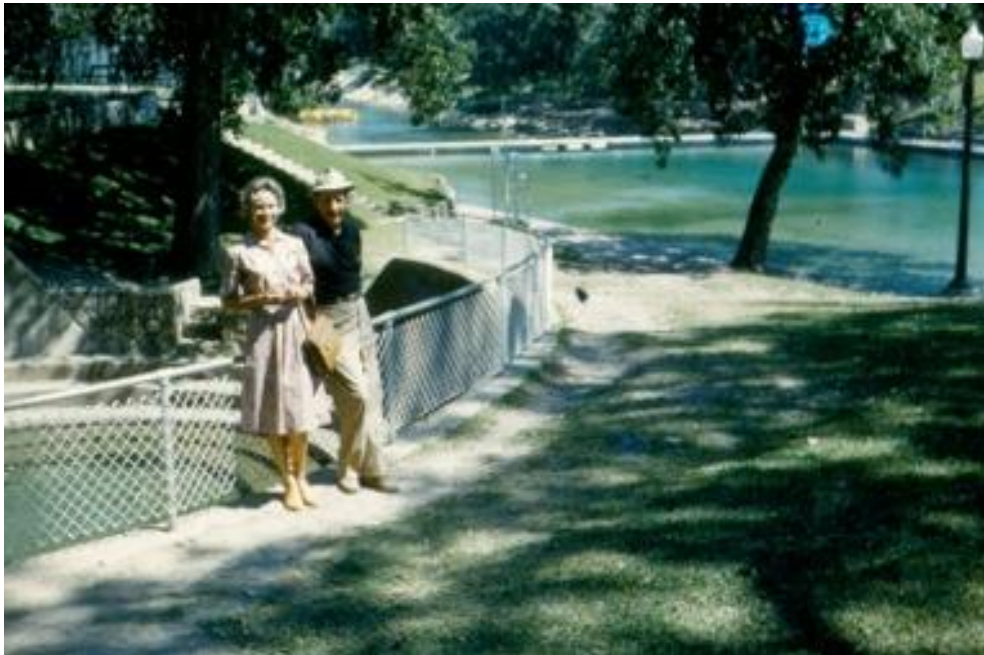
Figure 7. Eliza Spring in the 1960s. The water level is raised in the amphitheater, possibly due to issues with the pipe or grate clogging, or intentionally for recreation.

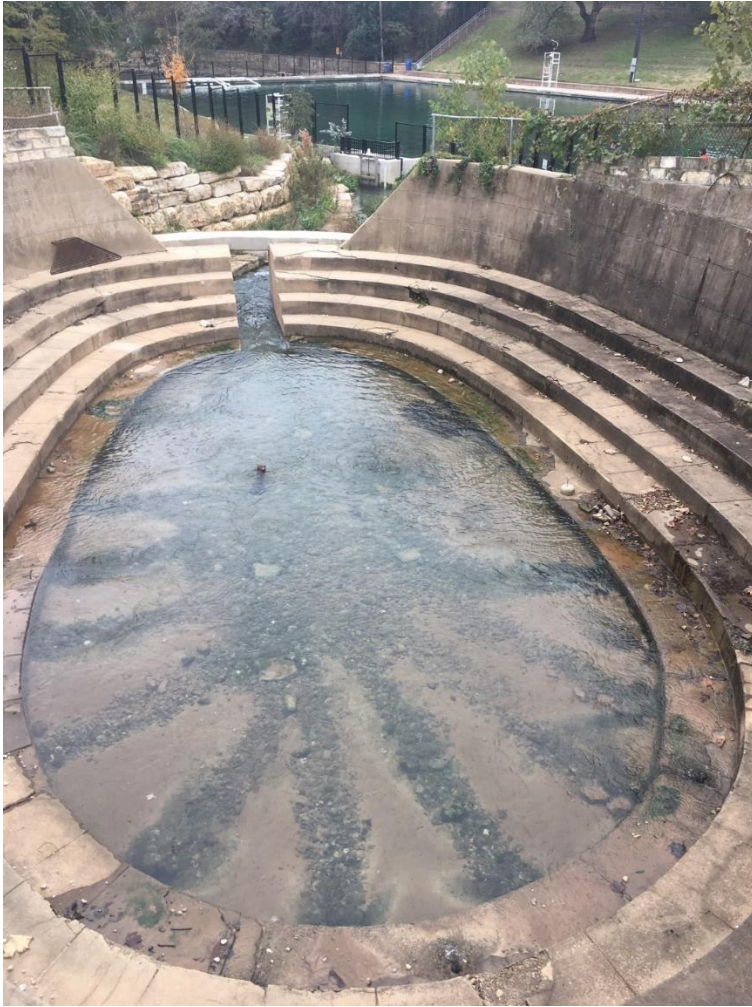
Figure 8. Eliza Spring in November 2018. The surface stream is reestablished and masonry removed from the keyway. The floor of the spring pool is covered in concrete, with limestone gravel added on top for salamander habitat. Lines of gravel substrate connecting the edge of the spring pool to the center follow the path of water leaving spring outlets along the concrete steps.

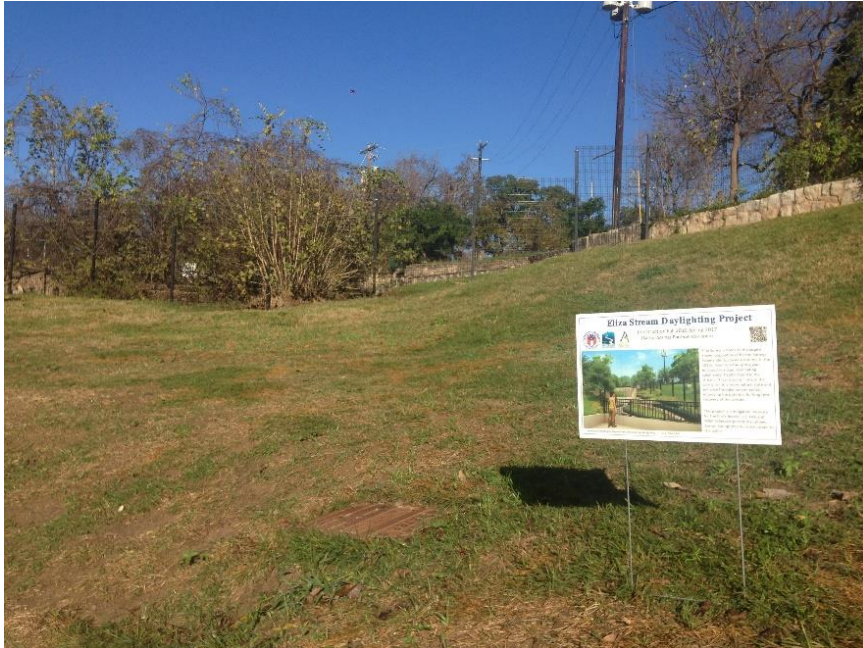
Figure 9. The north lawn of Barton Springs Pool before (above) and after (below) the Eliza Spring Daylighting project. The Eliza Spring amphitheater is also visible from the lawn after construction due to regrading around the stream that removed soil.

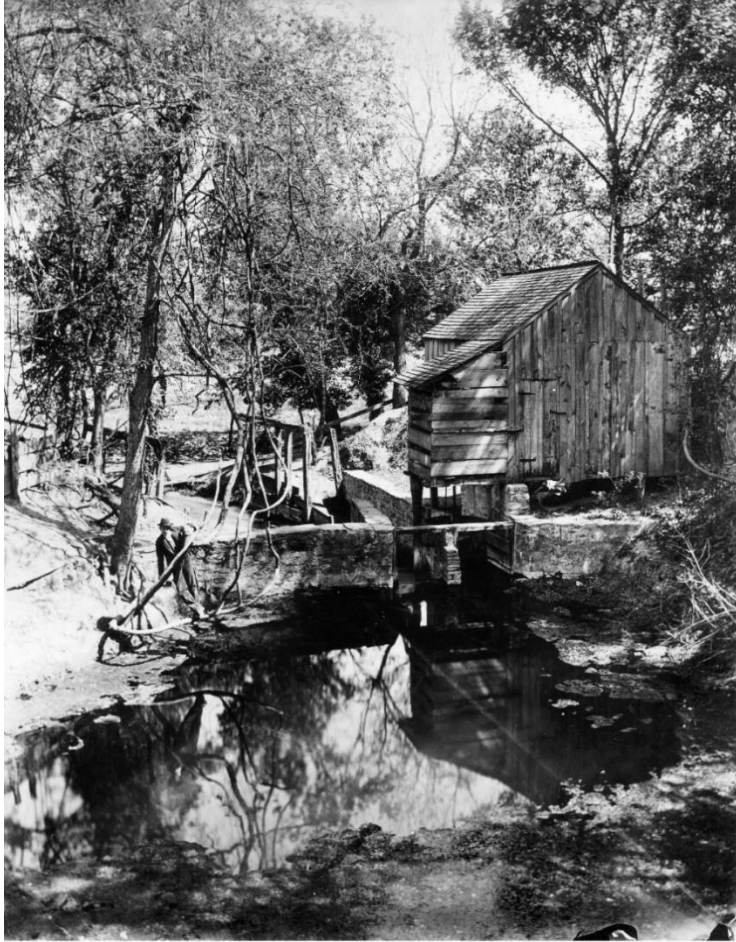
Figure 10. Photo of the Old Mill Spring and Paggi's Mill circa 1876. This is the earliest known photo of Old Mill Spring. The wall impounded the spring pool, slowing down the water velocity and increasing the water depth. Today most of the rock wall from the 1800s is gone. Photo from Austin History Center, C03293.

Old Mill Spring (also known as Sunken Garden Spring, Zenobia Spring, and Paggi's Mill) is located on the south side of Barton Creek downstream of Barton Springs Pool. Old Mill Spring and its salamander habitat were modified during the 1800s for a grist mill (Figure 10) and then again in the 1930s by the National Youth Administration, which built rock walls around the stream (Figure 11, 12, Limbaucher & Godfrey Architects 2008). Together these modifications have artificially increased the water depth, increased sediment deposition in the spring pool, reduced the riparian habitat around the spring pool, reduced the connection between the spring pool and the stream, and channelized the stream. Later, a pipe was added that diverted the flow from the streambed and decreased salamander habitat. Installation of the pipe was not documented but City of Austin staff believe it occurred during the 1970s.

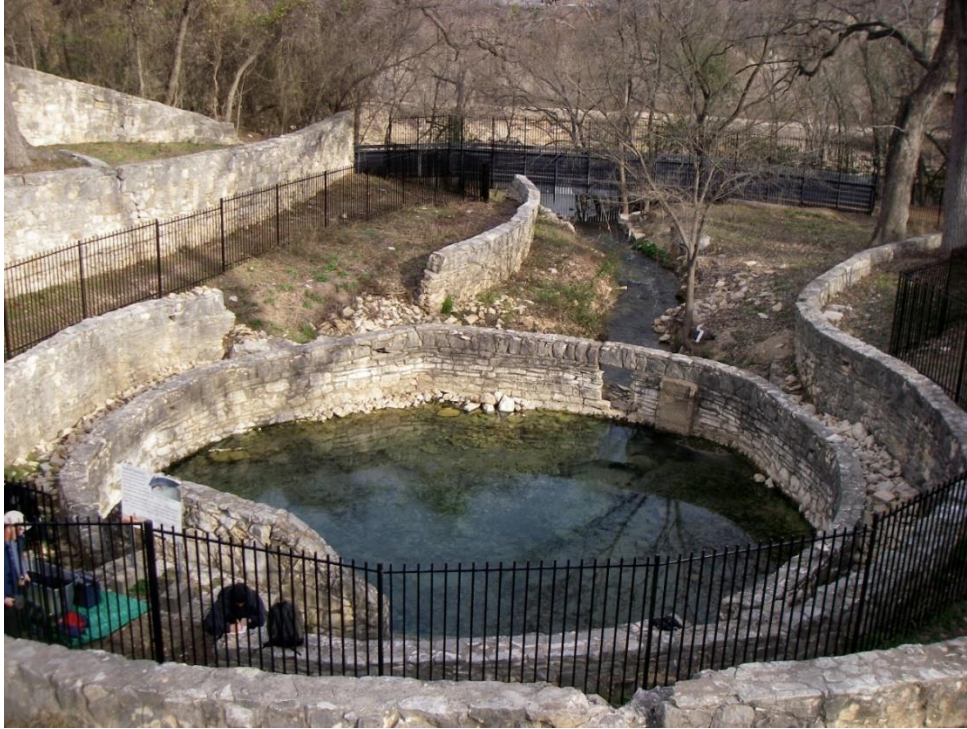
Figure 11. Old Mill Spring in 2008. The historical walls and wetted area of salamander habitat are the same as today (2018). The National Youth Administration walls remain surrounding the spring pool.

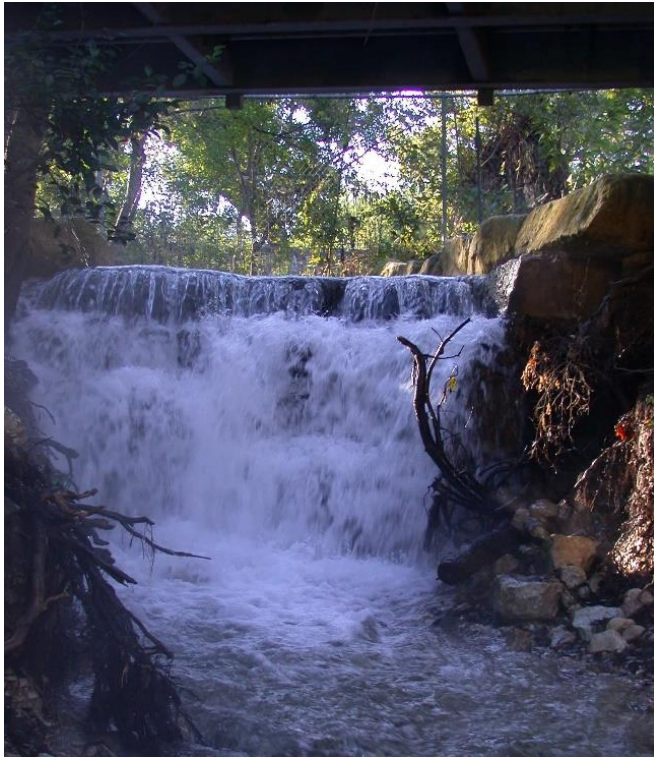
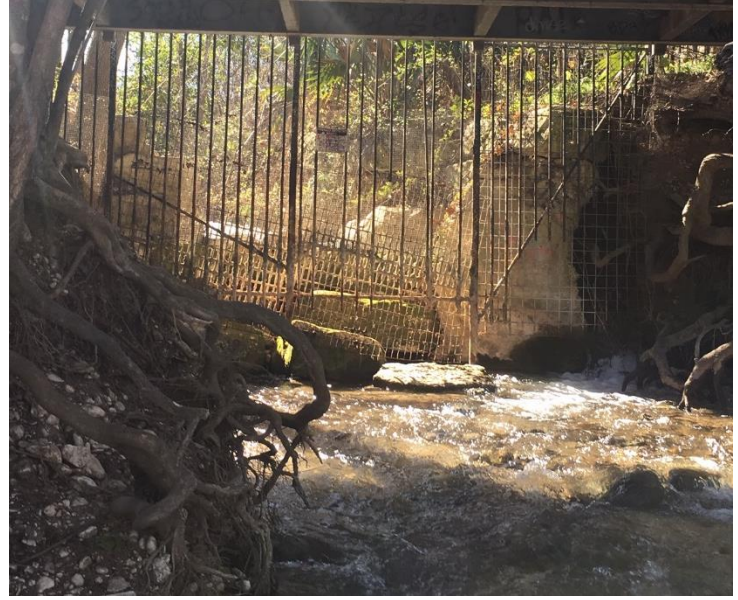
Figure 13. Waterfall installed at the Old Mill stream near Barton Creek in 2004 (left) and in 2019 (right) with the barrier fence installed. Concrete was removed from the water after construction. In the right, water is bypassing the waterfall and exiting through a cavity on the right bank near Barton Creek.
