HISTORIC LANDMARK COMMISSION
APRIL 27, 2020
APPLICATION FOR A CERTIFICATE OF APPROPRIATENESS
LHD-2020-0012
703 OAKLAND AVENUE
SMOOT/TERRACE PARK HISTORIC DISTRICT

PROPOSAL

Replace siding and windows, change the roof material, widen the front stoop, infill a second-story rear sleeping porch, demolish a rear garage, and add a below-grade basement.

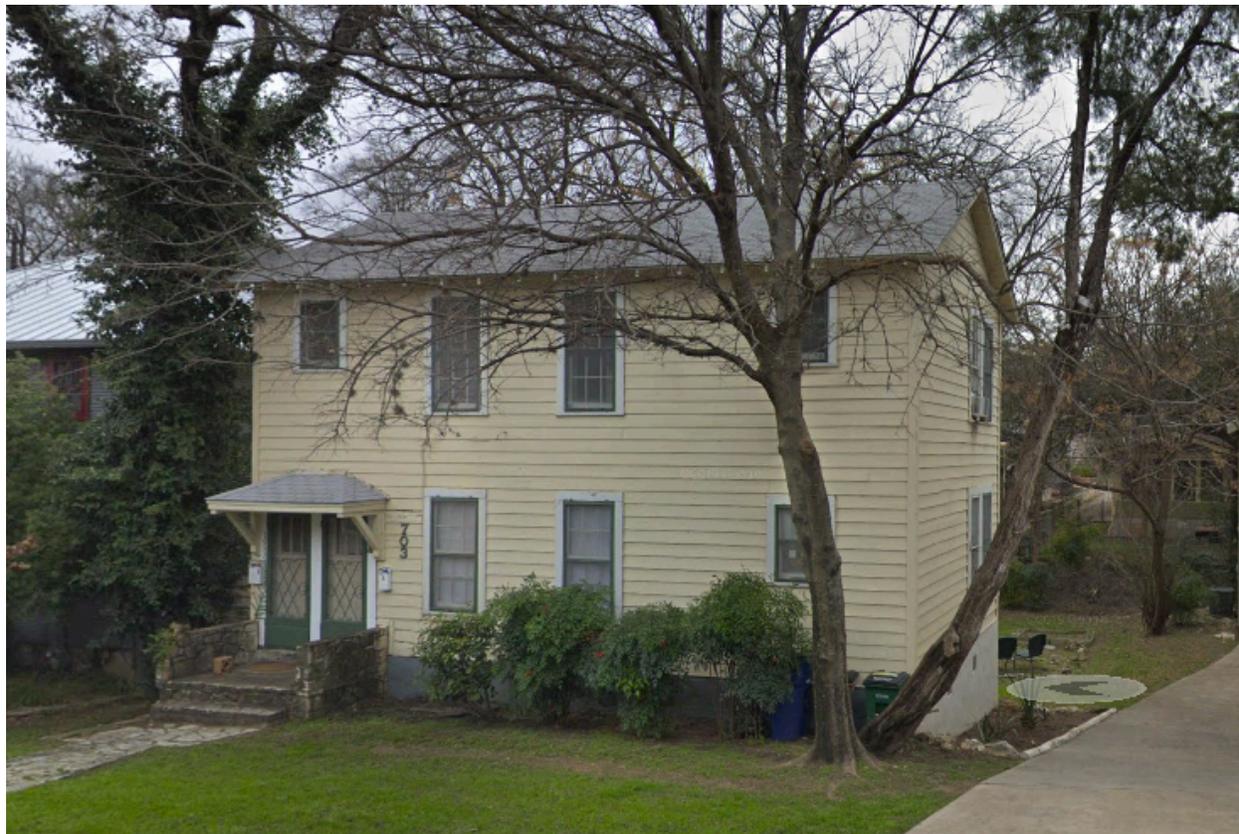
Primary (east) façade and south elevation of 703 Oakland Avenue. Source: Google Street View, February 2019.

Two-story, rectangular-plan house with a side-gabled roof, wood cladding, 1:1 and 6:6 wood-sash windows, and a hip-roofed entry portico with two wood doors.
