# HISTORIC LANDMARK COMMISSION APPLICATION FOR A CERTIFICATE OF APPROPRIATENESS NOVEMBER 15, 2021 C14H-2009-0029; HR-2021-148730 DAVIS HOUSE 1600 GASTON AVE.

## PROPOSAL

Construct a second-story addition over the garage.

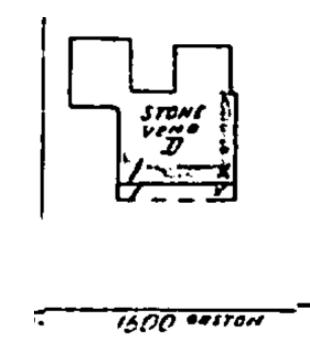
The 1961 Sanborn Fire Insurance Map of this property shows an integral garage at the current location.

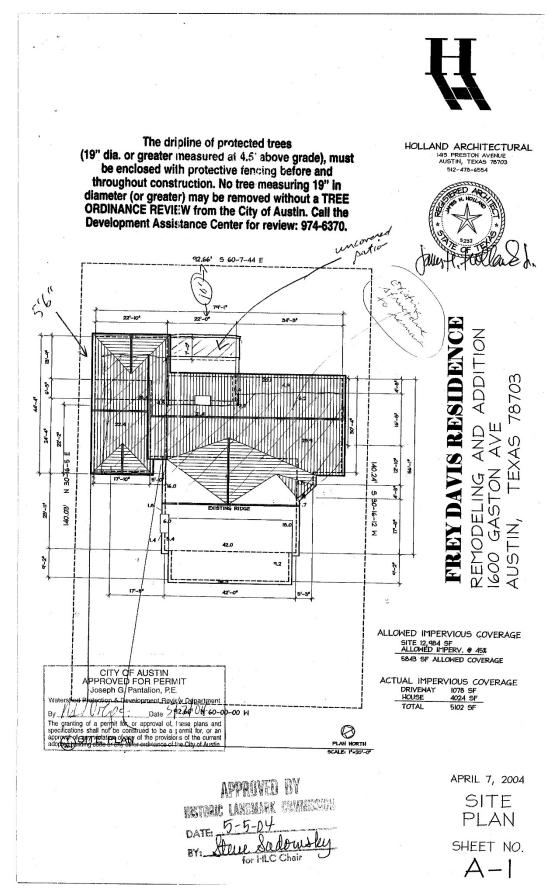
Building permit records indicate the garage was enlarged and rebuilt when other additions were made to the house in 2004, before the house became a landmark. No additional drawings, such as a demolition plan or elevation showing the changes to the garage, are currently available in permit records. Note the entire garage roof was replaced.

Modifications to the garage to accommodate the addition are more extensive, but this part of the house was previously changed. While detailed plan and elevation drawings are not available in permit records, the garage was enlarged and partially rebuilt in 2004, in conjunction with additions made to the house prior to landmark designation. Site plan drawings show a 5' increase in the width of the garage and full replacement of the roof to cover a larger overall footprint. The proposed work will reduce the width of the garage door, add a window, and relocate the entry door. These changes are compatible with the overall character of the house.

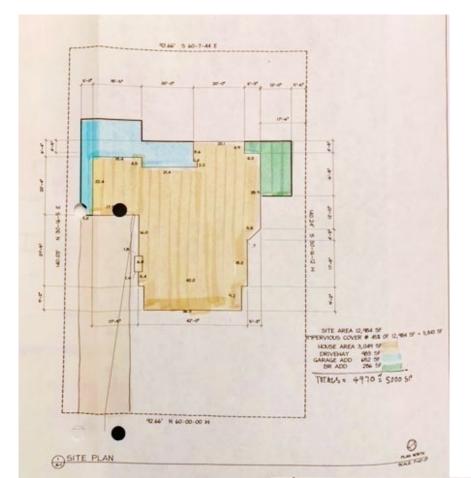
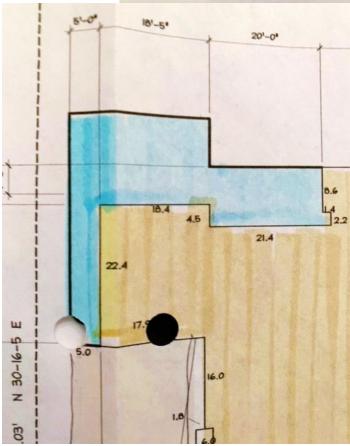
SITE AREA I	2,984 SF R @ 45% OF 12,984 SF = 5,843 SF
HOUSE AREA	3,049 SF 983 SF
TOTALS = "	+970 = 5000 SIE

Site plan (overall sheet and enlargements) showing footprint of 2004 garage addition, courtesy of applicant.
